Profile/Photo Observation Report

Date:	04/24/2018	Weather:		Coding:	PACP 6.0
Pipe Length (ft):	134.6	Owner:	NA	Pre Clean:	Not Known
P.O.#:		Surveyor:	Jen Costello	PSR:	P-905-030-031
Customer:		Clean Date:	01/01/1900	Shape:	C

Street:	130	Flow Control:	Not Controlled
City:	Hobart, IN	Year Renewed:	
Location:	Parking Lot	Tape/Media #:	
Purpose:	Maintenance Related	Dia/Height:	8"
Use:	Sanitary	Material:	PVC
Drain Area:	NA	Lining:	Cured in Place
Category:	NA		
Comment:

Location Details:		Direction of Survey:	Downstream
US MH:	M-905-030	DS MH:	M-905-031
		Total Length Surveyed (ft):	1.3

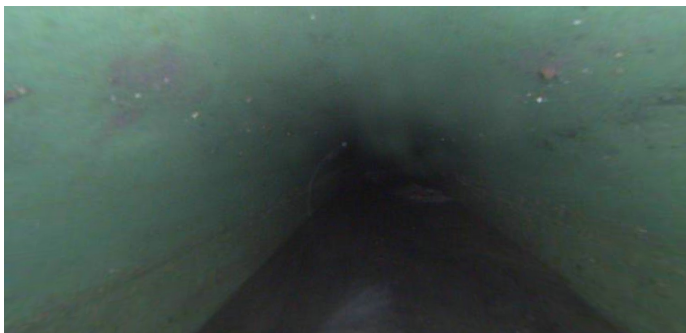
Code: **AMH**
Description: **Manhole**

Distance (ft): **.0**
Structural Grade: **0**
O&M Grade: **0**
Clock Start/From:
Clock To:
1st Value:
2nd Value:
Value Percent:
Continuous Index:
Within 8" of Joint: **NO**
Remarks: **M-905-030**

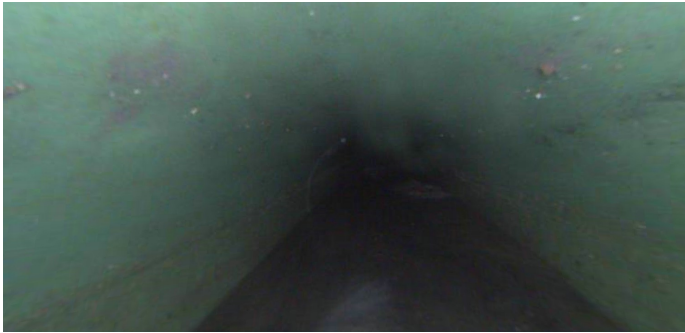
Code:	MWL
Description:	Water Level

Distance (ft):	.0
Structural Grade:	0
O&M Grade:	0
Clock Start/From:	
Clock To:	
1st Value:	
2nd Value:	
Value Percent:	30.000
Continuous Index:	
Within 8" of Joint:	NO
Remarks:

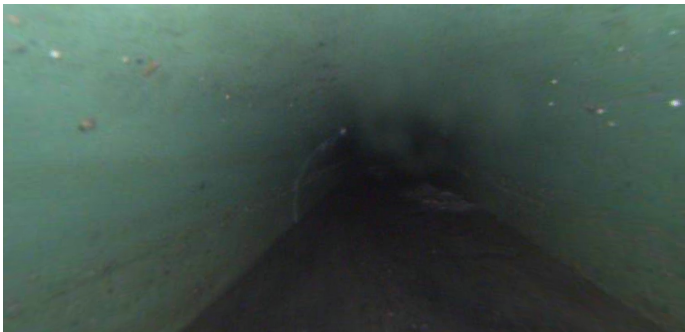
Code:	MSA
Description:	Abandoned Survey

Distance (ft):	1.3
Structural Grade:	0
O&M Grade:	0
Clock Start/From:	
Clock To:	
1st Value:	
2nd Value:	
Value Percent:	
Continuous Index:	
Within 8" of Joint:	NO
Remarks:	debris under water
