Profile/Photo Observation Report

Date:	04/23/2018	Weather:		Coding:	PACP 6.0
Pipe Length (ft):	263.1	Owner:	NA	Pre Clean:	Not Known
P.O.#:		Surveyor:	Jen Costello	PSR:	P-905-034-035
Customer:		Clean Date:	01/01/1900	Shape:	C

Street:	OFF S HOBART RD	Flow Control:	Not Controlled
City:	Hobart, IN	Year Renewed:	
Location:	Parking Lot	Tape/Media #:	
Purpose:	Maintenance Related	Dia/Height:	8"
Use:	Sanitary	Material:	PVC
Drain Area:	NA	Lining:	Cured in Place
Category:	NA		
Comment:	Pipe blocked with debris.		
Location Details:		Direction of Survey:	Downstream
US MH:	M-905-035	DS MH:	M-905-034
		Total Length Surveyed (ft):	1.6

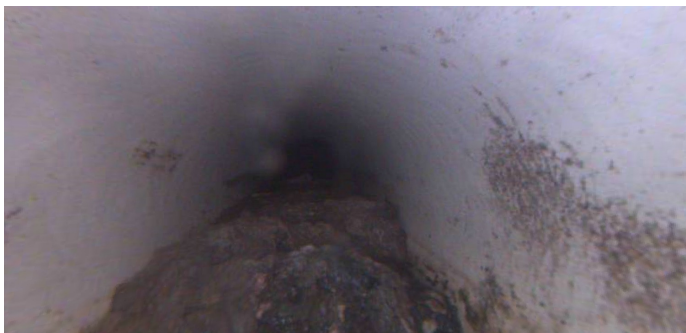
Code: **AMH**
Description: **Manhole**

Distance (ft): **.0**
Structural Grade: **0**
O&M Grade: **0**
Clock Start/From:
Clock To:
1st Value:
2nd Value:
Value Percent:
Continuous Index:
Within 8" of Joint: **NO**
Remarks: **M-905-035**

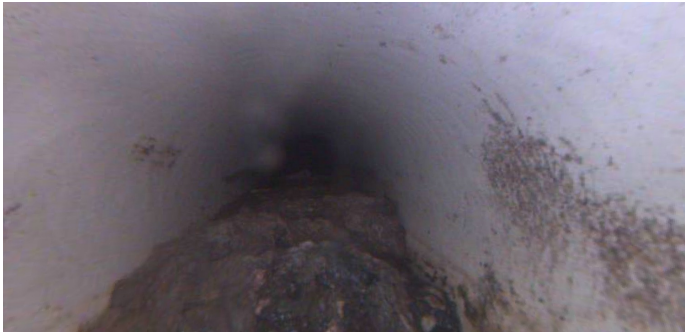
Code:	MWL
Description:	Water Level

Distance (ft):	.0
Structural Grade:	0
O&M Grade:	0
Clock Start/From:	
Clock To:	
1st Value:	
2nd Value:	
Value Percent:	0.000
Continuous Index:	
Within 8" of Joint:	NO
Remarks:

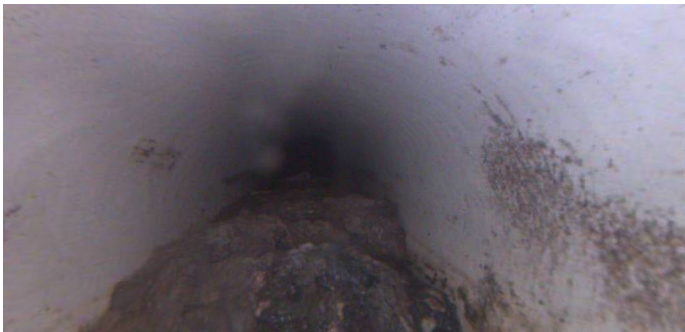
Code:	DSZ
Description:	Deposits Settled Other

Distance (ft):	.0
Structural Grade:	0
O&M Grade:	5
Clock Start/From:	3
Clock To:	9
1st Value:	
2nd Value:	
Value Percent:	40.000
Continuous Index:	
Within 8" of Joint:	NO
Remarks:	MISC

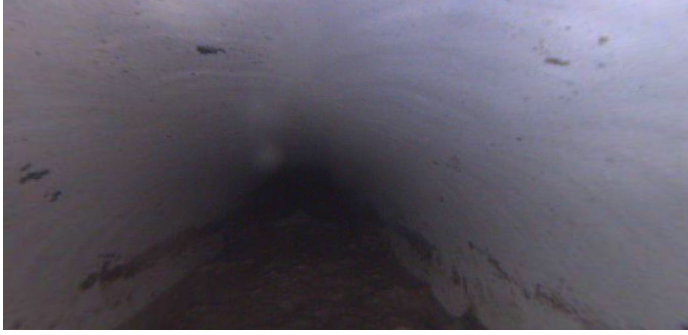
Code:	MSA
Description:	Abandoned Survey
Distance (ft):	1.6
Structural Grade:	0
O&M Grade:	0
Clock Start/From:	
Clock To:	
1st Value:	
2nd Value:	
Value Percent:	
Continuous Index:	
Within 8" of Joint:	NO
Remarks:	UNKNOWN
