Profile/Photo Observation Report

Street:	Hobart	Flow Control:	Not Controlled
City:	Hobart, IN	Year Renewed:	
Location:	Parking Lot	Tape/Media #:	
Purpose:	Maintenance Related	Dia/Height:	8"
Use:	Sanitary	Material:	PVC
Drain Area:	NA	Lining:	Cured in Place
Category:	NA		
Comment:	Pipe blocked with debris.

Location Details:		Direction of Survey:	Downstream
US MH:	M-905-035	DS MH:	M-905-034
		Total Length Surveyed (ft):	1.6

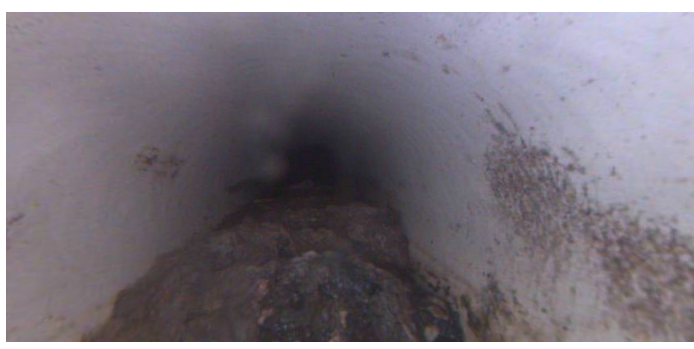
Code: **AMH**
Description: **Manhole**

Distance (ft): **.0**
Structural Grade: **0**
O&M Grade: **0**
Clock Start/From:
Clock To:
1st Value:
2nd Value:
Value Percent:
Continuous Index:
Within 8" of Joint: **NO**
Remarks: **M-905-035**

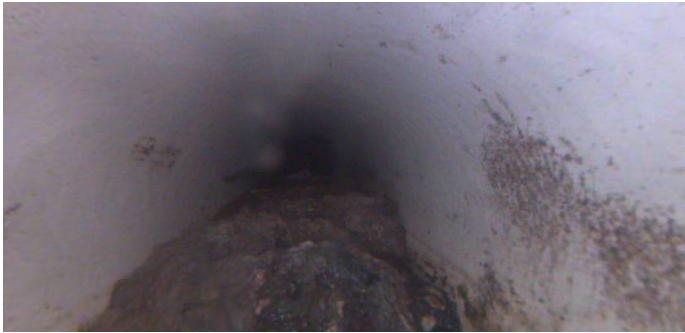
Code:	MWL
Description:	Water Level

Distance (ft):	.0
Structural Grade:	0
O&M Grade:	0
Clock Start/From:	
Clock To:	
1st Value:	
2nd Value:	
Value Percent:	0.000
Continuous Index:	
Within 8" of Joint:	NO
Remarks:

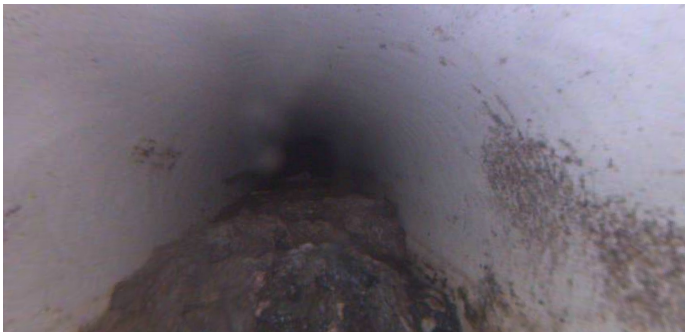
Code:	DSZ
Description:	Deposits Settled Other

Distance (ft):	.0
Structural Grade:	0
O&M Grade:	5
Clock Start/From:	3
Clock To:	9
1st Value:	
2nd Value:	
Value Percent:	40.000
Continuous Index:	
Within 8" of Joint:	NO
Remarks:	MISC

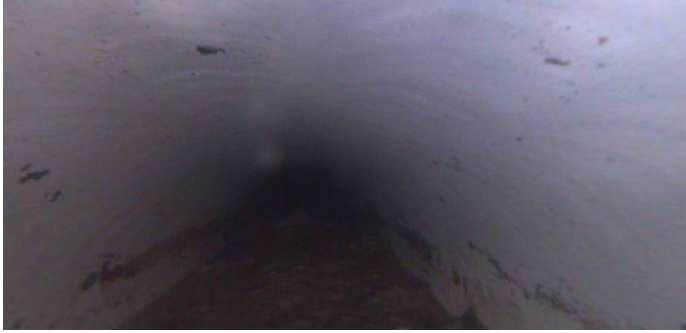
Code:	MSA
Description:	Abandoned Survey
Distance (ft):	1.6
Structural Grade:	0
O&M Grade:	0
Clock Start/From:	
Clock To:	
1st Value:	
2nd Value:	
Value Percent:	
Continuous Index:	
Within 8" of Joint:	NO
Remarks:	UNKNOWN
