Profile/Photo Observation Report

Date:	04/13/2018	Weather:		Coding:	PACP 6.0
Pipe Length (ft):	252.2	Owner:	NA	Pre Clean:	Not Known
P.O.#:		Surveyor:	Jen Costello	PSR:	P-906-001-002
Customer:		Clean Date:	01/01/1900	Shape:	C

Street:	E 10TH ST	Flow Control:	Not Controlled
City:	Hobart, IN	Year Renewed:	
Location:	Sidewalk	Tape/Media #:	
Purpose:	Maintenance Related	Dia/Height:	8"
Use:	Sanitary	Material:	VCP
Drain Area:	NA	Lining:	Cured in Place
Category:	NA		
Comment:	heavy debris/underwater at 242'.		
Location Details:		Direction of Survey:	Downstream
US MH:	M-906-001	DS MH:	M-906-002
		Total Length Surveyed (ft):	243.3

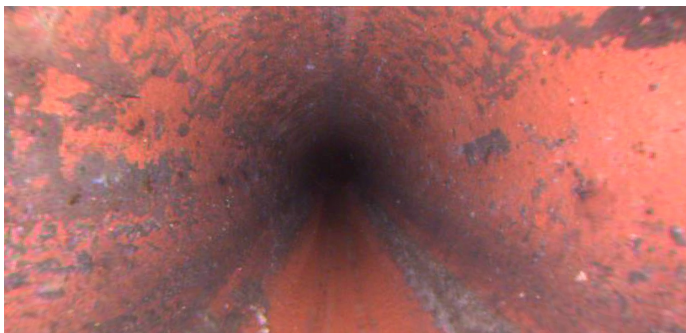
Code: **AMH**
Description: **Manhole**

Distance (ft): **.0**
Structural Grade: **0**
O&M Grade: **0**
Clock Start/From:
Clock To:
1st Value:
2nd Value:
Value Percent:
Continuous Index:
Within 8" of Joint: **NO**
Remarks: **M-906-001**

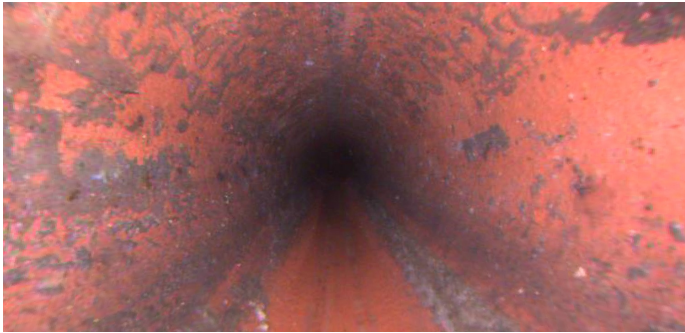
Code:	MWL
Description:	Water Level

Distance (ft):	.0
Structural Grade:	0
O&M Grade:	0
Clock Start/From:	
Clock To:	
1st Value:	
2nd Value:	
Value Percent:	5.000
Continuous Index:	
Within 8" of Joint:	NO
Remarks:

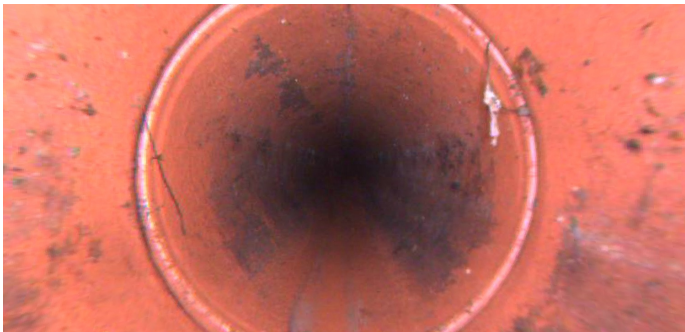
Code:	RFJ
Description:	Roots Fine Joint

Distance (ft):	4.5
Structural Grade:	0
O&M Grade:	1
Clock Start/From:	9
Clock To:	3
1st Value:	
2nd Value:	
Value Percent:	
Continuous Index:	
Within 8" of Joint:	YES
Remarks:

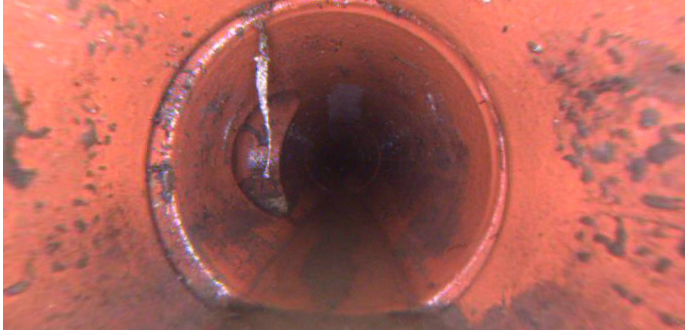
Code: **RFJ**
Description: **Roots Fine Joint**

Distance (ft): **9.9**
Structural Grade: **0**
O&M Grade: **1**
Clock Start/From: **8**
Clock To: **4**
1st Value:
2nd Value:
Value Percent:
Continuous Index: **S01**
Within 8" of Joint: **YES**
Remarks:

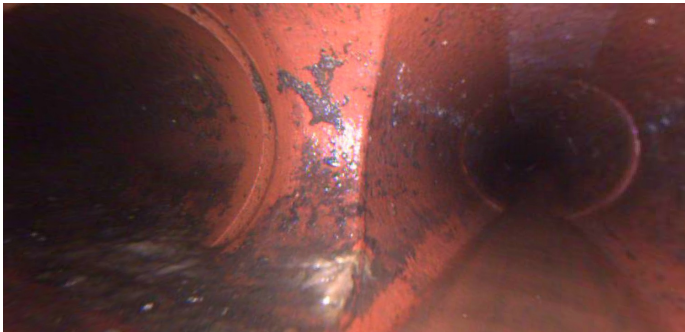
Code: **TF**
Description: **Tap Factory**

Distance (ft): **10.7**
Structural Grade: **0**
O&M Grade: **0**
Clock Start/From: **9**
Clock To:
1st Value: **4.000**
2nd Value:
Value Percent:
Continuous Index:
Within 8" of Joint:
Remarks:

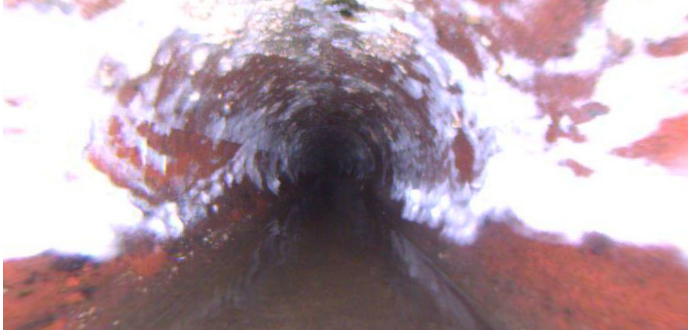
Code:	DAGS
Description:	Deposits Attached Grease
Distance (ft):	53.2
Structural Grade:	0
O&M Grade:	2
Clock Start/From:	8
Clock To:	4
1st Value:	
2nd Value:	
Value Percent:	5.000
Continuous Index:	S02
Within 8" of Joint:	NO
Remarks:

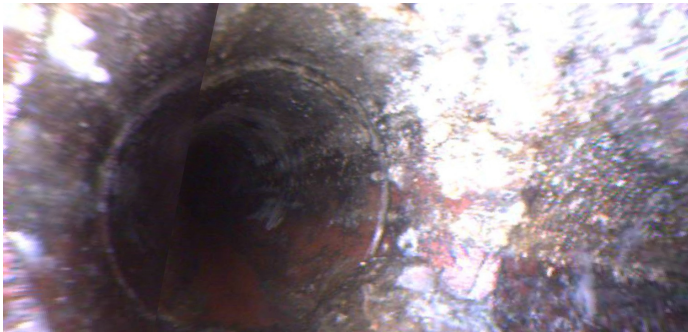
Code:	TF
Description:	Tap Factory
Distance (ft):	88.7
Structural Grade:	0
O&M Grade:	0
Clock Start/From:	9
Clock To:	
1st Value:	4.000
2nd Value:	
Value Percent:	
Continuous Index:	
Within 8" of Joint:	
Remarks:

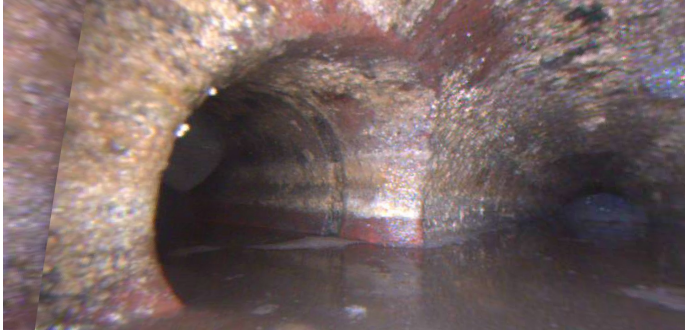
Code: **TFA**
Description: **Tap Factory Active**

Distance (ft): **183.4**
Structural Grade: **0**
O&M Grade: **0**
Clock Start/From: **9**
Clock To:
1st Value: **4.000**
2nd Value:
Value Percent:
Continuous Index:
Within 8" of Joint:
Remarks:
