Profile/Photo Observation Report

Street:	Capitol	Flow Control:	Not Controlled
City:	Hobart, IN	Year Renewed:	
Location:	Sidewalk	Tape/Media #:	
Purpose:	Maintenance Related	Dia/Height:	8"
Use:	Sanitary	Material:	VCP
Drain Area:	NA	Lining:	Cured in Place
Category:	NA		
Comment:	heavy debris/underwater at 242'.		
Location Details:		Direction of Survey:	Downstream
US MH:	M-906-001	DS MH:	M-906-002
		Total Length Surveyed (ft):	243.3

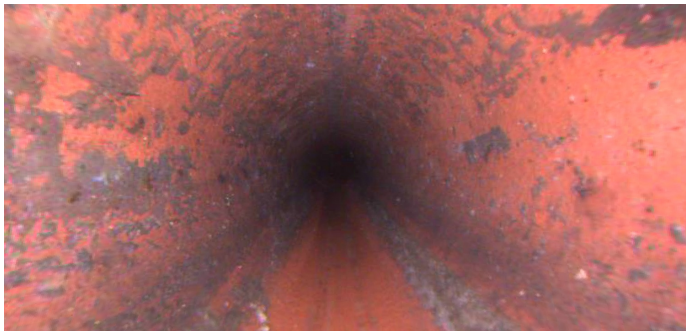
Code: **AMH**
Description: **Manhole**

Distance (ft): **.0**
Structural Grade: **0**
O&M Grade: **0**
Clock Start/From:
Clock To:
1st Value:
2nd Value:
Value Percent:
Continuous Index:
Within 8" of Joint: **NO**
Remarks: **M-906-001**

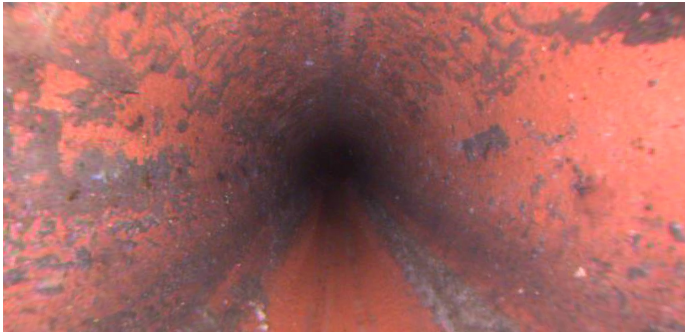
Code:	MWL
Description:	Water Level

Distance (ft):	.0
Structural Grade:	0
O&M Grade:	0
Clock Start/From:	
Clock To:	
1st Value:	
2nd Value:	
Value Percent:	5.000
Continuous Index:	
Within 8" of Joint:	NO
Remarks:

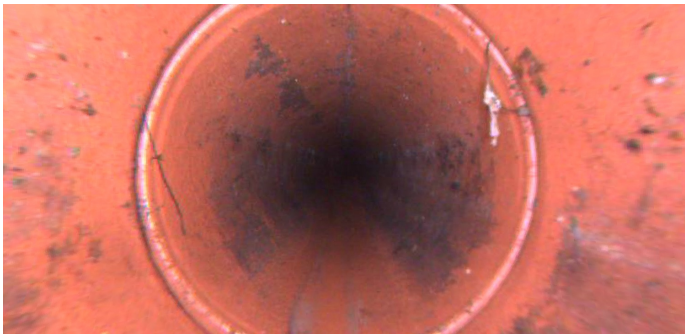
Code:	RFJ
Description:	Roots Fine Joint

Distance (ft):	4.5
Structural Grade:	0
O&M Grade:	1
Clock Start/From:	9
Clock To:	3
1st Value:	
2nd Value:	
Value Percent:	
Continuous Index:	
Within 8" of Joint:	YES
Remarks:

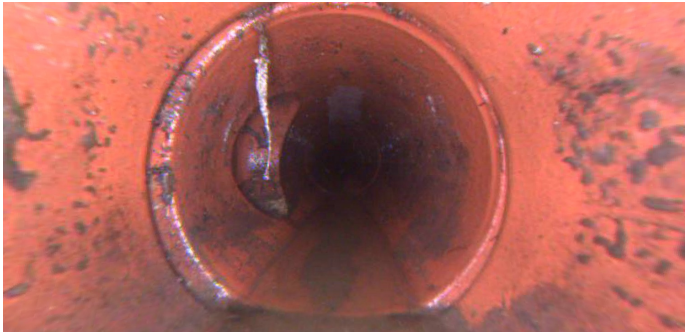
Code: **RFJ**
Description: **Roots Fine Joint**

Distance (ft): **9.9**
Structural Grade: **0**
O&M Grade: **1**
Clock Start/From: **8**
Clock To: **4**
1st Value:
2nd Value:
Value Percent:
Continuous Index: **S01**
Within 8" of Joint: **YES**
Remarks:

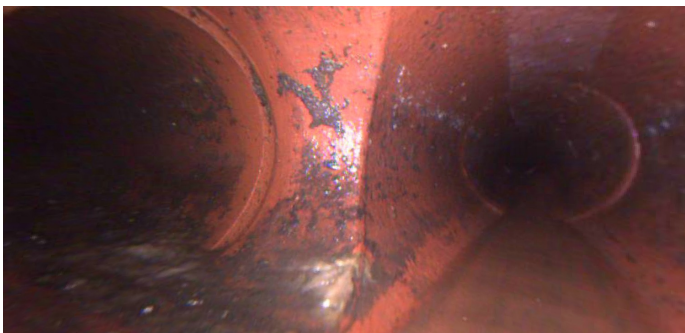
Code: **TF**
Description: **Tap Factory**

Distance (ft): **10.7**
Structural Grade: **0**
O&M Grade: **0**
Clock Start/From: **9**
Clock To:
1st Value: **4.000**
2nd Value:
Value Percent:
Continuous Index:
Within 8" of Joint:
Remarks:

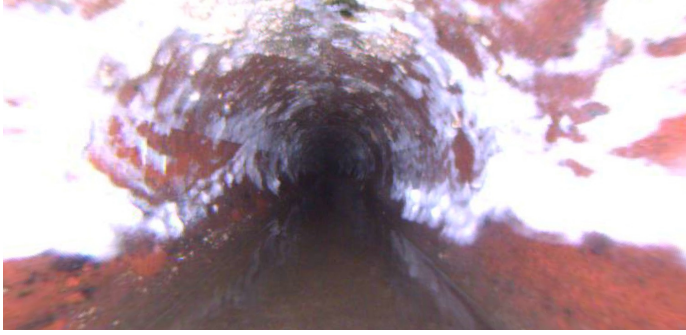
Code: **DAGS**
Description: **Deposits Attached Grease**

Distance (ft): **53.2**
Structural Grade: **0**
O&M Grade: **2**
Clock Start/From: **8**
Clock To: **4**
1st Value:
2nd Value:
Value Percent: **5.000**
Continuous Index: **S02**
Within 8" of Joint: **NO**
Remarks:

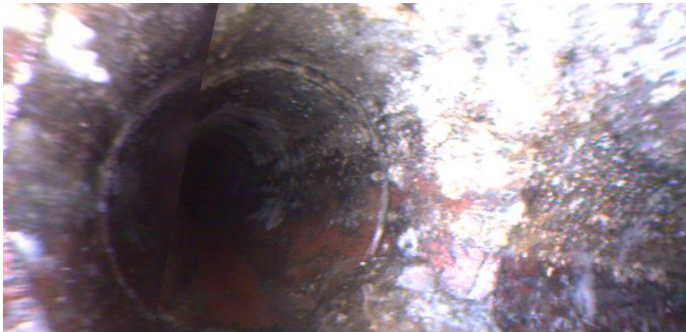
Code: **TF**
Description: **Tap Factory**

Distance (ft): **88.7**
Structural Grade: **0**
O&M Grade: **0**
Clock Start/From: **9**
Clock To:
1st Value: **4.000**
2nd Value:
Value Percent:
Continuous Index:
Within 8" of Joint:
Remarks:

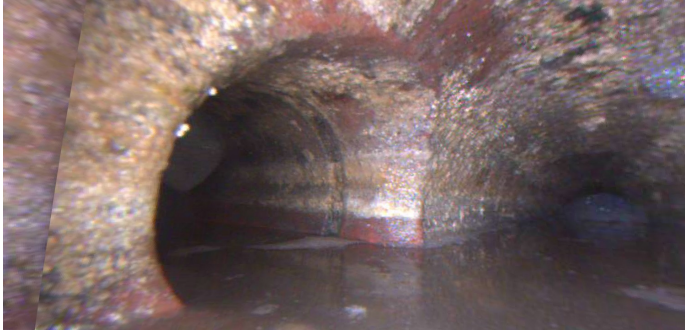
Code: **TFA**
Description: **Tap Factory Active**

Distance (ft): **183.4**
Structural Grade: **0**
O&M Grade: **0**
Clock Start/From: **9**
Clock To:
1st Value: **4.000**
2nd Value:
Value Percent:
Continuous Index:
Within 8" of Joint:
Remarks:
