Profile/Photo Observation Report

Street:	E 10TH ST & SULLIVAN ST	Flow Control:	Not Controlled
City:	Hobart, IN	Year Renewed:	
Location:	Sidewalk	Tape/Media #:	
Purpose:	Maintenance Related	Dia/Height:	8"
Use:	Sanitary	Material:	VCP
Drain Area:	NA	Lining:	Cured in Place
Category:	NA		
Comment:	possible roots at joint at 133'.		
Location Details:		Direction of Survey:	Downstream
US MH:	M-906-002	DS MH:	M-906-003
		Total Length Surveyed (ft):	134.6

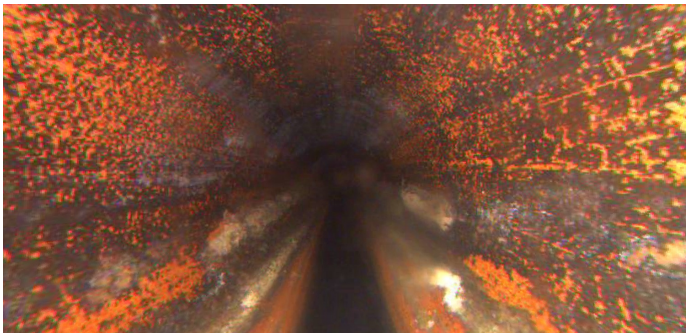
Code:	MWL
Description:	Water Level

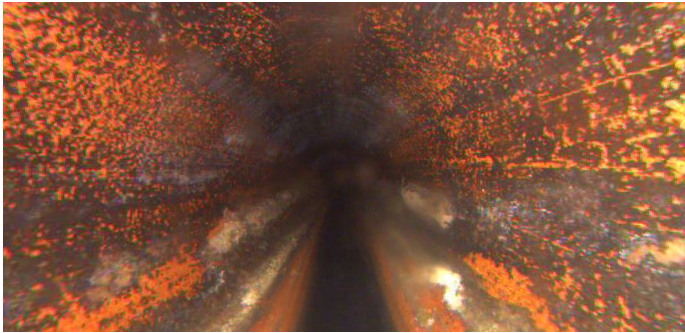
Code:	DAGS
Description:	Deposits Attached Grease

Distance (ft):	.0
Structural Grade:	0
O&M Grade:	2
Clock Start/From:	8
Clock To:	4
1st Value:	
2nd Value:	
Value Percent:	5.000
Continuous Index:	S01
Within 8" of Joint:	NO
Remarks:

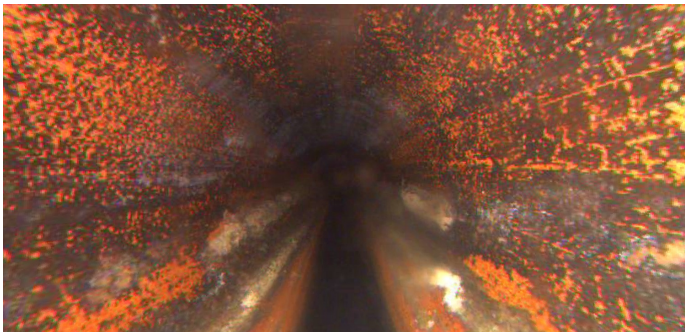
Code: **TFA**
Description: **Tap Factory Active**

Distance (ft): **31.1**
Structural Grade: **0**
O&M Grade: **0**
Clock Start/From: **9**
Clock To:
1st Value: **4.000**
2nd Value:
Value Percent:
Continuous Index:
Within 8" of Joint:
Remarks:

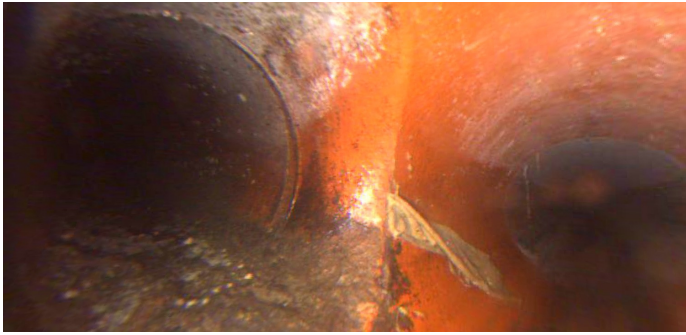
Code: **RFJ**
Description: **Roots Fine Joint**

Distance (ft): **32.2**
Structural Grade: **0**
O&M Grade: **1**
Clock Start/From: **10**
Clock To: **11**
1st Value:
2nd Value:
Value Percent:
Continuous Index:
Within 8" of Joint: **YES**
Remarks:

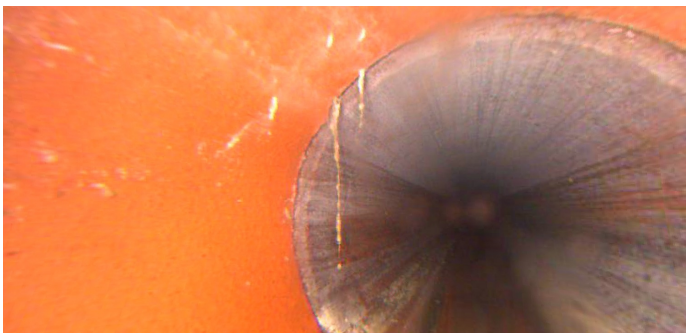
Code: **DAGS**
Description: **Deposits Attached Grease**

Distance (ft): **47.2**
Structural Grade: **0**
O&M Grade: **2**
Clock Start/From: **8**
Clock To: **4**
1st Value:
2nd Value:
Value Percent: **5.000**
Continuous Index: **F01**
Within 8" of Joint: **NO**
Remarks:

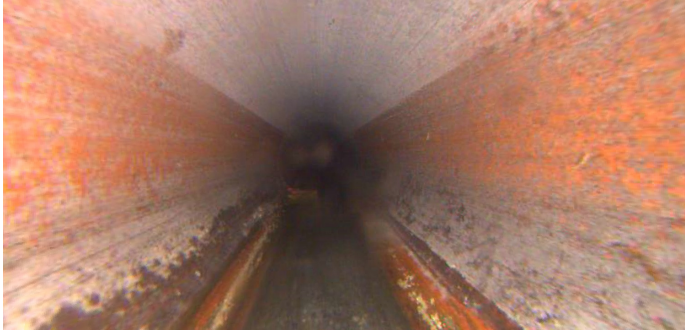
Code: **RMJ**
Description: **Roots Medium Joint**

Distance (ft): **105.2**
Structural Grade: **0**
O&M Grade: **3**
Clock Start/From: **3**
Clock To: **4**
1st Value:
2nd Value:
Value Percent: **10.000**
Continuous Index:
Within 8" of Joint: **YES**
Remarks:

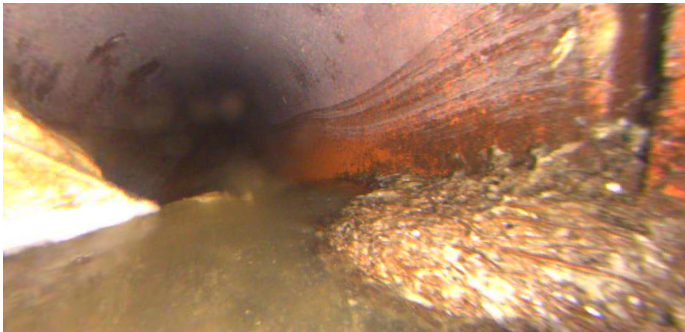
Code: **DAR**
Description: **Deposits Attached Ragging**

Distance (ft): **105.3**
Structural Grade: **0**
O&M Grade: **3**
Clock Start/From: **6**
Clock To: **10**
1st Value:
2nd Value:
Value Percent: **20.000**
Continuous Index:
Within 8" of Joint: **YES**
Remarks:

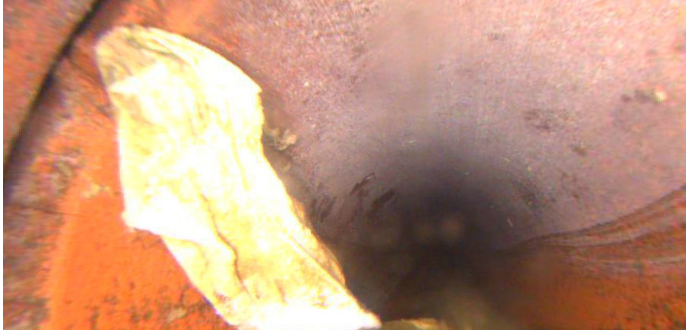
Code: **RFJ**
Description: **Roots Fine Joint**

Distance (ft): **127.5**
Structural Grade: **0**
O&M Grade: **1**
Clock Start/From: **4**
Clock To:
1st Value:
2nd Value:
Value Percent:
Continuous Index:
Within 8" of Joint: **YES**
Remarks:

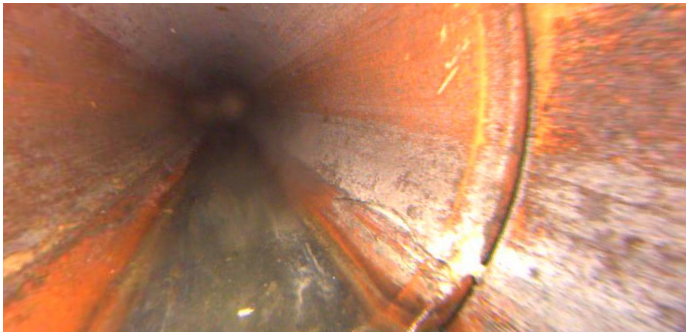
Code: **RMJ**
Description: **Roots Medium Joint**

Distance (ft): **133.3**
Structural Grade: **0**
O&M Grade: **3**
Clock Start/From: **7**
Clock To: **9**
1st Value:
2nd Value:
Value Percent: **5.000**
Continuous Index:
Within 8" of Joint: **YES**
Remarks:

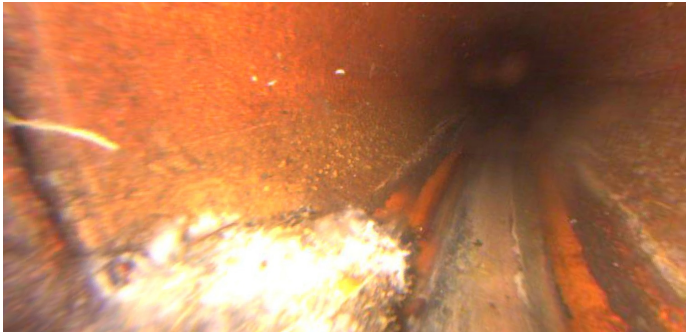
Code: **MSA**
Description: **Abandoned Survey**

Distance (ft): **134.6**
Structural Grade: **0**
O&M Grade: **0**
Clock Start/From:
Clock To:
1st Value:
2nd Value:
Value Percent:
Continuous Index:
Within 8" of Joint: **NO**
Remarks: **ROOTS**
