## Profile/Photo Observation Report

Street:	<b>Off 10th Street</b>	Flow Control:	
City:	<b>Hobart, IN</b>	Year Renewed:	
Location:	<b>Sidewalk</b>	Tape/Media #:	<b>968</b>
Purpose:	<b>Routine Assessment</b>	Dia/Height:	<b>8"</b>
Use:	<b>Sanitary</b>	Material:	<b>PVC</b>
Drain Area:		Lining:	
Category:	<b>NA</b>		
Comment:

Location Details:		Direction of Survey:	<b>Downstream</b>
US MH:	<b>M-906-3</b>	DS MH:	<b>M-907-22</b>
		Total Length Surveyed (ft):	<b>18.9</b>

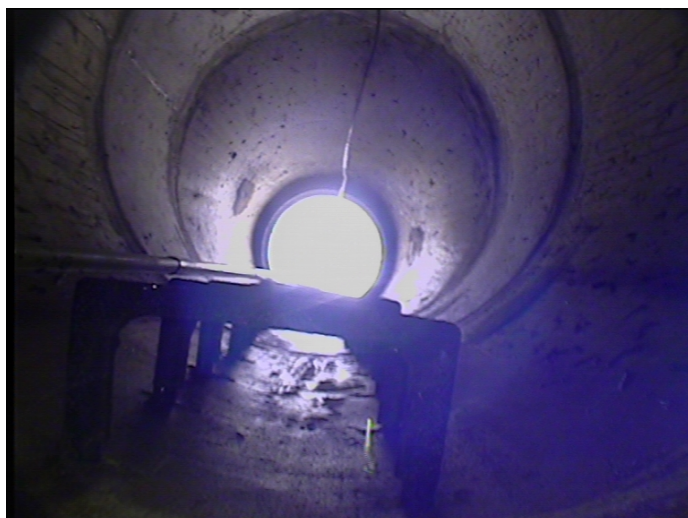
Code: **AMH**  
Description: **Manhole**

Distance (ft): **.0**  
Structural Grade: **0**  
O&M Grade: **0**  
Clock Start/From:  
Clock To:  
1st Value:  
2nd Value:  
Value Percent:  
Continuous Index:  
Within 8" of Joint: **NO**  
Remarks: **M-906-3**

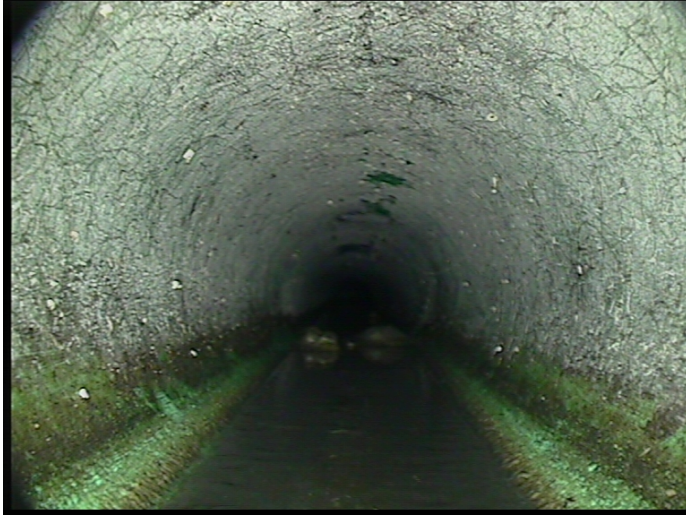
Code: **MWL**  
Description: **Water Level**

Distance (ft): **.0**  
Structural Grade: **0**  
O&M Grade: **0**  
Clock Start/From:  
Clock To:  
1st Value:  
2nd Value:  
Value Percent: **5.000**  
Continuous Index:  
Within 8" of Joint: **NO**  
Remarks:

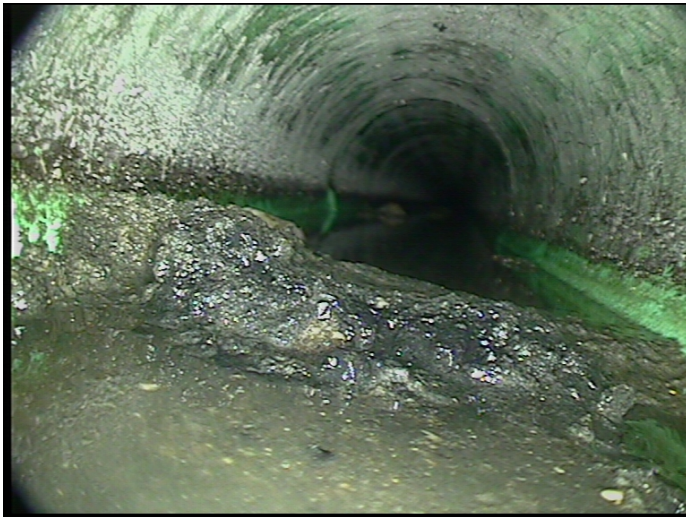
Code: **DSF**  
Description: **Deposits Settled Fine**

Distance (ft): **11.0**  
Structural Grade: **0**  
O&M Grade: **3**  
Clock Start/From: **4**  
Clock To: **8**  
1st Value:  
2nd Value:  
Value Percent: **15.000**  
Continuous Index:  
Within 8" of Joint: **NO**  
Remarks:

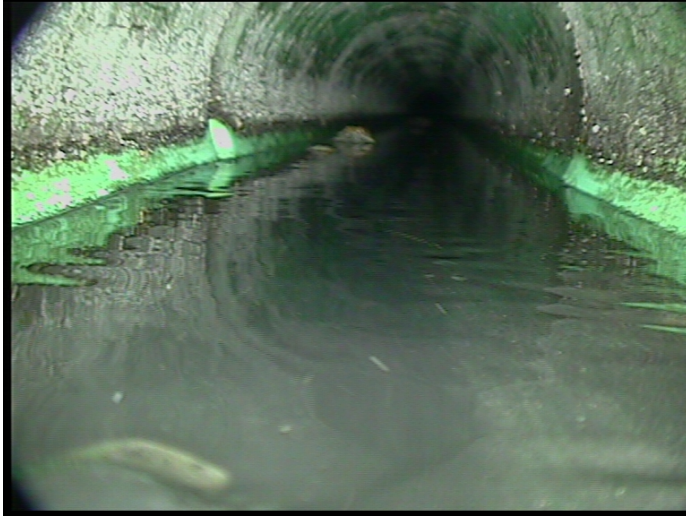
Code:	<b>MSA</b>
Description:	<b>Abandoned Survey</b>
Distance (ft):	<b>18.9</b>
Structural Grade:	<b>0</b>
O&M Grade:	<b>0</b>
Clock Start/From:	
Clock To:	
1st Value:	
2nd Value:	
Value Percent:	
Continuous Index:	
Within 8" of Joint:	<b>NO</b>
Remarks:	<b>Sediment and debris</b>
