## Profile/Photo Observation Report

Date:	<b>04/12/2018</b>	Weather:		Coding:	<b>PACP 6.0</b>
Pipe Length (ft):	<b>362.2</b>	Owner:	<b>NA</b>	Pre Clean:	<b>Not Known</b>
P.O.#:		Surveyor:	<b>Jen Costello</b>	PSR:	<b>P-906-006-005</b>
Customer:		Clean Date:	<b>01/01/1900</b>	Shape:	<b>C</b>

Street:	<b>Capitol</b>	Flow Control:	<b>Not Controlled</b>
City:	<b>Hobart, IN</b>	Year Renewed:	
Location:	<b>Yard</b>	Tape/Media #:	
Purpose:	<b>Maintenance Related</b>	Dia/Height:	<b>8"</b>
Use:	<b>Sanitary</b>	Material:	<b>VCP</b>
Drain Area:	<b>NA</b>	Lining:	<b>Cured in Place</b>
Category:	<b>NA</b>		
Comment:	<b>sediment on sidewall at 9'.</b>		
Location Details:		Direction of Survey:	<b>Upstream</b>
US MH:	<b>M-906-006</b>	DS MH:	<b>M-906-005</b>
		Total Length Surveyed (ft):	<b>9.3</b>

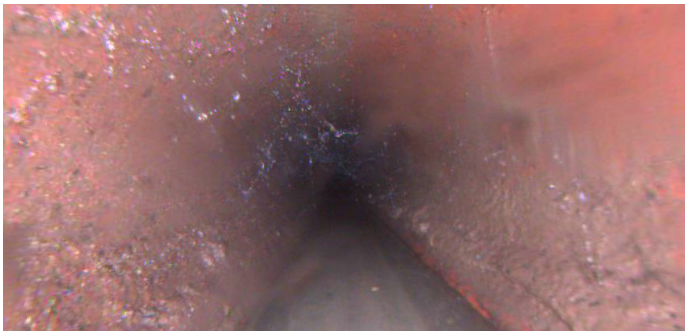
Code: **AMH**  
Description: **Manhole**

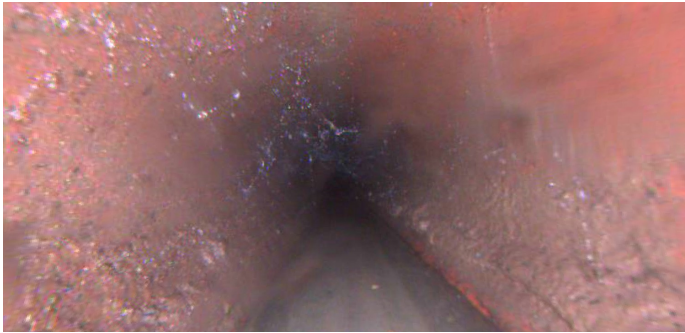
Code:	<b>MWL</b>
Description:	<b>Water Level</b>

Distance (ft):	<b>.0</b>
Structural Grade:	<b>0</b>
O&M Grade:	<b>0</b>
Clock Start/From:	
Clock To:	
1st Value:	
2nd Value:	
Value Percent:	<b>5.000</b>
Continuous Index:	
Within 8" of Joint:	<b>NO</b>
Remarks:

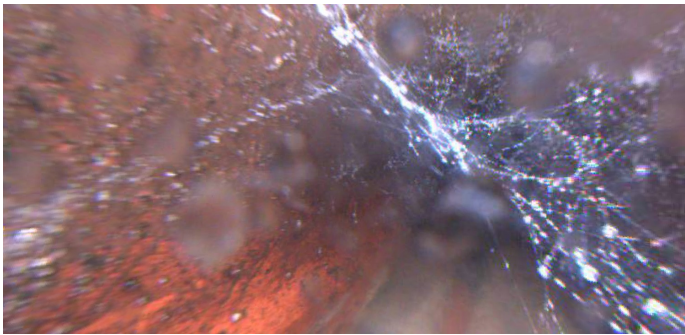
Code:	<b>DAGS</b>
Description:	<b>Deposits Attached Grease</b>

Distance (ft):	<b>9.3</b>
Structural Grade:	<b>0</b>
O&M Grade:	<b>2</b>
Clock Start/From:	<b>8</b>
Clock To:	<b>4</b>
1st Value:	
2nd Value:	
Value Percent:	<b>5.000</b>
Continuous Index:	
Within 8" of Joint:	<b>NO</b>
Remarks:

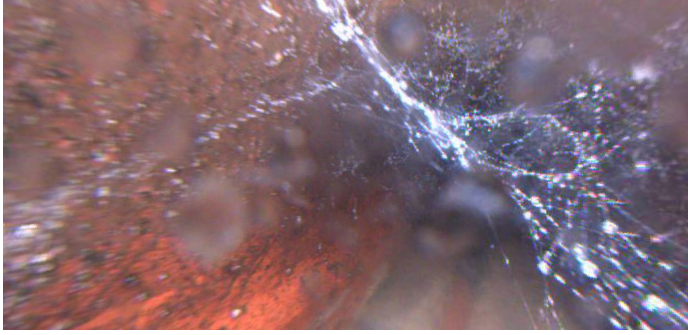
Code:	<b>MSA</b>
Description:	<b>Abandoned Survey</b>
Distance (ft):	<b>9.3</b>
Structural Grade:	<b>0</b>
O&M Grade:	<b>0</b>
Clock Start/From:	
Clock To:	
1st Value:	
2nd Value:	
Value Percent:	
Continuous Index:	
Within 8" of Joint:	<b>NO</b>
Remarks:	<b>dags</b>
