Profile/Photo Observation Report

Street:	E 10TH ST & SULLIVAN ST	Flow Control:	Not Controlled
City:	Hobart, IN	Year Renewed:	
Location:	Yard	Tape/Media #:	
Purpose:	Maintenance Related	Dia/Height:	8"
Use:	Sanitary	Material:	PVC
Drain Area:	NA	Lining:	Cured in Place
Category:	NA		
Comment:

Location Details:		Direction of Survey:	Downstream
US MH:	M-906-008	DS MH:	M-906-003
		Total Length Surveyed (ft):	229.2

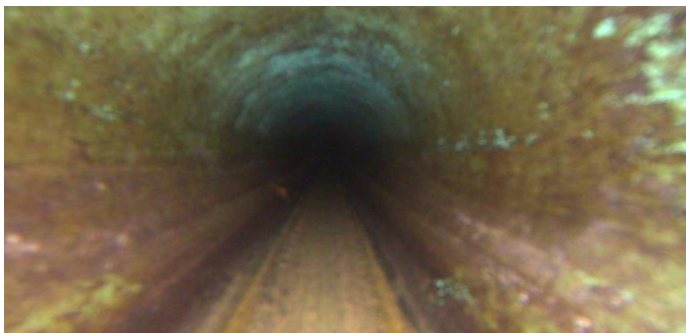
Code: **AMH**
Description: **Manhole**

Distance (ft): **.0**
Structural Grade: **0**
O&M Grade: **0**
Clock Start/From:
Clock To:
1st Value:
2nd Value:
Value Percent:
Continuous Index:
Within 8" of Joint: **NO**
Remarks: **M-906-008**

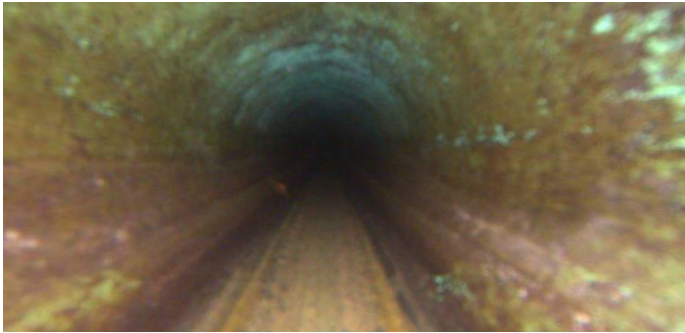
Code:	MWL
Description:	Water Level

Distance (ft):	.0
Structural Grade:	0
O&M Grade:	0
Clock Start/From:	
Clock To:	
1st Value:	
2nd Value:	
Value Percent:	5.000
Continuous Index:	
Within 8" of Joint:	NO
Remarks:

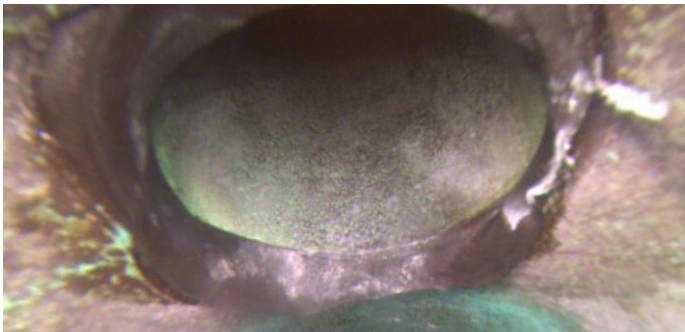
Code:	TS
Description:	Tap Saddle

Distance (ft):	24.6
Structural Grade:	0
O&M Grade:	0
Clock Start/From:	12
Clock To:	
1st Value:	4.000
2nd Value:	
Value Percent:	
Continuous Index:	
Within 8" of Joint:	
Remarks:

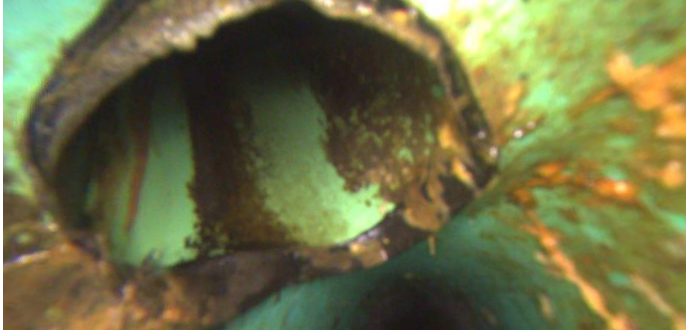
Code: **TS**
Description: **Tap Saddle**

Distance (ft): **37.4**
Structural Grade: **0**
O&M Grade: **0**
Clock Start/From: **11**
Clock To:
1st Value: **4.000**
2nd Value:
Value Percent:
Continuous Index:
Within 8" of Joint:
Remarks:

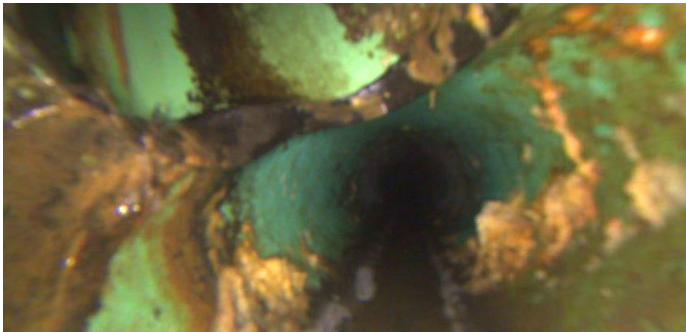
Code: **DAGS**
Description: **Deposits Attached Grease**

Distance (ft): **37.4**
Structural Grade: **0**
O&M Grade: **2**
Clock Start/From: **8**
Clock To: **4**
1st Value:
2nd Value:
Value Percent: **5.000**
Continuous Index:
Within 8" of Joint: **NO**
Remarks:

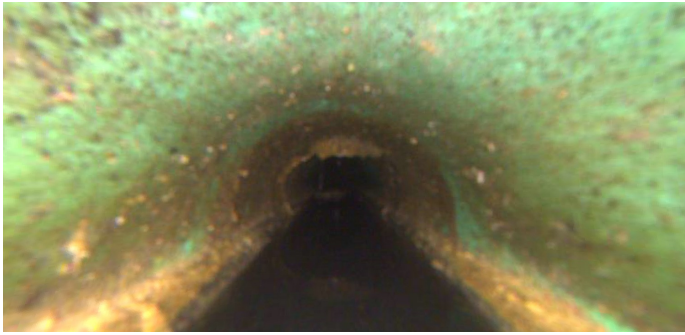
Code: **DAGS**
Description: **Deposits Attached Grease**

Distance (ft): **141.1**
Structural Grade: **0**
O&M Grade: **2**
Clock Start/From: **8**
Clock To: **4**
1st Value:
2nd Value:
Value Percent: **5.000**
Continuous Index: **S01**
Within 8" of Joint: **NO**
Remarks:

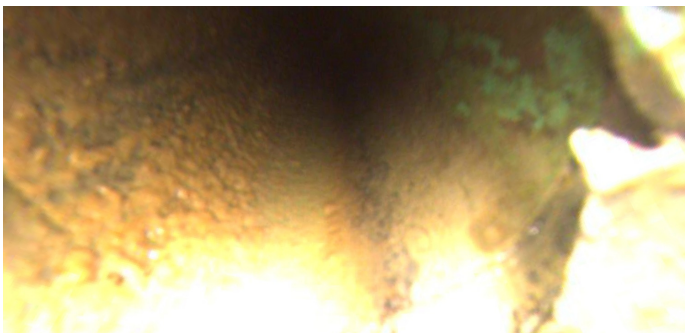
Code: **TBI**
Description: **Tap Break-in Intruding**

Distance (ft): **142.4**
Structural Grade: **0**
O&M Grade: **2**
Clock Start/From: **12**
Clock To:
1st Value: **4.000**
2nd Value: **1.000**
Value Percent:
Continuous Index:
Within 8" of Joint:
Remarks:

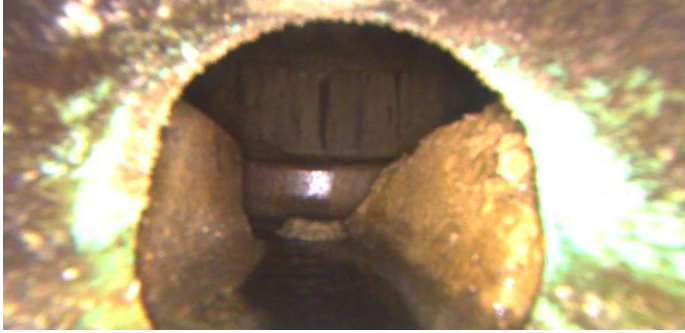
Code: **DAGS**
Description: **Deposits Attached Grease**

Distance (ft): **226.9**
Structural Grade: **0**
O&M Grade: **2**
Clock Start/From: **8**
Clock To: **4**
1st Value:
2nd Value:
Value Percent: **5.000**
Continuous Index: **F01**
Within 8" of Joint: **NO**
Remarks:
