Profile/Photo Observation Report

Date:	04/12/2018	Weather:		Coding:	PACP 6.0
Pipe Length (ft):	231.2	Owner:	NA	Pre Clean:	Not Known
P.O.#:		Surveyor:	Jen Costello	PSR:	P-906-004-008
Customer:		Clean Date:	01/01/1900	Shape:	C

Street:	Capitol	Flow Control:	Not Controlled
City:	Hobart, IN	Year Renewed:	
Location:	Yard	Tape/Media #:	
Purpose:	Maintenance Related	Dia/Height:	8"
Use:	Sanitary	Material:	PVC
Drain Area:	NA	Lining:	Cured in Place
Category:	NA		
Comment:	heavy black silt at 225'. -flow incorrect.		
Location Details:		Direction of Survey:	Downstream
US MH:	M-906-008	DS MH:	M-906-004
		Total Length Surveyed (ft):	226.7

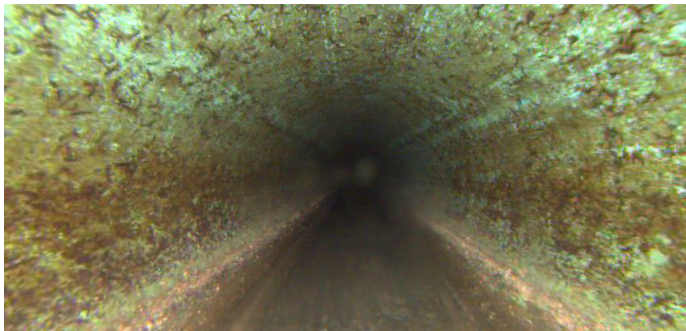
Code: **AMH**
Description: **Manhole**

Distance (ft): **.0**
Structural Grade: **0**
O&M Grade: **0**
Clock Start/From:
Clock To:
1st Value:
2nd Value:
Value Percent:
Continuous Index:
Within 8" of Joint: **NO**
Remarks: **M-906-008**

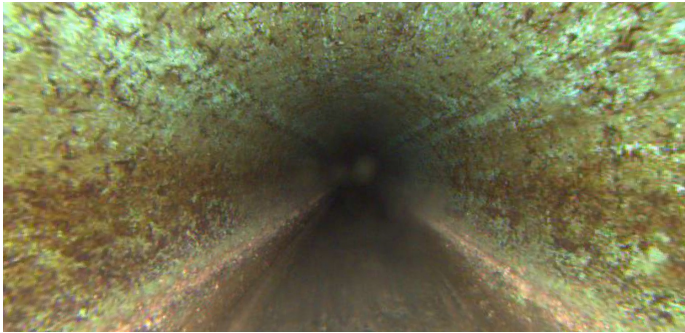
Code:	MWL
Description:	Water Level

Distance (ft):	.0
Structural Grade:	0
O&M Grade:	0
Clock Start/From:	
Clock To:	
1st Value:	
2nd Value:	
Value Percent:	5.000
Continuous Index:	
Within 8" of Joint:	NO
Remarks:

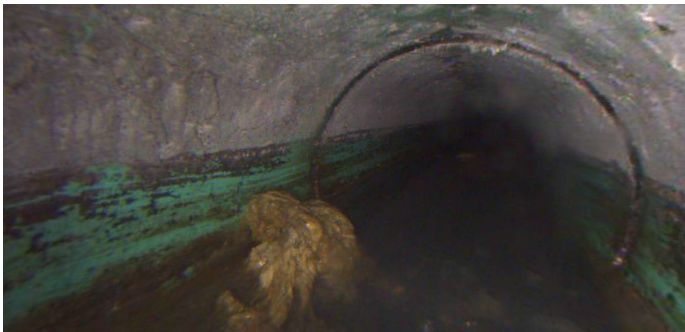
Code:	DAGS
Description:	Deposits Attached Grease

Distance (ft):	208.6
Structural Grade:	0
O&M Grade:	2
Clock Start/From:	8
Clock To:	9
1st Value:	
2nd Value:	
Value Percent:	10.000
Continuous Index:	
Within 8" of Joint:	YES
Remarks:

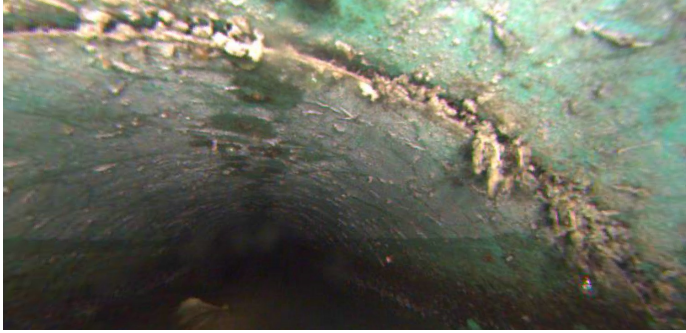
Code: **RFJ**
Description: **Roots Fine Joint**

Distance (ft): **222.2**
Structural Grade: **0**
O&M Grade: **1**
Clock Start/From: **8**
Clock To: **4**
1st Value:
2nd Value:
Value Percent:
Continuous Index:
Within 8" of Joint: **YES**
Remarks:

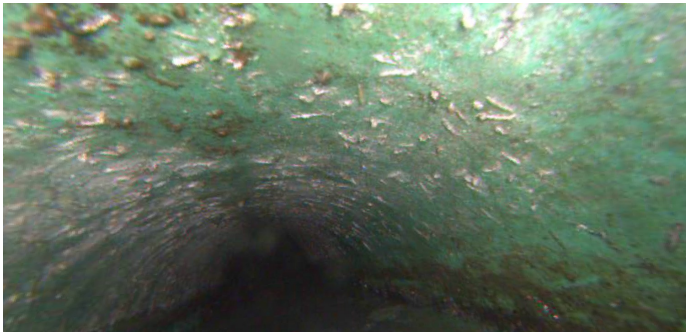
Code: **MSA**
Description: **Abandoned Survey**

Distance (ft): **226.7**
Structural Grade: **0**
O&M Grade: **0**
Clock Start/From:
Clock To:
1st Value:
2nd Value:
Value Percent:
Continuous Index:
Within 8" of Joint: **NO**
Remarks: **DEBRIS UNDER WATER**
