## Profile/Photo Observation Report

Street:	<b>Capitol</b>	Flow Control:	<b>Not Controlled</b>
City:	<b>Hobart, IN</b>	Year Renewed:	
Location:	<b>Sidewalk</b>	Tape/Media #:	
Purpose:	<b>Maintenance Related</b>	Dia/Height:	<b>8"</b>
Use:	<b>Sanitary</b>	Material:	<b>PVC</b>
Drain Area:	<b>NA</b>	Lining:	<b>Cured in Place</b>
Category:	<b>NA</b>		
Comment:

Location Details:		Direction of Survey:	<b>Upstream</b>
US MH:	<b>M-906-010</b>	DS MH:	<b>M-906-001</b>
		Total Length Surveyed (ft):	<b>378.6</b>

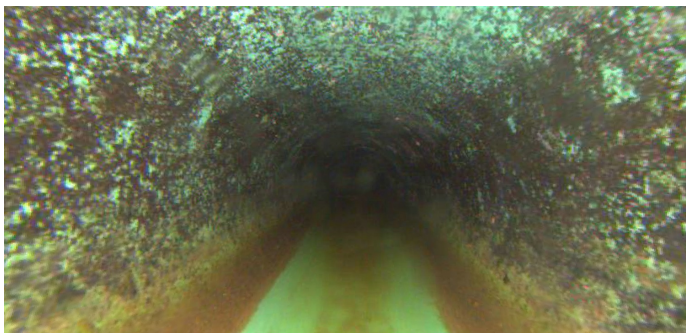
Code: **AMH**  
Description: **Manhole**

Distance (ft): **.0**  
Structural Grade: **0**  
O&M Grade: **0**  
Clock Start/From:  
Clock To:  
1st Value:  
2nd Value:  
Value Percent:  
Continuous Index:  
Within 8" of Joint: **NO**  
Remarks: **M-906-001**

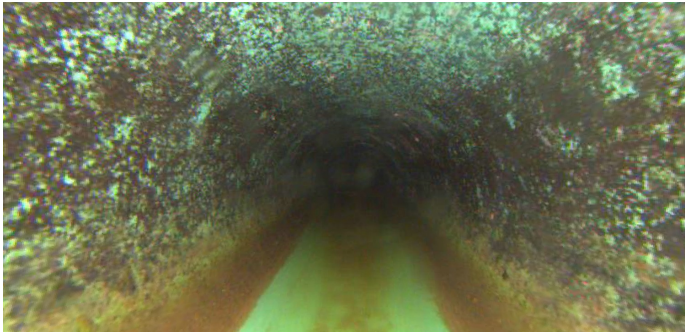
Code:	<b>MWL</b>
Description:	<b>Water Level</b>

Distance (ft):	<b>.0</b>
Structural Grade:	<b>0</b>
O&M Grade:	<b>0</b>
Clock Start/From:	
Clock To:	
1st Value:	
2nd Value:	
Value Percent:	<b>5.000</b>
Continuous Index:	
Within 8" of Joint:	<b>NO</b>
Remarks:

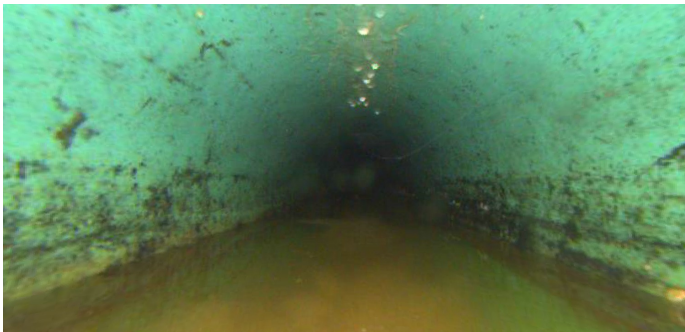
Code:	<b>MWL</b>
Description:	<b>Water Level</b>

Distance (ft):	<b>8.8</b>
Structural Grade:	<b>0</b>
O&M Grade:	<b>0</b>
Clock Start/From:	
Clock To:	
1st Value:	
2nd Value:	
Value Percent:	<b>40.000</b>
Continuous Index:	
Within 8" of Joint:	<b>NO</b>
Remarks:

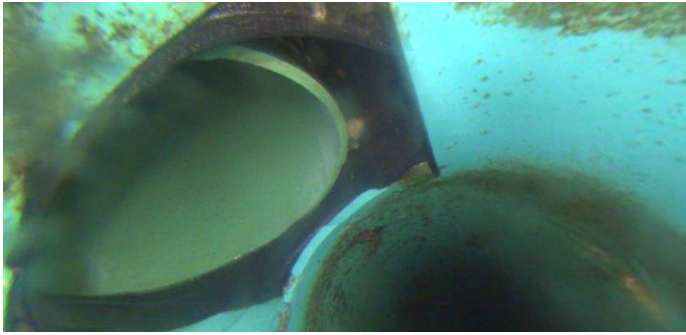
Code: **TB**  
Description: **Tap Break-in**

Distance (ft): **35.8**  
Structural Grade: **0**  
O&M Grade: **0**  
Clock Start/From: **2**  
Clock To:  
1st Value: **4.000**  
2nd Value:  
Value Percent:  
Continuous Index:  
Within 8" of Joint:  
Remarks:

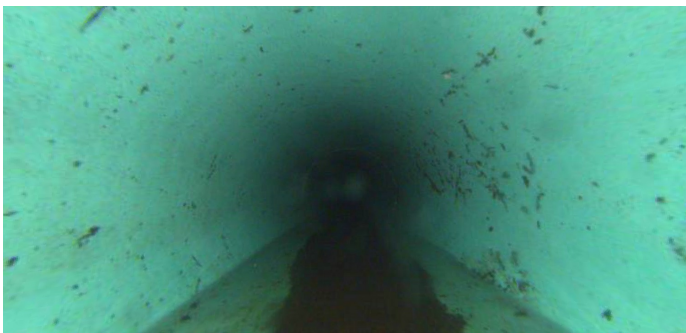
Code: **MWL**  
Description: **Water Level**

Distance (ft): **89.5**  
Structural Grade: **0**  
O&M Grade: **0**  
Clock Start/From:  
Clock To:  
1st Value:  
2nd Value:  
Value Percent: **10.000**  
Continuous Index:  
Within 8" of Joint: **NO**  
Remarks:

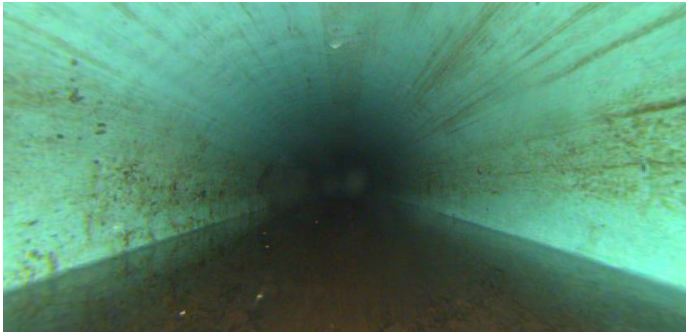
Code: **MWL**  
Description: **Water Level**

Distance (ft): **171.4**  
Structural Grade: **0**  
O&M Grade: **0**  
Clock Start/From:  
Clock To:  
1st Value:  
2nd Value:  
Value Percent: **30.000**  
Continuous Index:  
Within 8" of Joint: **NO**  
Remarks:

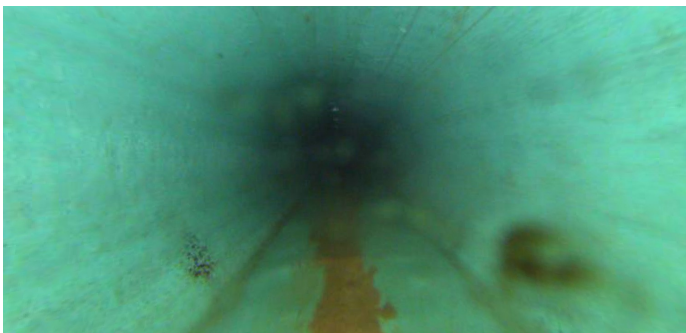
Code: **MWL**  
Description: **Water Level**

Distance (ft): **224.4**  
Structural Grade: **0**  
O&M Grade: **0**  
Clock Start/From:  
Clock To:  
1st Value:  
2nd Value:  
Value Percent: **5.000**  
Continuous Index:  
Within 8" of Joint: **NO**  
Remarks:

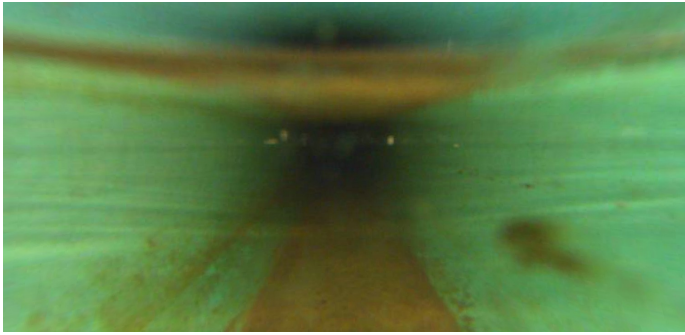
Code: **MCU**  
Description: **Camera Underwater**

Distance (ft): **258.1**  
Structural Grade: **0**  
O&M Grade: **4**  
Clock Start/From:  
Clock To:  
1st Value:  
2nd Value:  
Value Percent:  
Continuous Index: **S01**  
Within 8" of Joint: **NO**  
Remarks:

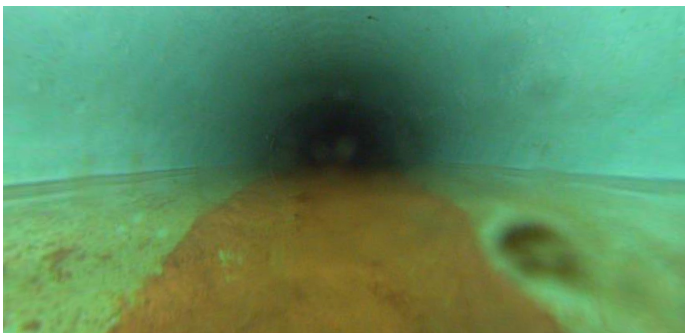
Code: **MCU**  
Description: **Camera Underwater**

Distance (ft): **273.7**  
Structural Grade: **0**  
O&M Grade: **4**  
Clock Start/From:  
Clock To:  
1st Value:  
2nd Value:  
Value Percent:  
Continuous Index: **F01**  
Within 8" of Joint: **NO**  
Remarks:

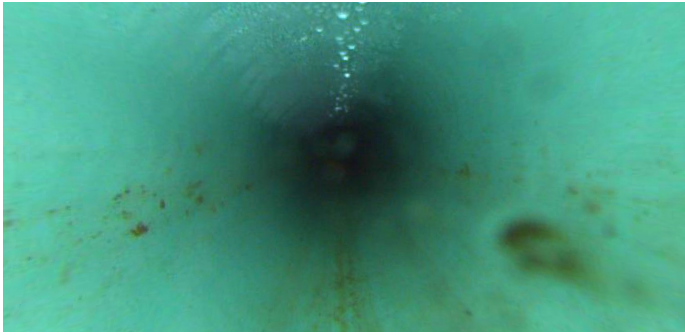
Code: **MWL**  
Description: **Water Level**

Distance (ft): **284.5**  
Structural Grade: **0**  
O&M Grade: **0**  
Clock Start/From:  
Clock To:  
1st Value:  
2nd Value:  
Value Percent: **0.000**  
Continuous Index:  
Within 8" of Joint: **NO**  
Remarks:

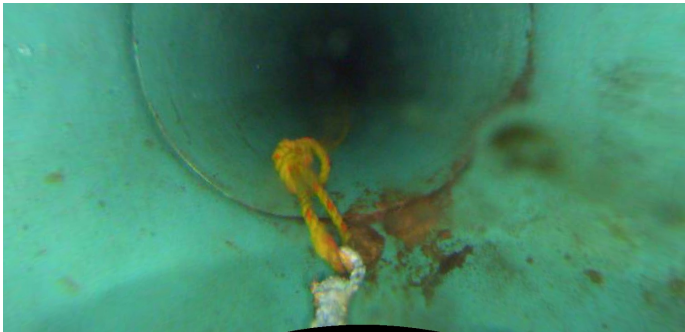
Code: **OBZ**  
Description: **Obstacle Other**

Distance (ft): **287.7**  
Structural Grade: **0**  
O&M Grade: **2**  
Clock Start/From: **6**  
Clock To:  
1st Value:  
2nd Value:  
Value Percent: **5.000**  
Continuous Index:  
Within 8" of Joint: **NO**  
Remarks: **rope**

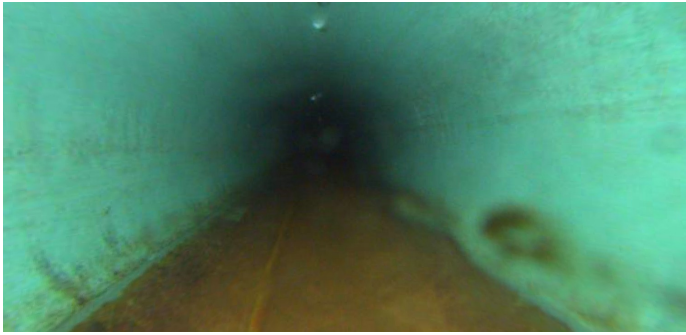
Code: **MWL**  
Description: **Water Level**

Distance (ft): **345.1**  
Structural Grade: **0**  
O&M Grade: **0**  
Clock Start/From:  
Clock To:  
1st Value:  
2nd Value:  
Value Percent: **10.000**  
Continuous Index:  
Within 8" of Joint: **NO**  
Remarks:

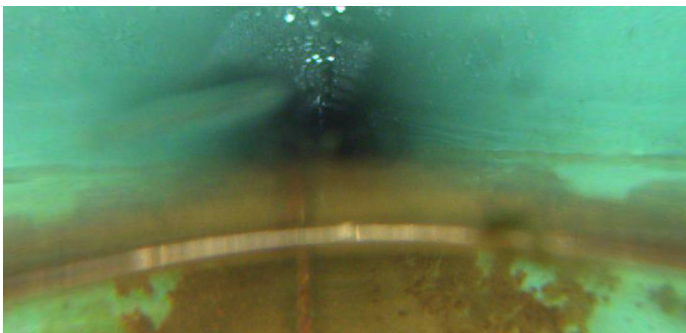
Code: **MWL**  
Description: **Water Level**

Distance (ft): **357.2**  
Structural Grade: **0**  
O&M Grade: **0**  
Clock Start/From:  
Clock To:  
1st Value:  
2nd Value:  
Value Percent: **40.000**  
Continuous Index:  
Within 8" of Joint: **NO**  
Remarks:

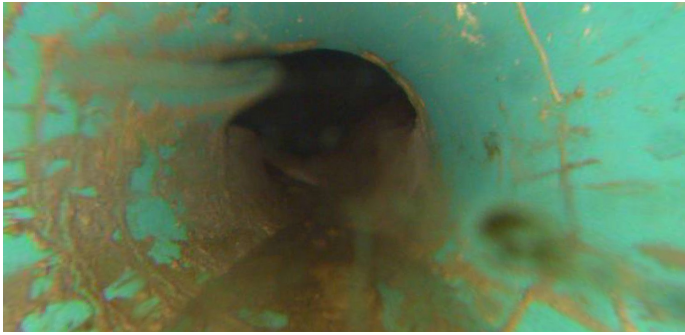
Code: **MWL**  
Description: **Water Level**

Distance (ft): **375.8**  
Structural Grade: **0**  
O&M Grade: **0**  
Clock Start/From:  
Clock To:  
1st Value:  
2nd Value:  
Value Percent: **5.000**  
Continuous Index:  
Within 8" of Joint: **NO**  
Remarks:

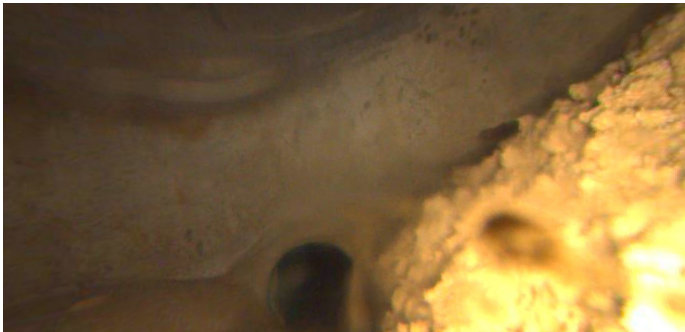
Code: **AMH**  
Description: **Manhole**

Distance (ft): **378.6**  
Structural Grade: **0**  
O&M Grade: **0**  
Clock Start/From:  
Clock To:  
1st Value:  
2nd Value:  
Value Percent:  
Continuous Index:  
Within 8" of Joint: **NO**  
Remarks: **M-906-010**
