Profile/Photo Observation Report

Location Details:		Direction of Survey:	Downstream
US MH:	M-906-013	DS MH:	M-906-014
		Total Length Surveyed (ft):	339.5

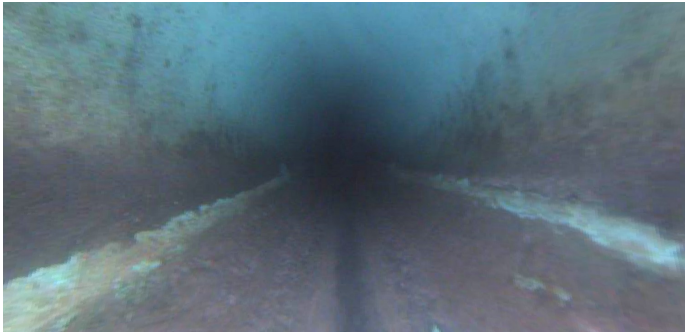
Code:	MWL
Description:	Water Level

Distance (ft):	.0
Structural Grade:	0
O&M Grade:	0
Clock Start/From:	
Clock To:	
1st Value:	
2nd Value:	
Value Percent:	5.000
Continuous Index:	
Within 8" of Joint:	NO
Remarks:

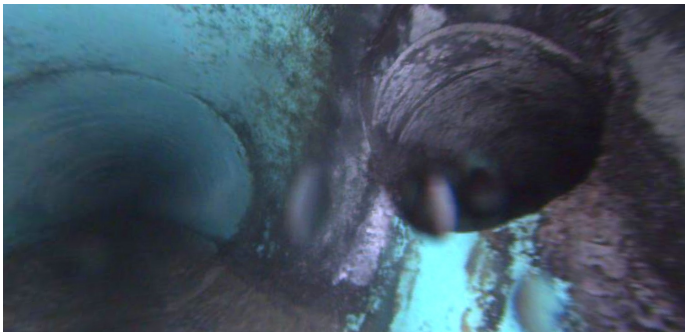
Code:	TF
Description:	Tap Factory

Distance (ft):	253.7
Structural Grade:	0
O&M Grade:	0
Clock Start/From:	3
Clock To:	
1st Value:	4.000
2nd Value:	
Value Percent:	
Continuous Index:	
Within 8" of Joint:	
Remarks:

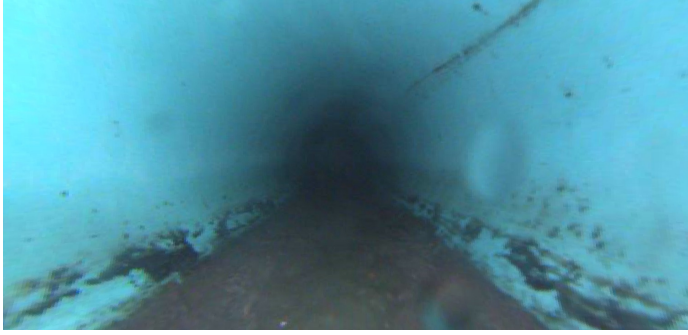
Code:	AMH
Description:	Manhole
Distance (ft):	339.5
Structural Grade:	0
O&M Grade:	0
Clock Start/From:	
Clock To:	
1st Value:	
2nd Value:	
Value Percent:	
Continuous Index:	
Within 8" of Joint:	NO
Remarks:	M-906-014
