## Profile/Photo Observation Report

Street:	<b>E 10TH ST</b>	Flow Control:	<b>Not Controlled</b>
City:	<b>Hobart, IN</b>	Year Renewed:	
Location:	<b>Sidewalk</b>	Tape/Media #:	
Purpose:	<b>Maintenance Related</b>	Dia/Height:	<b>12"</b>
Use:	<b>Sanitary</b>	Material:	<b>PVC</b>
Drain Area:	<b>NA</b>	Lining:	<b>Cured in Place</b>
Category:	<b>NA</b>		
Comment:

Location Details:		Direction of Survey:	<b>Downstream</b>
US MH:	<b>M-906-014</b>	DS MH:	<b>M-906-015</b>
		Total Length Surveyed (ft):	<b>358.2</b>

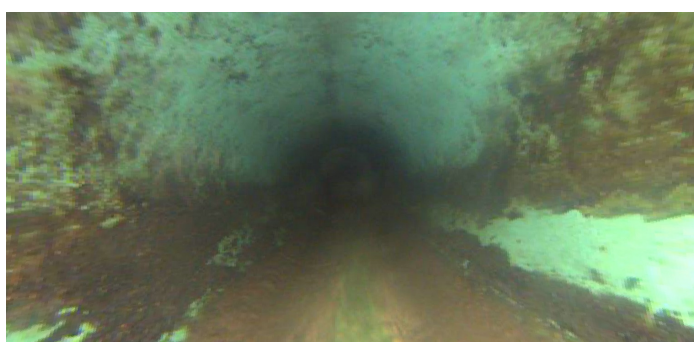
Code: **AMH**  
Description: **Manhole**

Distance (ft): **.0**  
Structural Grade: **0**  
O&M Grade: **0**  
Clock Start/From:  
Clock To:  
1st Value:  
2nd Value:  
Value Percent:  
Continuous Index:  
Within 8" of Joint: **NO**  
Remarks: **M-906-014**

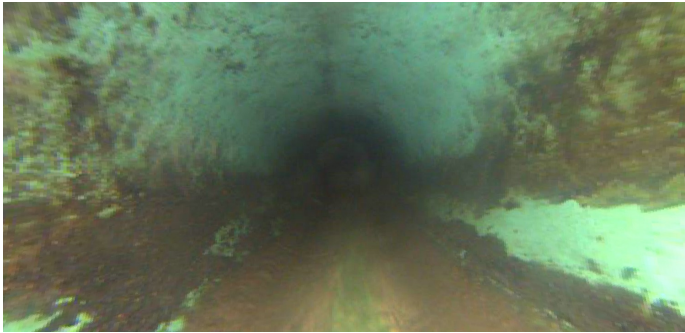
Code:	<b>MWL</b>
Description:	<b>Water Level</b>

Distance (ft):	<b>.0</b>
Structural Grade:	<b>0</b>
O&M Grade:	<b>0</b>
Clock Start/From:	
Clock To:	
1st Value:	
2nd Value:	
Value Percent:	<b>5.000</b>
Continuous Index:	
Within 8" of Joint:	<b>NO</b>
Remarks:

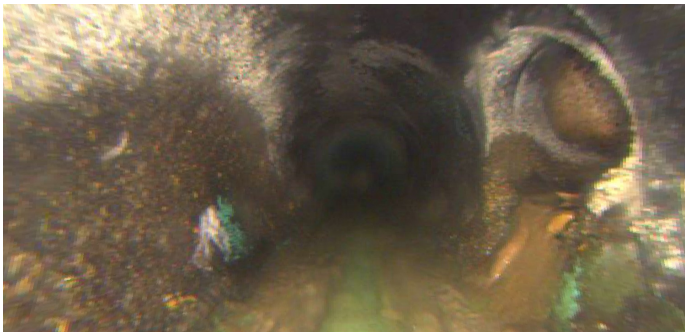
Code:	<b>TF</b>
Description:	<b>Tap Factory</b>

Distance (ft):	<b>227.6</b>
Structural Grade:	<b>0</b>
O&M Grade:	<b>0</b>
Clock Start/From:	<b>3</b>
Clock To:	
1st Value:	<b>4.000</b>
2nd Value:	
Value Percent:	
Continuous Index:	
Within 8" of Joint:	
Remarks:

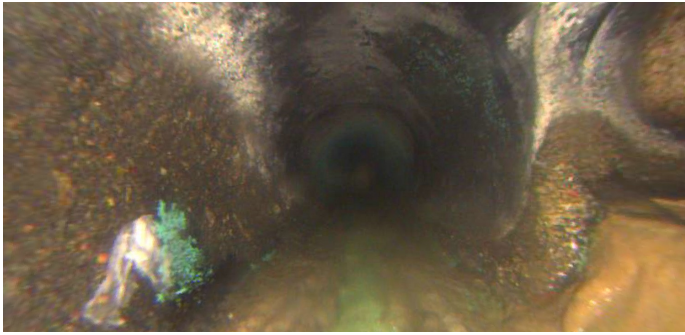
Code: **DAGS**  
Description: **Deposits Attached Grease**

Distance (ft): **227.9**  
Structural Grade: **0**  
O&M Grade: **2**  
Clock Start/From: **8**  
Clock To: **4**  
1st Value:  
2nd Value:  
Value Percent: **5.000**  
Continuous Index:  
Within 8" of Joint: **NO**  
Remarks:

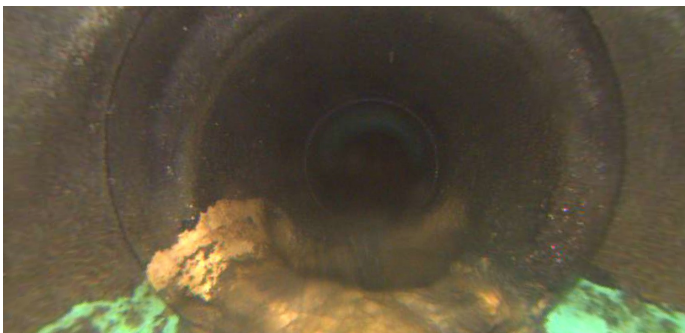
Code: **TF**  
Description: **Tap Factory**

Distance (ft): **345.1**  
Structural Grade: **0**  
O&M Grade: **0**  
Clock Start/From: **6**  
Clock To:  
1st Value: **6.000**  
2nd Value:  
Value Percent:  
Continuous Index:  
Within 8" of Joint:  
Remarks: **DROP**
