Profile/Photo Observation Report

Date:	10/22/2021	Weather:		Coding:	PACP 6.0
Pipe Length (ft):		Owner:	Hobart, IN	Pre Clean:	Not Known
P.O.#:	966_1	Surveyor:	M. Pielacha	PSR:	P-906-021-014
Customer:	Hobart, IN	Clean Date:		Shape:	C

Street:	10th Street	Flow Control:	
City:	Hobart, IN	Year Renewed:	
Location:	Light Highway	Tape/Media #:	966
Purpose:	Routine Assessment	Dia/Height:	10"
Use:	Sanitary	Material:	PVC
Drain Area:		Lining:	
Category:	NA		
Comment:

Location Details:		Direction of Survey:	Upstream
US MH:	M-906-14	DS MH:	M-906-21
		Total Length Surveyed (ft):	48.3

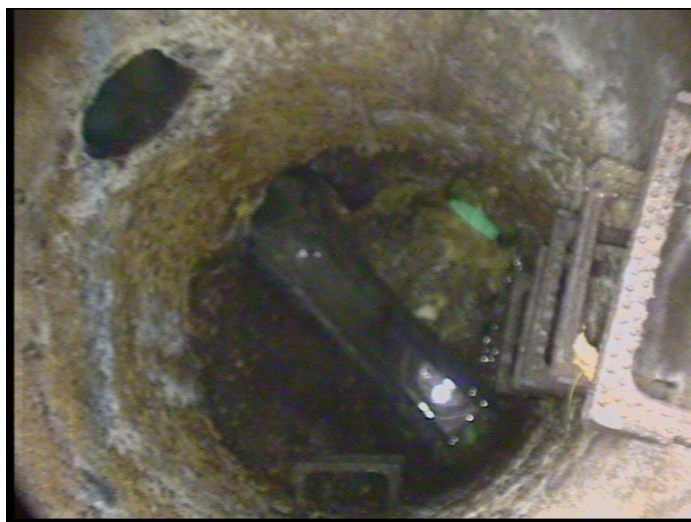
Code: **AMH**
Description: **Manhole**

Distance (ft): **.0**
Structural Grade: **0**
O&M Grade: **0**
Clock Start/From:
Clock To:
1st Value:
2nd Value:
Value Percent:
Continuous Index:
Within 8" of Joint: **NO**
Remarks: **M-906-21**

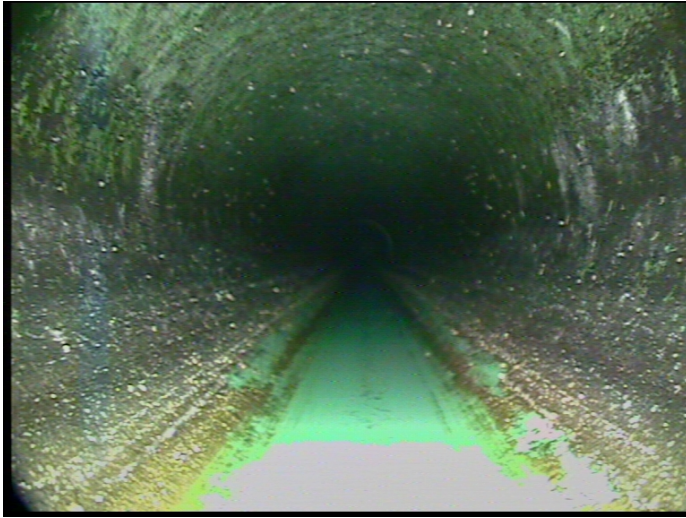
Code: **MWL**
Description: **Water Level**

Distance (ft): **.0**
Structural Grade: **0**
O&M Grade: **0**
Clock Start/From:
Clock To:
1st Value:
2nd Value:
Value Percent: **5.000**
Continuous Index:
Within 8" of Joint: **NO**
Remarks:

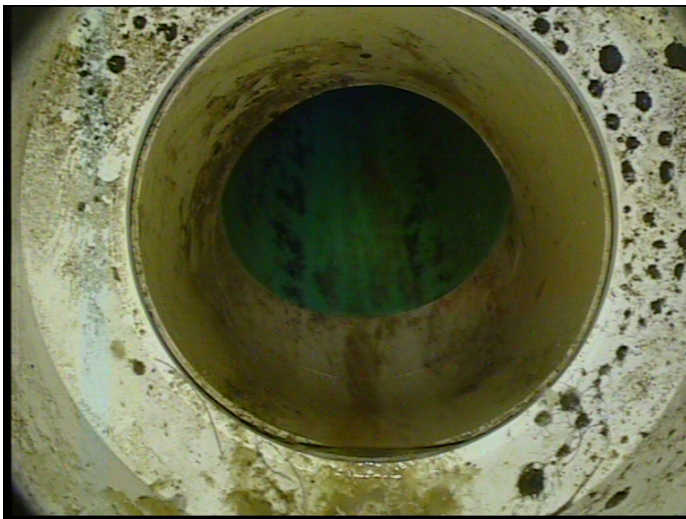
Code: **MGO**
Description: **General Observation**

Distance (ft): **48.3**
Structural Grade: **0**
O&M Grade: **0**
Clock Start/From:
Clock To:
1st Value:
2nd Value:
Value Percent:
Continuous Index:
Within 8" of Joint: **NO**
Remarks: **appears to be a service connection**

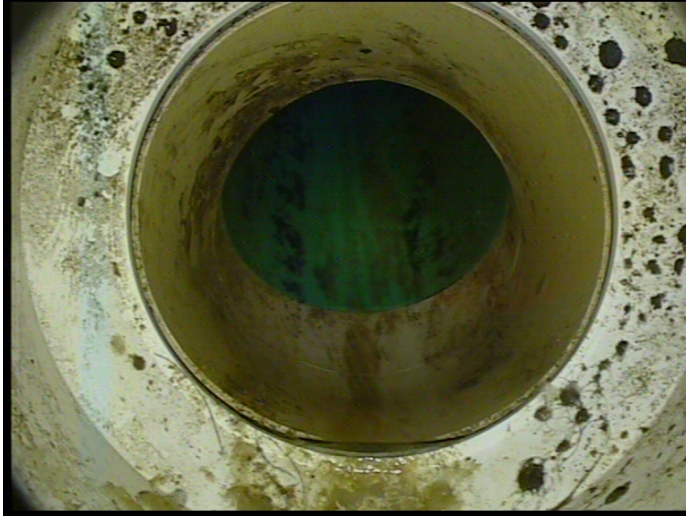
Code:	AMH
Description:	Manhole
Distance (ft):	48.3
Structural Grade:	0
O&M Grade:	0
Clock Start/From:	
Clock To:	
1st Value:	
2nd Value:	
Value Percent:	
Continuous Index:	
Within 8" of Joint:	NO
Remarks:	M-906-14
