Profile/Photo Observation Report

Street:	S HOBART RD	Flow Control:	Not Controlled
City:	Hobart, IN	Year Renewed:	
Location:	Ditch	Tape/Media #:	
Purpose:	Maintenance Related	Dia/Height:	12"
Use:	Sanitary	Material:	PVC
Drain Area:	NA	Lining:	Cured in Place
Category:	NA		
Comment:	battery at 380'-flow incorrect.

Location Details:		Direction of Survey:	Downstream
US MH:	M-907-001	DS MH:	M-907-007
		Total Length Surveyed (ft):	381.2

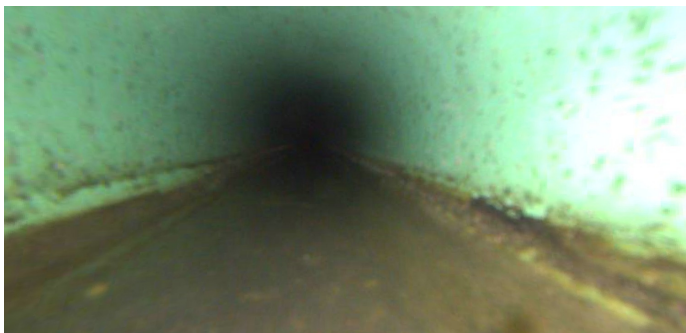
Code: **AMH**
Description: **Manhole**

Distance (ft): **.0**
Structural Grade: **0**
O&M Grade: **0**
Clock Start/From:
Clock To:
1st Value:
2nd Value:
Value Percent:
Continuous Index:
Within 8" of Joint: **NO**
Remarks: **M-907-001**

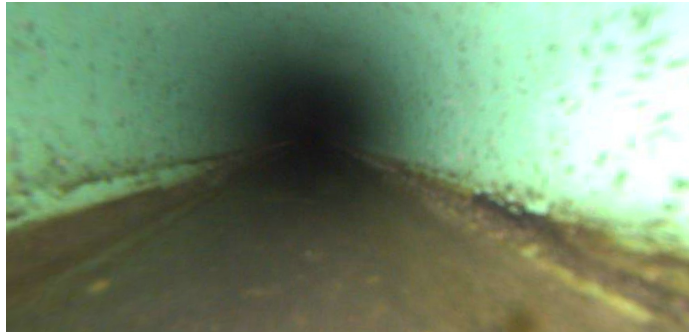
Code: **MWL**
Description: **Water Level**

Distance (ft): **.0**
Structural Grade: **0**
O&M Grade: **0**
Clock Start/From:
Clock To:
1st Value:
2nd Value:
Value Percent: **20.000**
Continuous Index:
Within 8" of Joint: **NO**
Remarks:

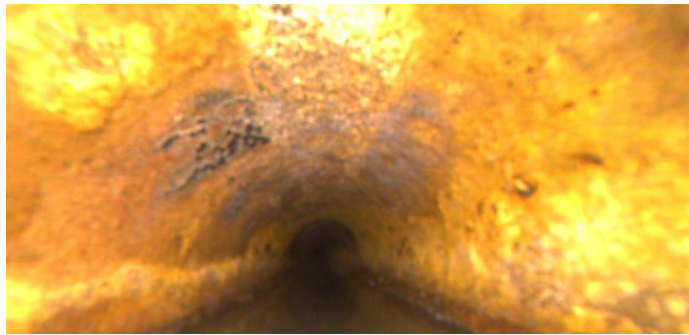
Code: **MMC**
Description: **Material Change**

Distance (ft): **54.4**
Structural Grade: **0**
O&M Grade: **0**
Clock Start/From:
Clock To:
1st Value:
2nd Value:
Value Percent:
Continuous Index:
Within 8" of Joint: **NO**
Remarks: **cp**

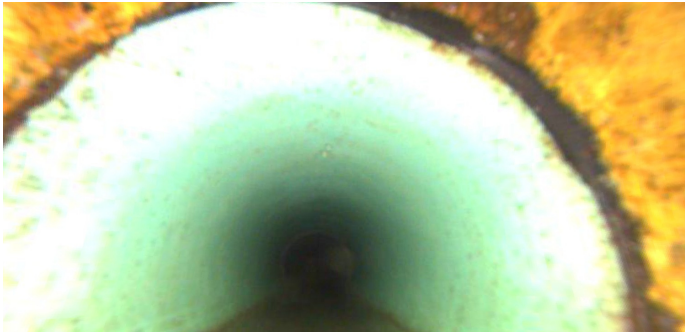
Code: **MMC**
Description: **Material Change**

Distance (ft): **71.8**
Structural Grade: **0**
O&M Grade: **0**
Clock Start/From:
Clock To:
1st Value:
2nd Value:
Value Percent:
Continuous Index:
Within 8" of Joint: **NO**
Remarks: **PVC**

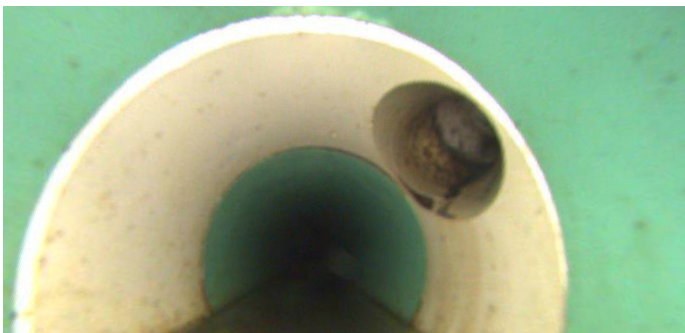
Code: **TF**
Description: **Tap Factory**

Distance (ft): **121.0**
Structural Grade: **0**
O&M Grade: **0**
Clock Start/From: **2**
Clock To:
1st Value: **4.000**
2nd Value:
Value Percent:
Continuous Index:
Within 8" of Joint:
Remarks:

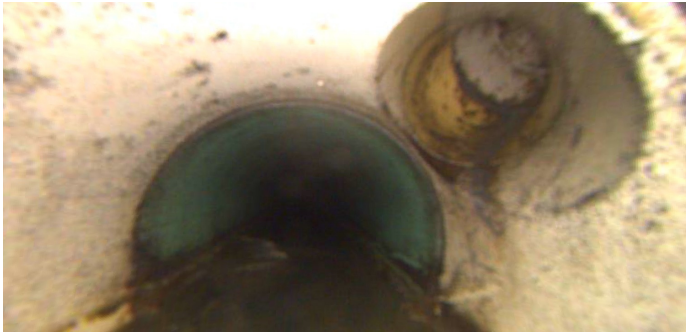
Code: **TF**
Description: **Tap Factory**

Distance (ft): **351.9**
Structural Grade: **0**
O&M Grade: **0**
Clock Start/From: **2**
Clock To:
1st Value: **4.000**
2nd Value:
Value Percent:
Continuous Index:
Within 8" of Joint:
Remarks:

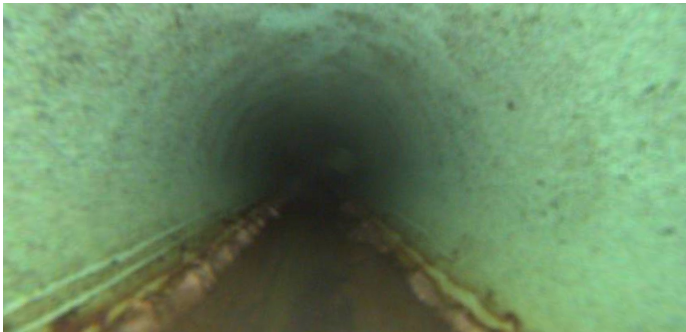
Code: **MSA**
Description: **Abandoned Survey**

Distance (ft): **381.2**
Structural Grade: **0**
O&M Grade: **0**
Clock Start/From:
Clock To:
1st Value:
2nd Value:
Value Percent:
Continuous Index:
Within 8" of Joint: **NO**
Remarks: **UNKNOWN**
