Profile/Photo Observation Report

Date:	04/11/2018	Weather:		Coding:	PACP 6.0
Pipe Length (ft):	399.4	Owner:	NA	Pre Clean:	Not Known
P.O.#:		Surveyor:	Jen Costello	PSR:	P-907-007-001
Customer:		Clean Date:	01/01/1900	Shape:	C

Street:	Capitol	Flow Control:	Not Controlled
City:	Hobart, IN	Year Renewed:	
Location:	Ditch	Tape/Media #:	
Purpose:	Maintenance Related	Dia/Height:	12"
Use:	Sanitary	Material:	PVC
Drain Area:	NA	Lining:	Cured in Place
Category:	NA		
Comment:	battery at 380'-flow incorrect.		
Location Details:		Direction of Survey:	Downstream
US MH:	M-907-001	DS MH:	M-907-007
		Total Length Surveyed (ft):	381.2

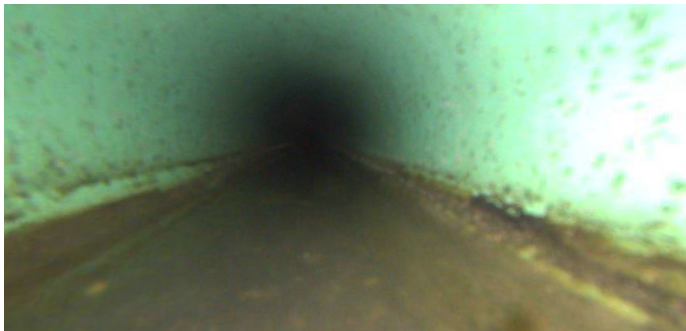
Code: **AMH**
Description: **Manhole**

Distance (ft): **.0**
Structural Grade: **0**
O&M Grade: **0**
Clock Start/From:
Clock To:
1st Value:
2nd Value:
Value Percent:
Continuous Index:
Within 8" of Joint: **NO**
Remarks: **M-907-001**

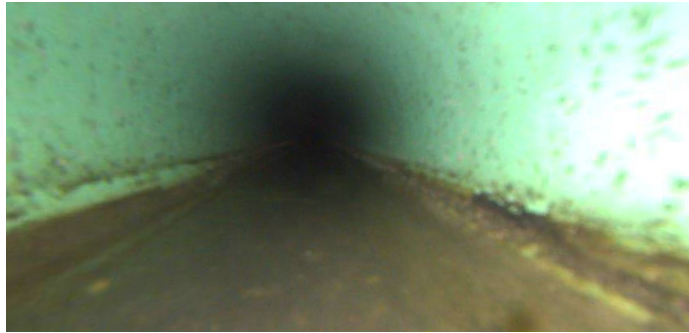
Code: **MWL**
Description: **Water Level**

Distance (ft): **.0**
Structural Grade: **0**
O&M Grade: **0**
Clock Start/From:
Clock To:
1st Value:
2nd Value:
Value Percent: **20.000**
Continuous Index:
Within 8" of Joint: **NO**
Remarks:

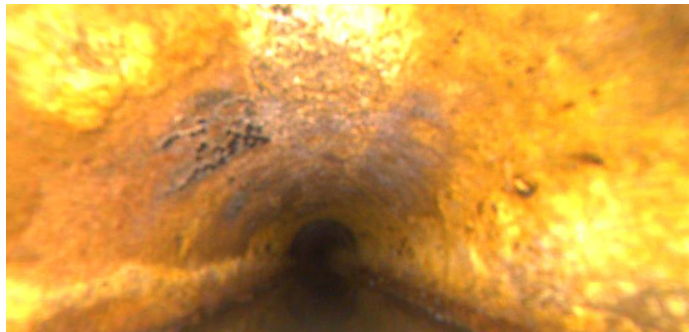
Code: **MMC**
Description: **Material Change**

Distance (ft): **54.4**
Structural Grade: **0**
O&M Grade: **0**
Clock Start/From:
Clock To:
1st Value:
2nd Value:
Value Percent:
Continuous Index:
Within 8" of Joint: **NO**
Remarks: **cp**

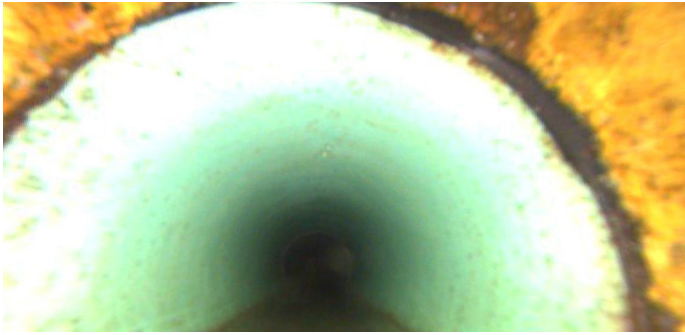
Code: **MMC**
Description: **Material Change**

Distance (ft): **71.8**
Structural Grade: **0**
O&M Grade: **0**
Clock Start/From:
Clock To:
1st Value:
2nd Value:
Value Percent:
Continuous Index:
Within 8" of Joint: **NO**
Remarks: **PVC**

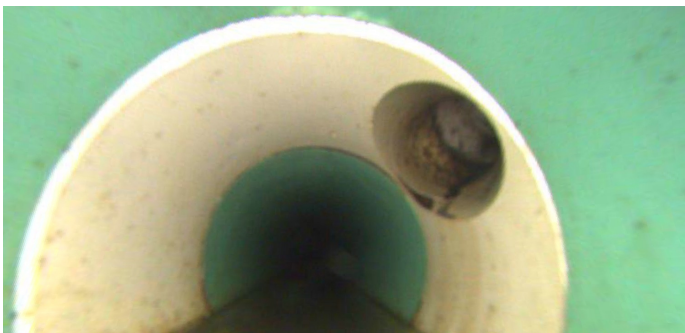
Code: **TF**
Description: **Tap Factory**

Distance (ft): **121.0**
Structural Grade: **0**
O&M Grade: **0**
Clock Start/From: **2**
Clock To:
1st Value: **4.000**
2nd Value:
Value Percent:
Continuous Index:
Within 8" of Joint:
Remarks:

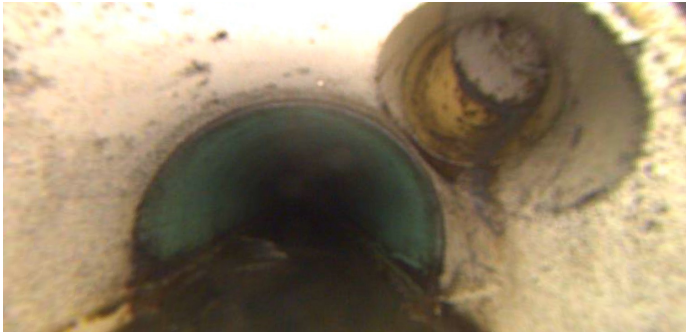
Code: **TF**
Description: **Tap Factory**

Distance (ft): **351.9**
Structural Grade: **0**
O&M Grade: **0**
Clock Start/From: **2**
Clock To:
1st Value: **4.000**
2nd Value:
Value Percent:
Continuous Index:
Within 8" of Joint:
Remarks:

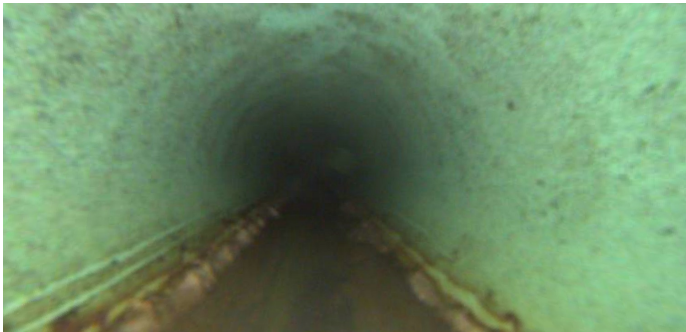
Code: **MSA**
Description: **Abandoned Survey**

Distance (ft): **381.2**
Structural Grade: **0**
O&M Grade: **0**
Clock Start/From:
Clock To:
1st Value:
2nd Value:
Value Percent:
Continuous Index:
Within 8" of Joint: **NO**
Remarks: **UNKNOWN**
