Profile/Ph	oto Observatio	n Report			RedZone
Date:	04/11/2018	Weather:		Coding:	PACP 6.0
Pipe Length (ft)	: 389.5	Owner:	NA	Pre Clean:	Not Known
P.O.#:		Surveyor:	Jen Costello	PSR:	P-907-001-002
Customer:		Clean Date:	01/01/1900	Shape:	C
Street:	Capitol		Flow Control:	Not Controlled	
City:	Hobart, IN		Year Renewed:		
Location:	Ditch		Tape/Media #:		
Purpose:	Maintenance Rel	ated	Dia/Height:	12"	
Use:	Sanitary		Material:	PVC	
Drain Area:	NA		Lining:	Cured in Place	
Category:	NA				
Comment:	heavy blk silt at 19'incorrect flow				
Location Detail	s:		Direction of Surv	vey: Upstream	
US MH:	M-907-002	DS MH:	M-907-001	Total Length Surveyed (ft)	: 20.5
0&M Index:	0.00	O&M Quick:	000	0 O&M Rating:	0.00
tructural Index:	0.00	Structural Qu	uick: 000		0.00
Overall Index:	0.00	Overall Quic	k: 000	0 Overall Rating:	0.00

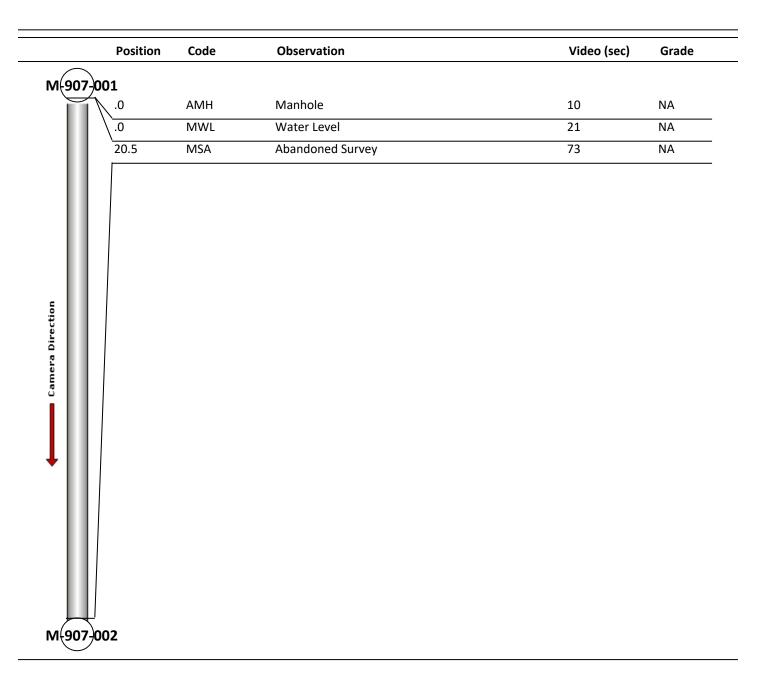
Code: Description:	AMH Manhole
Distance (ft):	.0
Structural Grade:	0
O&M Grade:	0
Clock Start/From:	
Clock To:	
1st Value:	
2nd Value:	
Value Percent:	
Continuous Index:	
Within 8" of Joint:	NO
Remarks:	M-907-001

Code: MWL Description: Water Level

Distance (ft): .0 Structural Grade: 0 O&M Grade: 0 Clock Start/From: Clock To: 1st Value: 2nd Value: Value Percent: 5.000 Continuous Index: Within 8" of Joint: NO Remarks:

Description:	Abandoned Survey
Distance (ft):	20.5
Structural Grade:	0
O&M Grade:	0
Clock Start/From:	
Clock To:	
1st Value:	
2nd Value:	
Value Percent:	
Continuous Index:	
Within 8" of Joint:	NO
Remarks:	debris under water
