Profile/Photo Observation Report

| Street: | S HOBART RD | Flow Control: | Not Controlled |
| City: | Hobart, IN | Year Renewed: | |

| US MH: | M-907-003 | DS MH: | M-907-002 |

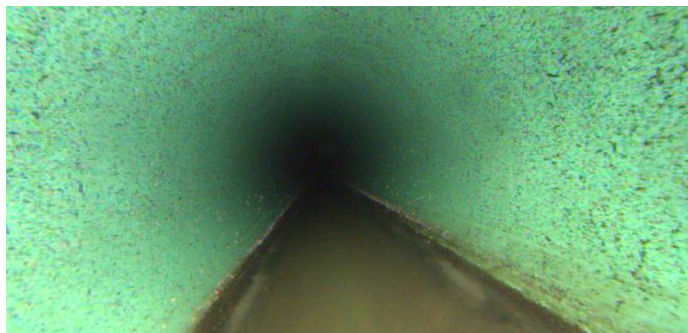
Code: **AMH**
Description: **Manhole**

Distance (ft): **.0**
Structural Grade: **0**
O&M Grade: **0**
Clock Start/From:
Clock To:
1st Value:
2nd Value:
Value Percent:
Continuous Index:
Within 8" of Joint: **NO**
Remarks: **M-907-003**

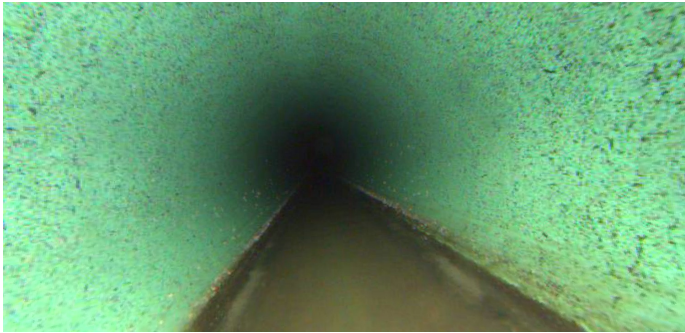
| Code: | MWL |
| Description: | Water Level |

| Distance (ft): | .0 |
| Value Percent: | 10.000 |

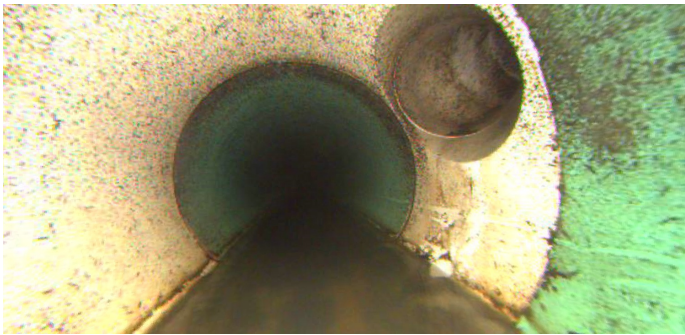
| Code: | TF |
| Description: | Tap Factory |

| Distance (ft): | 100.1 |
| Clock Start/From: | 2 |
| 1st Value: | 4.000 |

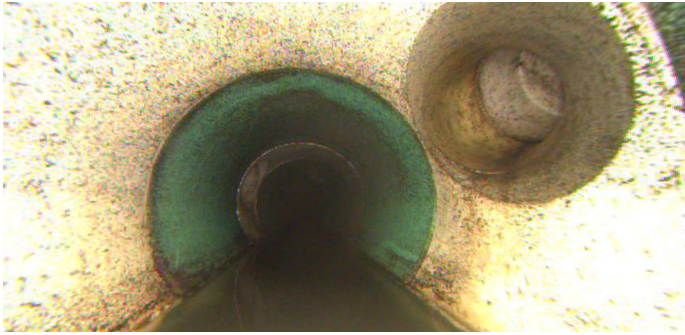
Code: **TF**
Description: **Tap Factory**

Distance (ft): **166.2**
Structural Grade: **0**
O&M Grade: **0**
Clock Start/From: **2**
Clock To:
1st Value: **4.000**
2nd Value:
Value Percent:
Continuous Index:
Within 8" of Joint:
Remarks:

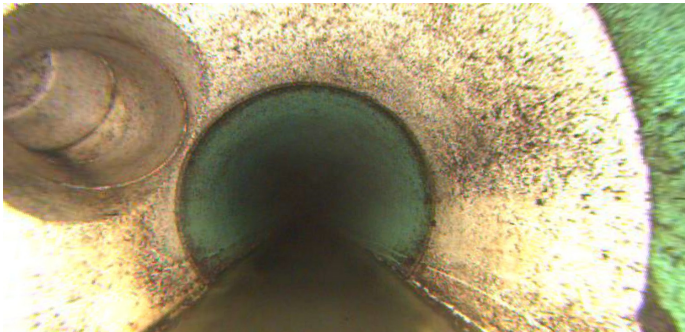
Code: **TF**
Description: **Tap Factory**

Distance (ft): **168.2**
Structural Grade: **0**
O&M Grade: **0**
Clock Start/From: **9**
Clock To:
1st Value: **4.000**
2nd Value:
Value Percent:
Continuous Index:
Within 8" of Joint:
Remarks:

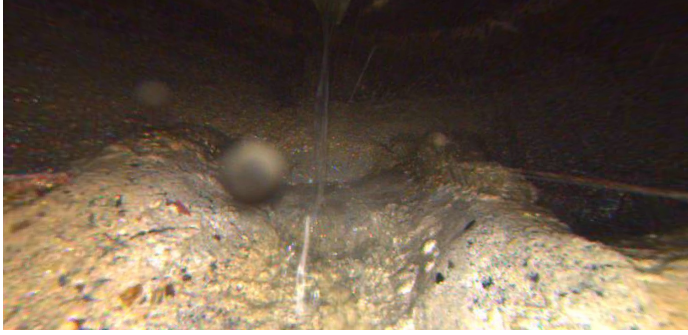
| Code: | AMH |
| Description: | Manhole |
| Distance (ft): | 203.5 |
| Remarks: | M-907-002 |
