Profile/Photo Observation Report

Date:	04/05/2018	Weather:		Coding:	PACP 6.0
Pipe Length (ft):	398.5	Owner:	NA	Pre Clean:	Not Known
P.O.#:		Surveyor:	Jen Costello	PSR:	P-907-031-005
Customer:		Clean Date:	01/01/1900	Shape:	C

Street:	Hobart	Flow Control:	Not Controlled
City:	Hobart, IN	Year Renewed:	
Location:	Light Highway	Tape/Media #:	
Purpose:	Maintenance Related	Dia/Height:	12"
Use:	Sanitary	Material:	PVC
Drain Area:	NA	Lining:	Cured in Place
Category:	NA		
Comment:	Flow direction wrong.

Location Details:		Direction of Survey:	Upstream
US MH:	M-907-005	DS MH:	M-808-031
		Total Length Surveyed (ft):	137.1

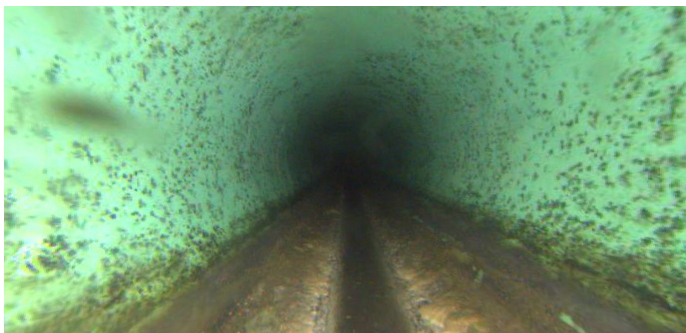
Code: **AMH**
Description: **Manhole**

Distance (ft): **.0**
Structural Grade: **0**
O&M Grade: **0**
Clock Start/From:
Clock To:
1st Value:
2nd Value:
Value Percent:
Continuous Index:
Within 8" of Joint: **NO**
Remarks: **M-808-031**

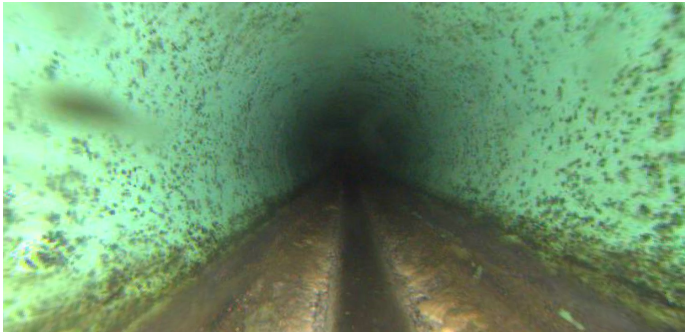
Code:	MWL
Description:	Water Level

Distance (ft):	.0
Structural Grade:	0
O&M Grade:	0
Clock Start/From:	
Clock To:	
1st Value:	
2nd Value:	
Value Percent:	5.000
Continuous Index:	
Within 8" of Joint:	NO
Remarks:

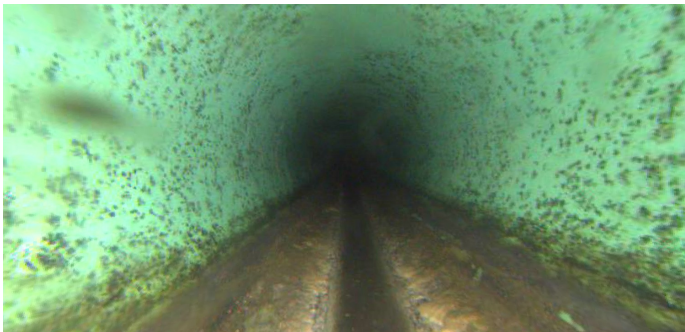
Code:	DSC
Description:	Deposits Settled Compacted

Distance (ft):	.0
Structural Grade:	0
O&M Grade:	2
Clock Start/From:	5
Clock To:	7
1st Value:	
2nd Value:	
Value Percent:	10.000
Continuous Index:	S01
Within 8" of Joint:	NO
Remarks:

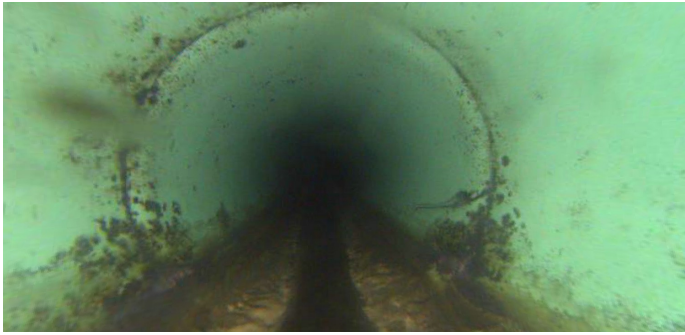
Code: **RFJ**
Description: **Roots Fine Joint**

Distance (ft): **108.3**
Structural Grade: **0**
O&M Grade: **1**
Clock Start/From: **3**
Clock To:
1st Value:
2nd Value:
Value Percent:
Continuous Index:
Within 8" of Joint: **YES**
Remarks:

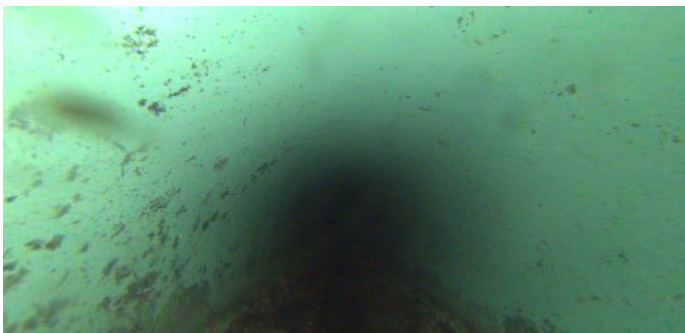
Code: **MSA**
Description: **Abandoned Survey**

Distance (ft): **137.1**
Structural Grade: **0**
O&M Grade: **0**
Clock Start/From:
Clock To:
1st Value:
2nd Value:
Value Percent:
Continuous Index:
Within 8" of Joint: **NO**
Remarks: **debris**

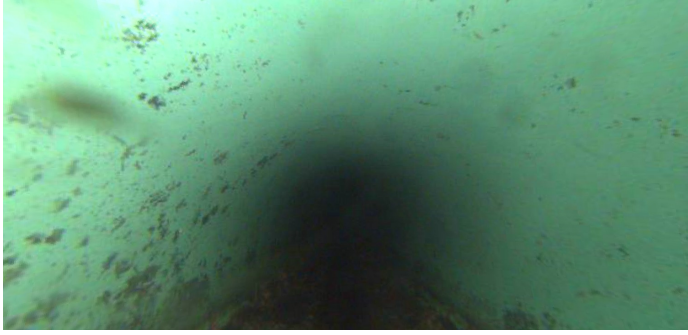
Code:	DSC
Description:	Deposits Settled Compacted
Distance (ft):	137.1
Structural Grade:	0
O&M Grade:	2
Clock Start/From:	5
Clock To:	7
1st Value:	
2nd Value:	
Value Percent:	10.000
Continuous Index:	F01
Within 8" of Joint:	NO
Remarks:
