## Profile/Photo Observation Report

Street:	<b>S HOBART RD</b>	Flow Control:	<b>Not Controlled</b>
City:	<b>Hobart, IN</b>	Year Renewed:	
Location:	<b>Light Highway</b>	Tape/Media #:	
Purpose:	<b>Maintenance Related</b>	Dia/Height:	<b>12"</b>
Use:	<b>Sanitary</b>	Material:	<b>PVC</b>
Drain Area:	<b>NA</b>	Lining:	<b>Cured in Place</b>
Category:	<b>NA</b>		
Comment:	<b>Flow direction wrong. Reverse setup.</b>

Location Details:		Direction of Survey:	<b>Downstream</b>
US MH:	<b>M-907-005</b>	DS MH:	<b>M-808-031</b>
		Total Length Surveyed (ft):	<b>413.6</b>

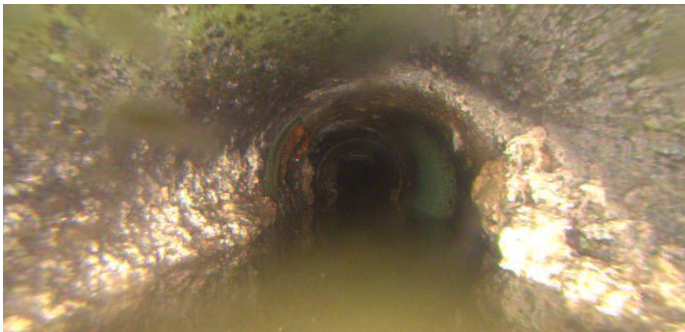
Code:	<b>DAGS</b>
Description:	<b>Deposits Attached Grease</b>

Distance (ft):	<b>105.2</b>
Structural Grade:	<b>0</b>
O&M Grade:	<b>2</b>
Clock Start/From:	<b>8</b>
Clock To:	<b>4</b>
1st Value:	
2nd Value:	
Value Percent:	<b>10.000</b>
Continuous Index:	
Within 8" of Joint:	<b>NO</b>
Remarks:

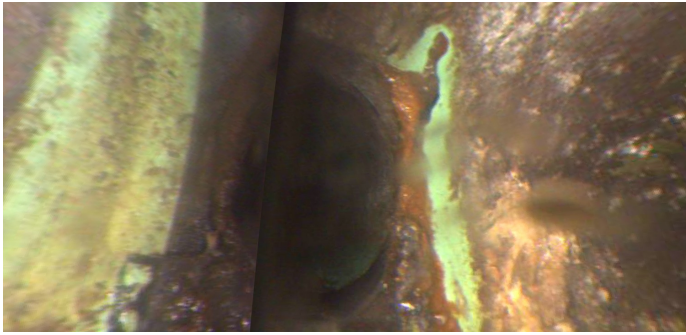
Code: **TBD**  
Description: **Tap Break-in Defective**

Distance (ft): **107.4**  
Structural Grade: **0**  
O&M Grade: **3**  
Clock Start/From: **9**  
Clock To:  
1st Value: **4.000**  
2nd Value:  
Value Percent:  
Continuous Index:  
Within 8" of Joint:  
Remarks: **DAE**

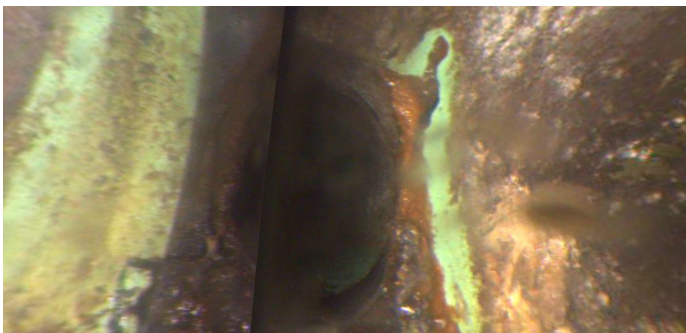
Code: **DAE**  
Description: **Deposits Attached Encrustation**

Distance (ft): **107.4**  
Structural Grade: **0**  
O&M Grade: **2**  
Clock Start/From: **8**  
Clock To: **9**  
1st Value:  
2nd Value:  
Value Percent: **5.000**  
Continuous Index:  
Within 8" of Joint: **NO**  
Remarks:

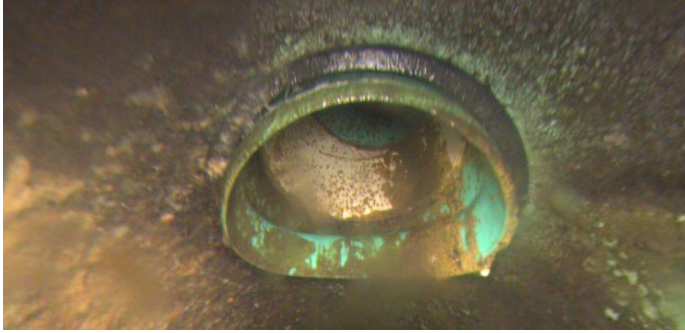
Code: **TSI**  
Description: **Tap Saddle Intruding**

Distance (ft): **110.0**  
Structural Grade: **0**  
O&M Grade: **2**  
Clock Start/From: **12**  
Clock To:  
1st Value: **4.000**  
2nd Value: **1.000**  
Value Percent:  
Continuous Index:  
Within 8" of Joint:  
Remarks:

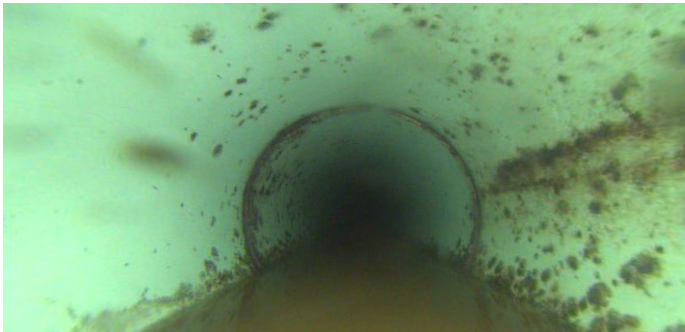
Code: **FL**  
Description: **Fracture Longitudinal**

Distance (ft): **135.2**  
Structural Grade: **3**  
O&M Grade: **0**  
Clock Start/From: **3**  
Clock To:  
1st Value:  
2nd Value:  
Value Percent:  
Continuous Index:  
Within 8" of Joint: **YES**  
Remarks:

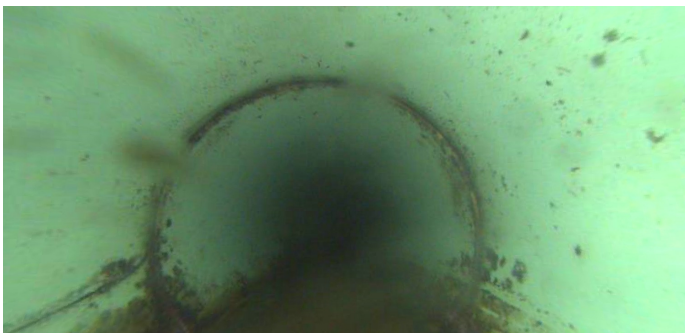
Code: **RFJ**  
Description: **Roots Fine Joint**

Distance (ft): **314.3**  
Structural Grade: **0**  
O&M Grade: **1**  
Clock Start/From: **9**  
Clock To:  
1st Value:  
2nd Value:  
Value Percent:  
Continuous Index:  
Within 8" of Joint: **YES**  
Remarks:

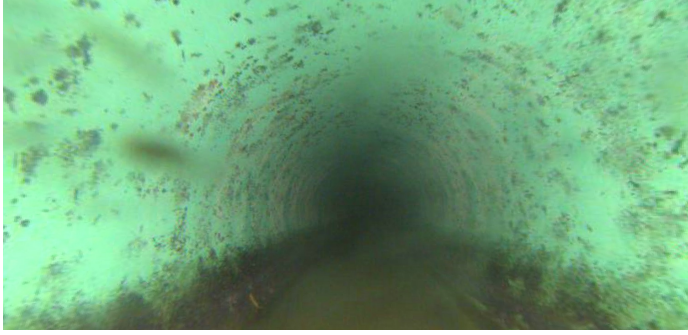
Code:	<b>MSA</b>
Description:	<b>Abandoned Survey</b>
Distance (ft):	<b>413.6</b>
Structural Grade:	<b>0</b>
O&M Grade:	<b>0</b>
Clock Start/From:	
Clock To:	
1st Value:	
2nd Value:	
Value Percent:	
Continuous Index:	
Within 8" of Joint:	<b>NO</b>
Remarks:	<b>TETHER ENDS</b>
