Profile/Photo Observation Report

Street:	Hobart	Flow Control:	Not Controlled
City:	Hobart, IN	Year Renewed:	
Location:	Light Highway	Tape/Media #:	
Purpose:	Maintenance Related	Dia/Height:	12"
Use:	Sanitary	Material:	PVC
Drain Area:	NA	Lining:	Cured in Place
Category:	NA		
Comment:	Flow direction wrong. Reverse setup.

Location Details:		Direction of Survey:	Downstream
US MH:	M-907-005	DS MH:	M-808-031
		Total Length Surveyed (ft):	413.6

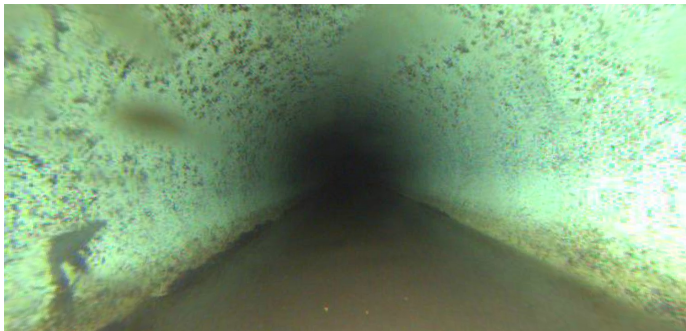
Code: **AMH**
Description: **Manhole**

Distance (ft): **.0**
Structural Grade: **0**
O&M Grade: **0**
Clock Start/From:
Clock To:
1st Value:
2nd Value:
Value Percent:
Continuous Index:
Within 8" of Joint: **NO**
Remarks: **M-907-005**

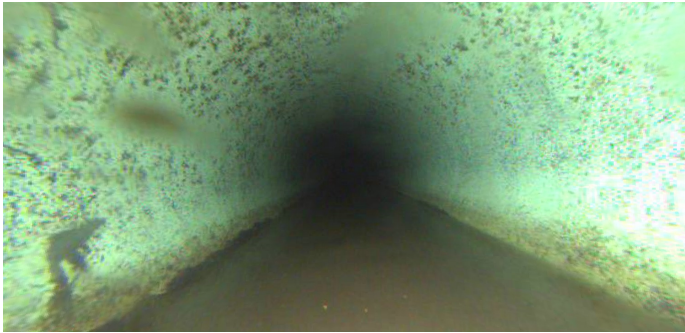
Code:	MWL
Description:	Water Level

Distance (ft):	.0
Structural Grade:	0
O&M Grade:	0
Clock Start/From:	
Clock To:	
1st Value:	
2nd Value:	
Value Percent:	20.000
Continuous Index:	
Within 8" of Joint:	NO
Remarks:

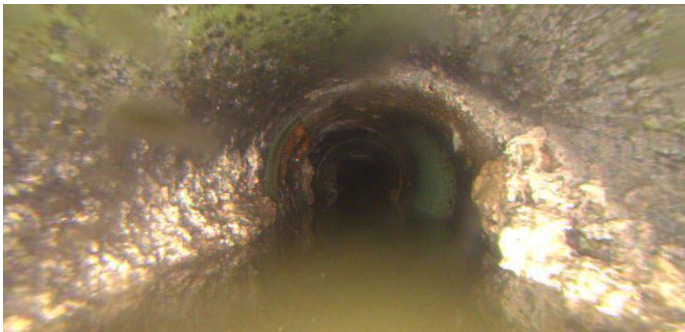
Code:	DAGS
Description:	Deposits Attached Grease

Distance (ft):	105.2
Structural Grade:	0
O&M Grade:	2
Clock Start/From:	8
Clock To:	4
1st Value:	
2nd Value:	
Value Percent:	10.000
Continuous Index:	
Within 8" of Joint:	NO
Remarks:

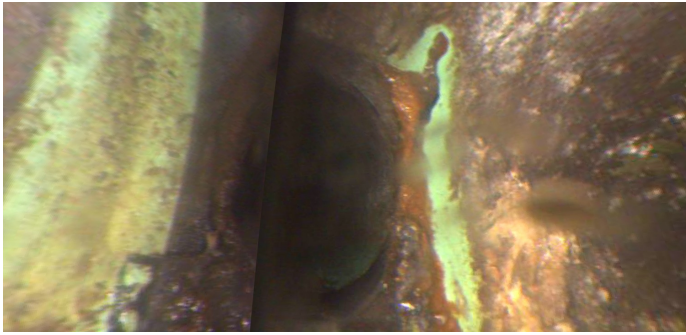
Code: **TBD**
Description: **Tap Break-in Defective**

Distance (ft): **107.4**
Structural Grade: **0**
O&M Grade: **3**
Clock Start/From: **9**
Clock To:
1st Value: **4.000**
2nd Value:
Value Percent:
Continuous Index:
Within 8" of Joint:
Remarks: **DAE**

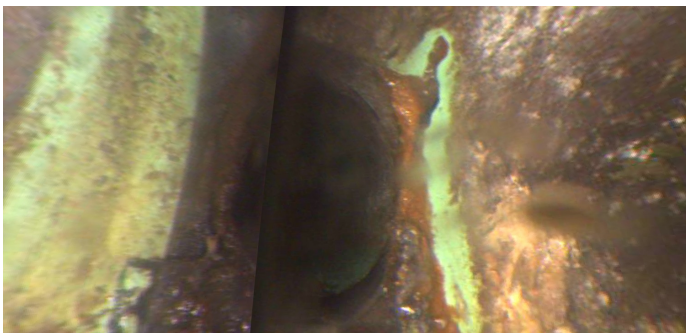
Code: **DAE**
Description: **Deposits Attached Encrustation**

Distance (ft): **107.4**
Structural Grade: **0**
O&M Grade: **2**
Clock Start/From: **8**
Clock To: **9**
1st Value:
2nd Value:
Value Percent: **5.000**
Continuous Index:
Within 8" of Joint: **NO**
Remarks:

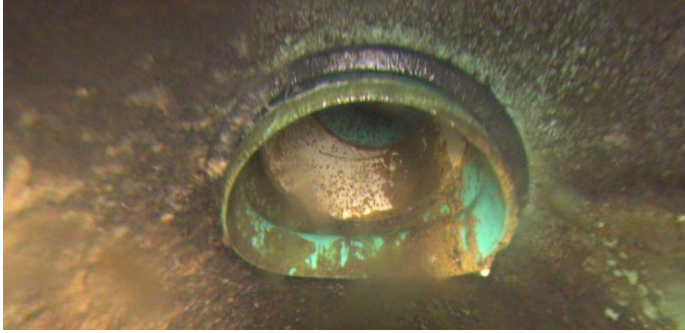
Code: **TSI**
Description: **Tap Saddle Intruding**

Distance (ft): **110.0**
Structural Grade: **0**
O&M Grade: **2**
Clock Start/From: **12**
Clock To:
1st Value: **4.000**
2nd Value: **1.000**
Value Percent:
Continuous Index:
Within 8" of Joint:
Remarks:

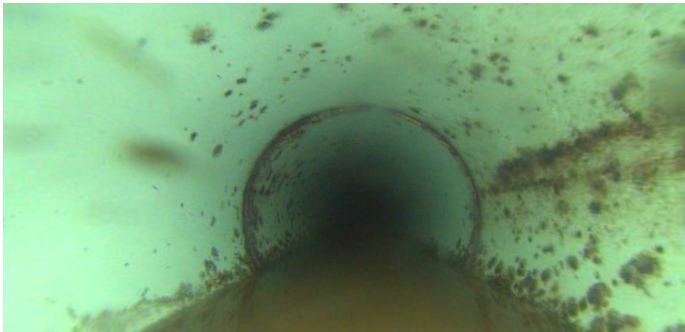
Code: **FL**
Description: **Fracture Longitudinal**

Distance (ft): **135.2**
Structural Grade: **3**
O&M Grade: **0**
Clock Start/From: **3**
Clock To:
1st Value:
2nd Value:
Value Percent:
Continuous Index:
Within 8" of Joint: **YES**
Remarks:

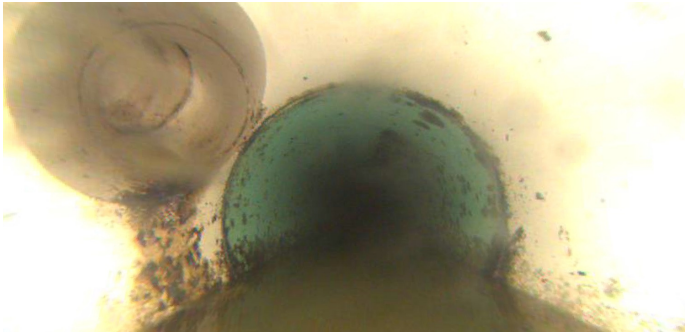
Code: **TF**
Description: **Tap Factory**

Distance (ft): **220.4**
Structural Grade: **0**
O&M Grade: **0**
Clock Start/From: **10**
Clock To:
1st Value: **4.000**
2nd Value:
Value Percent:
Continuous Index:
Within 8" of Joint:
Remarks:

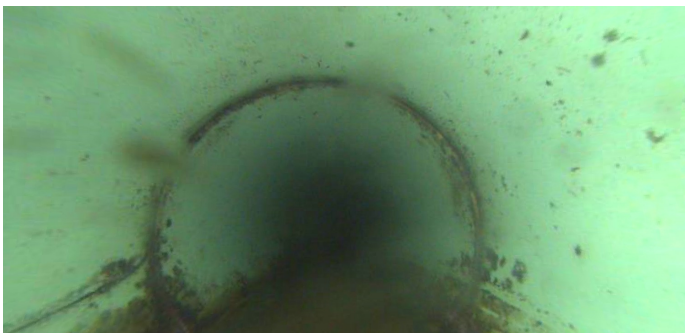
Code: **RFJ**
Description: **Roots Fine Joint**

Distance (ft): **314.3**
Structural Grade: **0**
O&M Grade: **1**
Clock Start/From: **9**
Clock To:
1st Value:
2nd Value:
Value Percent:
Continuous Index:
Within 8" of Joint: **YES**
Remarks:

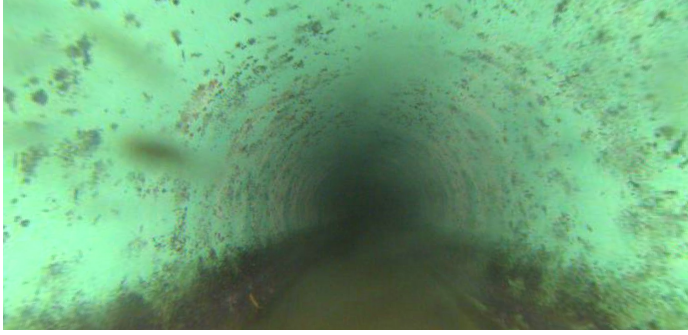
Code:	MSA
Description:	Abandoned Survey
Distance (ft):	413.6
Structural Grade:	0
O&M Grade:	0
Clock Start/From:	
Clock To:	
1st Value:	
2nd Value:	
Value Percent:	
Continuous Index:	
Within 8" of Joint:	NO
Remarks:	TETHER ENDS
