Profile/Photo Observation Report

Date:	04/11/2018	Weather:		Coding:	PACP 6.0
Pipe Length (ft):	401.2	Owner:	NA	Pre Clean:	Not Known
P.O.#:		Surveyor:	Jen Costello	PSR:	P-907-005-006
Customer:		Clean Date:	01/01/1900	Shape:	C

Street:	S HOBART RD	Flow Control:	Not Controlled
City:	Hobart, IN	Year Renewed:	
Location:	Ditch	Tape/Media #:	
Purpose:	Maintenance Related	Dia/Height:	12"
Use:	Sanitary	Material:	PVC
Drain Area:	NA	Lining:	Cured in Place
Category:	NA		
Comment:	flow incorrect.reverse setup. sludge at 255'.		
Location Details:		Direction of Survey:	Upstream
US MH:	M-907-006	DS MH:	M-907-005
		Total Length Surveyed (ft):	256.1

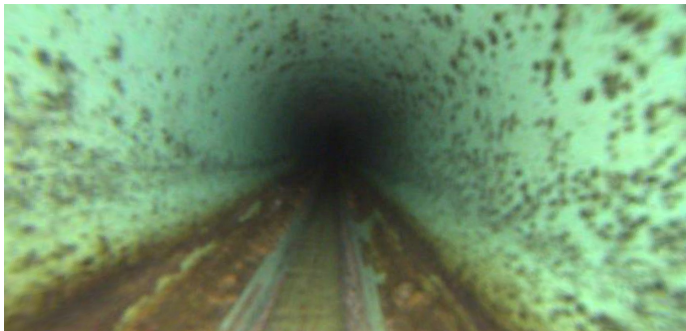
Code: **AMH**
Description: **Manhole**

Distance (ft): **.0**
Structural Grade: **0**
O&M Grade: **0**
Clock Start/From:
Clock To:
1st Value:
2nd Value:
Value Percent:
Continuous Index:
Within 8" of Joint: **NO**
Remarks: **M-907-005**

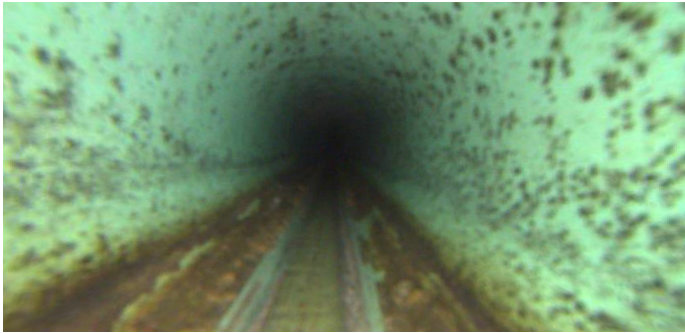
Code:	MWL
Description:	Water Level

Distance (ft):	.0
Structural Grade:	0
O&M Grade:	0
Clock Start/From:	
Clock To:	
1st Value:	
2nd Value:	
Value Percent:	5.000
Continuous Index:	
Within 8" of Joint:	NO
Remarks:

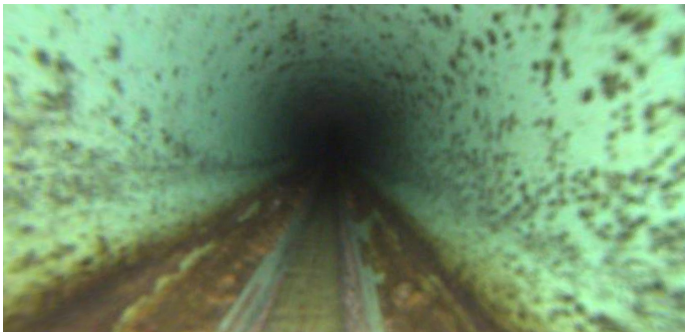
Code:	DAGS
Description:	Deposits Attached Grease

Distance (ft):	.0
Structural Grade:	0
O&M Grade:	2
Clock Start/From:	5
Clock To:	7
1st Value:	
2nd Value:	
Value Percent:	5.000
Continuous Index:	S01
Within 8" of Joint:	NO
Remarks:

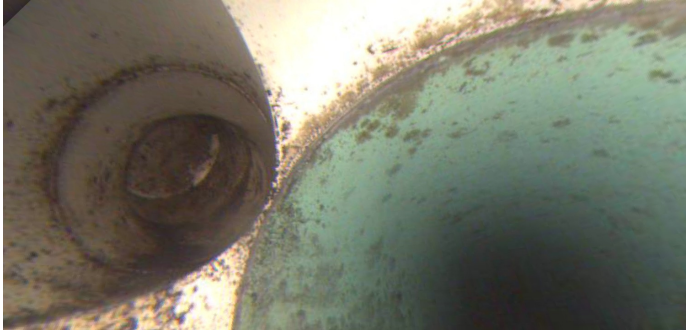
Code: **TF**
Description: **Tap Factory**

Distance (ft): **88.3**
Structural Grade: **0**
O&M Grade: **0**
Clock Start/From: **2**
Clock To:
1st Value: **4.000**
2nd Value:
Value Percent:
Continuous Index:
Within 8" of Joint:
Remarks:

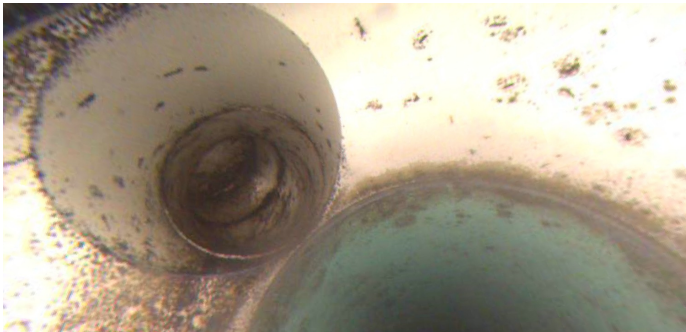
Code: **TF**
Description: **Tap Factory**

Distance (ft): **127.0**
Structural Grade: **0**
O&M Grade: **0**
Clock Start/From: **1**
Clock To:
1st Value: **4.000**
2nd Value:
Value Percent:
Continuous Index:
Within 8" of Joint:
Remarks:

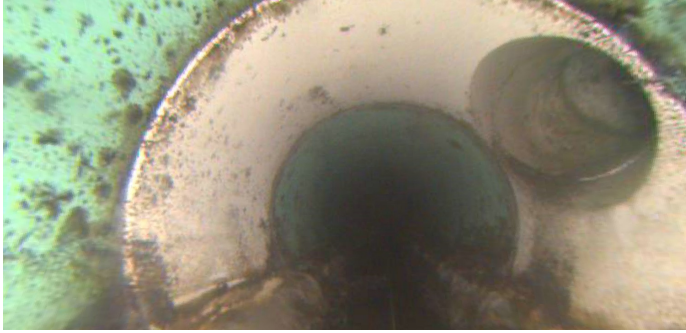
Code: **TF**
Description: **Tap Factory**

Distance (ft): **142.2**
Structural Grade: **0**
O&M Grade: **0**
Clock Start/From: **2**
Clock To:
1st Value: **4.000**
2nd Value:
Value Percent:
Continuous Index:
Within 8" of Joint:
Remarks:

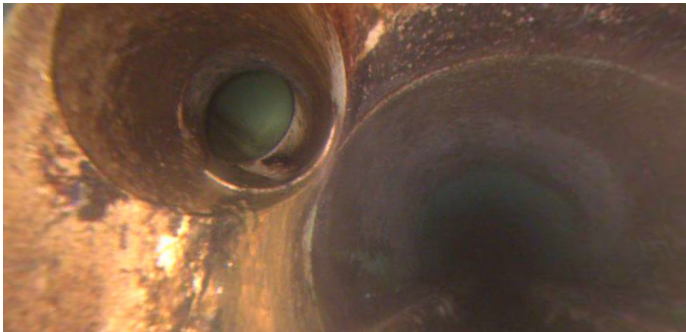
Code: **TF**
Description: **Tap Factory**

Distance (ft): **248.6**
Structural Grade: **0**
O&M Grade: **0**
Clock Start/From: **2**
Clock To:
1st Value: **4.000**
2nd Value:
Value Percent:
Continuous Index:
Within 8" of Joint:
Remarks:

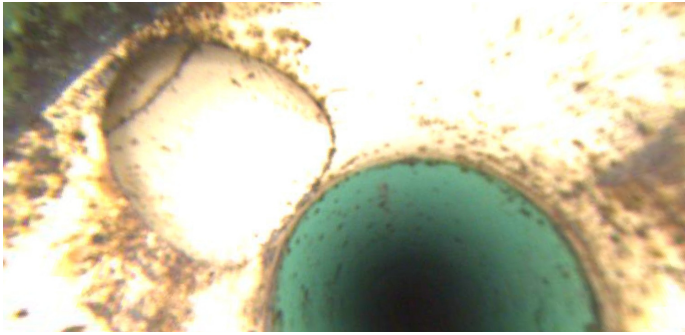
Code: **TF**
Description: **Tap Factory**

Distance (ft): **254.7**
Structural Grade: **0**
O&M Grade: **0**
Clock Start/From: **10**
Clock To:
1st Value: **4.000**
2nd Value:
Value Percent:
Continuous Index:
Within 8" of Joint:
Remarks:

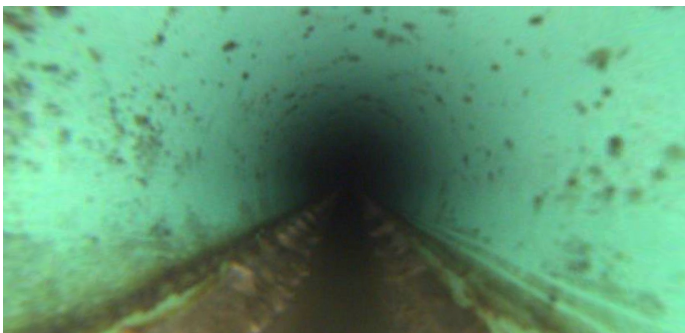
Code: **DAGS**
Description: **Deposits Attached Grease**

Distance (ft): **256.1**
Structural Grade: **0**
O&M Grade: **2**
Clock Start/From: **5**
Clock To: **7**
1st Value:
2nd Value:
Value Percent: **5.000**
Continuous Index: **F01**
Within 8" of Joint: **NO**
Remarks:

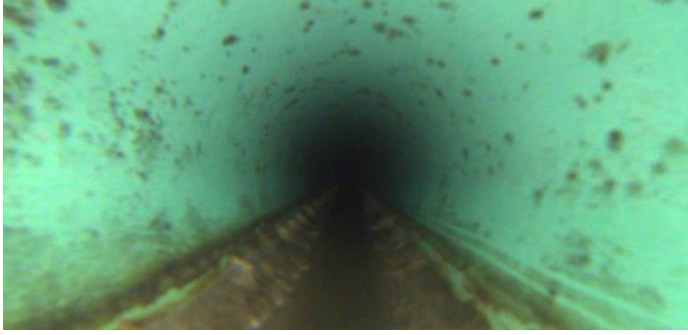
Code:	MSA
Description:	Abandoned Survey
Distance (ft):	256.1
Structural Grade:	0
O&M Grade:	0
Clock Start/From:	
Clock To:	
1st Value:	
2nd Value:	
Value Percent:	
Continuous Index:	
Within 8" of Joint:	NO
Remarks:	dags
