Profile/Photo Observation Report

Date:	04/11/2018	Weather:		Coding:	PACP 6.0
Pipe Length (ft):	401.2	Owner:	NA	Pre Clean:	Not Known
P.O.#:		Surveyor:	Jen Costello	PSR:	P-907-005-006
Customer:		Clean Date:	01/01/1900	Shape:	C

Street:	Capitol	Flow Control:	Not Controlled
City:	Hobart, IN	Year Renewed:	
Location:	Ditch	Tape/Media #:	
Purpose:	Maintenance Related	Dia/Height:	12"
Use:	Sanitary	Material:	PVC
Drain Area:	NA	Lining:	Cured in Place
Category:	NA		
Comment:	flow incorrect.reverse setup. sludge at 255'.		
Location Details:		Direction of Survey:	Upstream
US MH:	M-907-006	DS MH:	M-907-005
		Total Length Surveyed (ft):	256.1

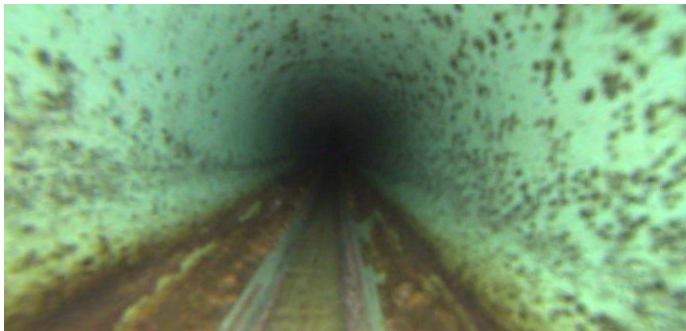
Code: **AMH**
Description: **Manhole**

Distance (ft): **.0**
Structural Grade: **0**
O&M Grade: **0**
Clock Start/From:
Clock To:
1st Value:
2nd Value:
Value Percent:
Continuous Index:
Within 8" of Joint: **NO**
Remarks: **M-907-005**

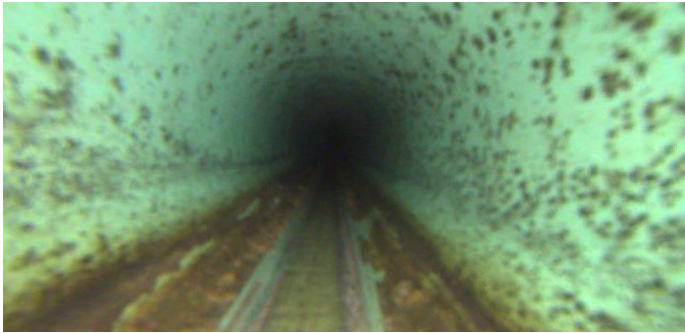
Code:	MWL
Description:	Water Level

Distance (ft):	.0
Structural Grade:	0
O&M Grade:	0
Clock Start/From:	
Clock To:	
1st Value:	
2nd Value:	
Value Percent:	5.000
Continuous Index:	
Within 8" of Joint:	NO
Remarks:

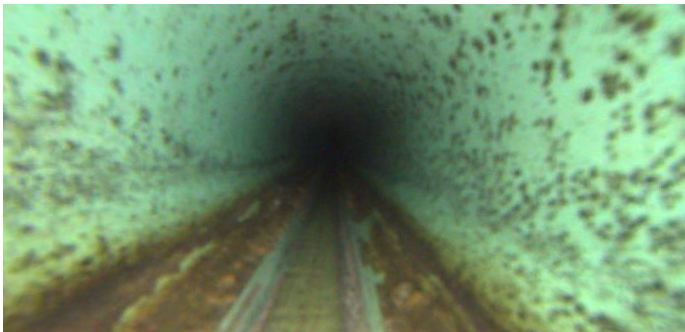
Code:	DAGS
Description:	Deposits Attached Grease

Distance (ft):	.0
Structural Grade:	0
O&M Grade:	2
Clock Start/From:	5
Clock To:	7
1st Value:	
2nd Value:	
Value Percent:	5.000
Continuous Index:	S01
Within 8" of Joint:	NO
Remarks:

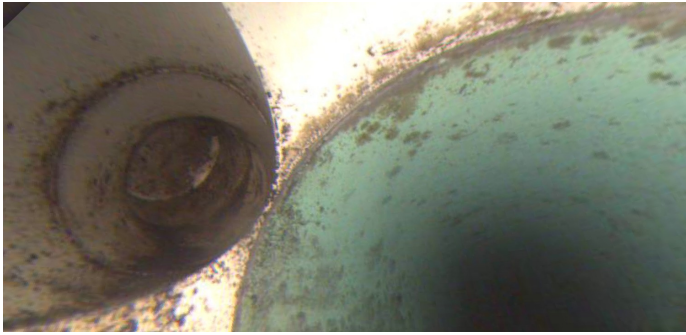
Code: **TF**
Description: **Tap Factory**

Distance (ft): **88.3**
Structural Grade: **0**
O&M Grade: **0**
Clock Start/From: **2**
Clock To:
1st Value: **4.000**
2nd Value:
Value Percent:
Continuous Index:
Within 8" of Joint:
Remarks:

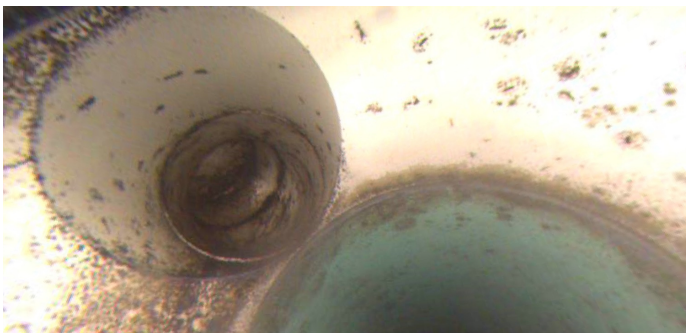
Code: **TF**
Description: **Tap Factory**

Distance (ft): **127.0**
Structural Grade: **0**
O&M Grade: **0**
Clock Start/From: **1**
Clock To:
1st Value: **4.000**
2nd Value:
Value Percent:
Continuous Index:
Within 8" of Joint:
Remarks:

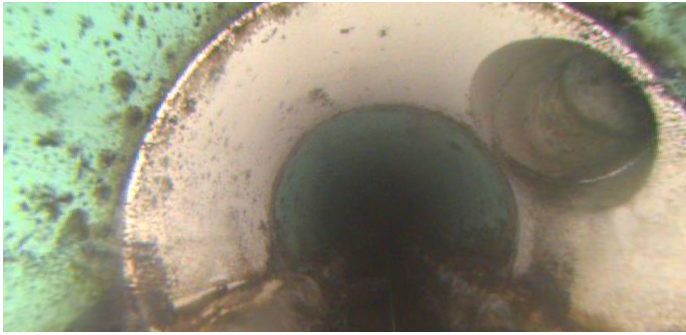
Code: **TF**
Description: **Tap Factory**

Distance (ft): **142.2**
Structural Grade: **0**
O&M Grade: **0**
Clock Start/From: **2**
Clock To:
1st Value: **4.000**
2nd Value:
Value Percent:
Continuous Index:
Within 8" of Joint:
Remarks:

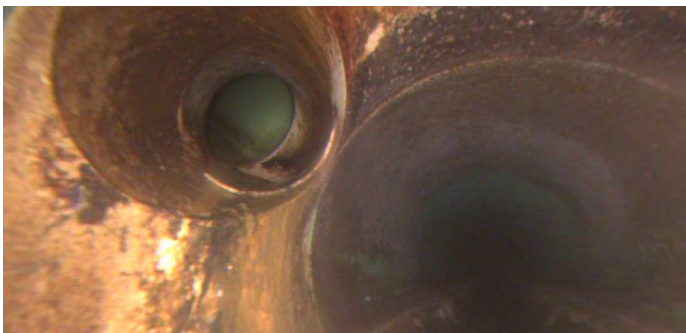
Code: **TF**
Description: **Tap Factory**

Distance (ft): **248.6**
Structural Grade: **0**
O&M Grade: **0**
Clock Start/From: **2**
Clock To:
1st Value: **4.000**
2nd Value:
Value Percent:
Continuous Index:
Within 8" of Joint:
Remarks:

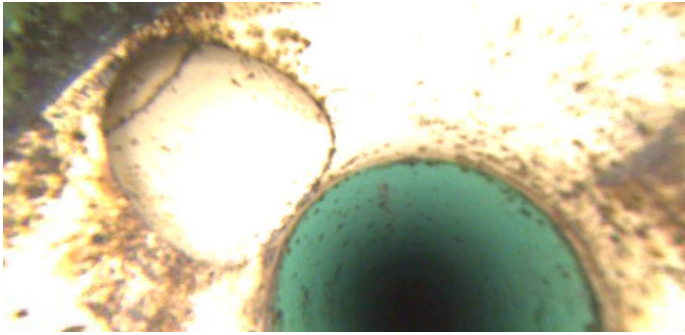
Code: **TF**
Description: **Tap Factory**

Distance (ft): **254.7**
Structural Grade: **0**
O&M Grade: **0**
Clock Start/From: **10**
Clock To:
1st Value: **4.000**
2nd Value:
Value Percent:
Continuous Index:
Within 8" of Joint:
Remarks:

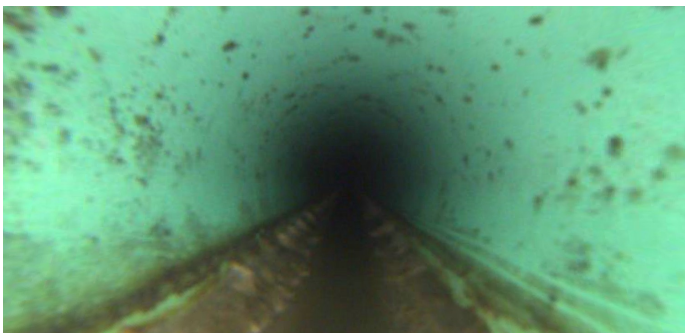
Code: **DAGS**
Description: **Deposits Attached Grease**

Distance (ft): **256.1**
Structural Grade: **0**
O&M Grade: **2**
Clock Start/From: **5**
Clock To: **7**
1st Value:
2nd Value:
Value Percent: **5.000**
Continuous Index: **F01**
Within 8" of Joint: **NO**
Remarks:

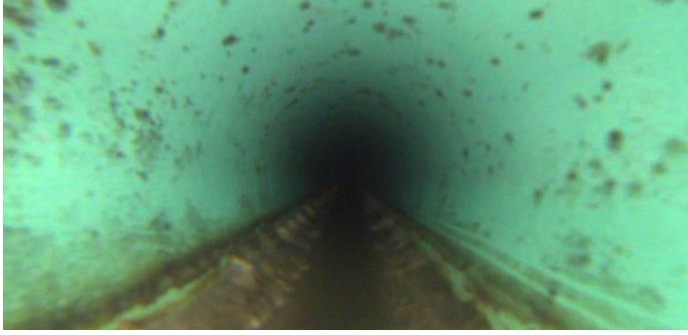
Code:	MSA
Description:	Abandoned Survey
Distance (ft):	256.1
Structural Grade:	0
O&M Grade:	0
Clock Start/From:	
Clock To:	
1st Value:	
2nd Value:	
Value Percent:	
Continuous Index:	
Within 8" of Joint:	NO
Remarks:	dags
