## Profile/Photo Observation Report

Date:	<b>04/11/2018</b>	Weather:		Coding:	<b>PACP 6.0</b>
Pipe Length (ft):	<b>358.7</b>	Owner:	<b>NA</b>	Pre Clean:	<b>Not Known</b>
P.O.#:		Surveyor:	<b>Jen Costello</b>	PSR:	<b>P-907-006-007</b>
Customer:		Clean Date:	<b>01/01/1900</b>	Shape:	<b>C</b>

Street:	<b>S HOBART RD</b>	Flow Control:	<b>Not Controlled</b>
City:	<b>Hobart, IN</b>	Year Renewed:	
Location:	<b>Ditch</b>	Tape/Media #:	
Purpose:	<b>Maintenance Related</b>	Dia/Height:	<b>12"</b>
Use:	<b>Sanitary</b>	Material:	<b>PVC</b>
Drain Area:	<b>NA</b>	Lining:	<b>Cured in Place</b>
Category:	<b>NA</b>		
Comment:	<b>battery at 350'-flow incorrect</b>		
Location Details:		Direction of Survey:	<b>Upstream</b>
US MH:	<b>M-907-007</b>	DS MH:	<b>M-907-006</b>
		Total Length Surveyed (ft):	<b>351.3</b>

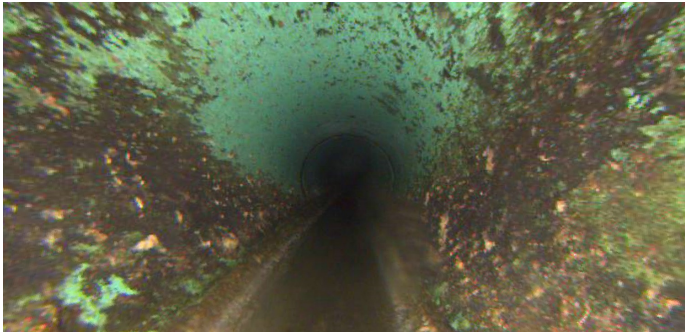
Code:	<b>MWL</b>
Description:	<b>Water Level</b>

Distance (ft):	<b>.0</b>
Structural Grade:	<b>0</b>
O&M Grade:	<b>0</b>
Clock Start/From:	
Clock To:	
1st Value:	
2nd Value:	
Value Percent:	<b>5.000</b>
Continuous Index:	
Within 8" of Joint:	<b>NO</b>
Remarks:

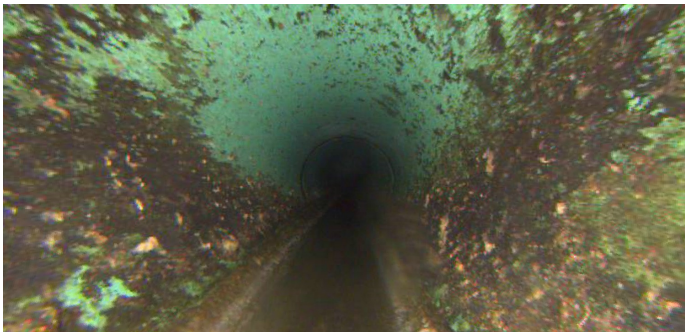
Code:	<b>DAGS</b>
Description:	<b>Deposits Attached Grease</b>

Distance (ft):	<b>.0</b>
Structural Grade:	<b>0</b>
O&M Grade:	<b>2</b>
Clock Start/From:	<b>8</b>
Clock To:	<b>4</b>
1st Value:	
2nd Value:	
Value Percent:	<b>5.000</b>
Continuous Index:	<b>S01</b>
Within 8" of Joint:	<b>NO</b>
Remarks:

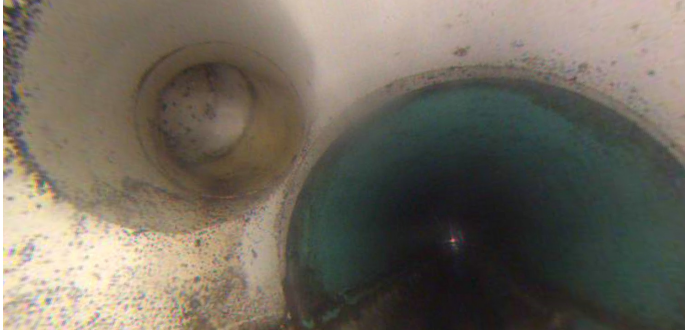
Code: **TF**  
Description: **Tap Factory**

Distance (ft): **67.0**  
Structural Grade: **0**  
O&M Grade: **0**  
Clock Start/From: **2**  
Clock To:  
1st Value: **4.000**  
2nd Value:  
Value Percent:  
Continuous Index:  
Within 8" of Joint:  
Remarks:

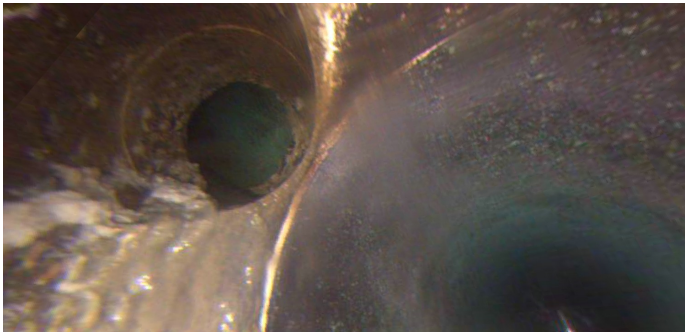
Code: **TF**  
Description: **Tap Factory**

Distance (ft): **104.2**  
Structural Grade: **0**  
O&M Grade: **0**  
Clock Start/From: **2**  
Clock To:  
1st Value: **4.000**  
2nd Value:  
Value Percent:  
Continuous Index:  
Within 8" of Joint:  
Remarks:

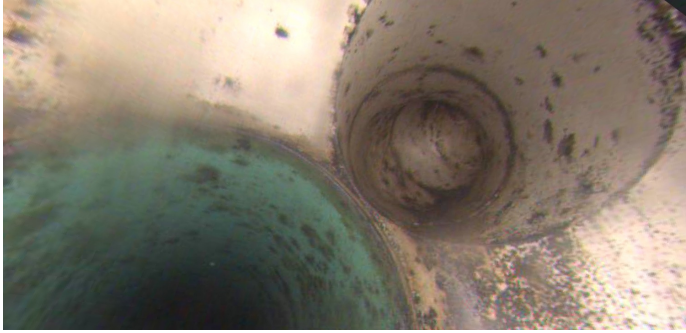
Code: **TF**  
Description: **Tap Factory**

Distance (ft): **312.7**  
Structural Grade: **0**  
O&M Grade: **0**  
Clock Start/From: **10**  
Clock To:  
1st Value: **4.000**  
2nd Value:  
Value Percent:  
Continuous Index:  
Within 8" of Joint:  
Remarks:

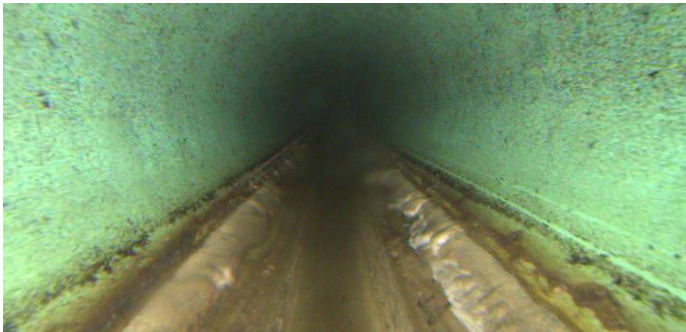
Code: **MSA**  
Description: **Abandoned Survey**

Distance (ft): **351.3**  
Structural Grade: **0**  
O&M Grade: **0**  
Clock Start/From:  
Clock To:  
1st Value:  
2nd Value:  
Value Percent:  
Continuous Index:  
Within 8" of Joint: **NO**  
Remarks: **dags**

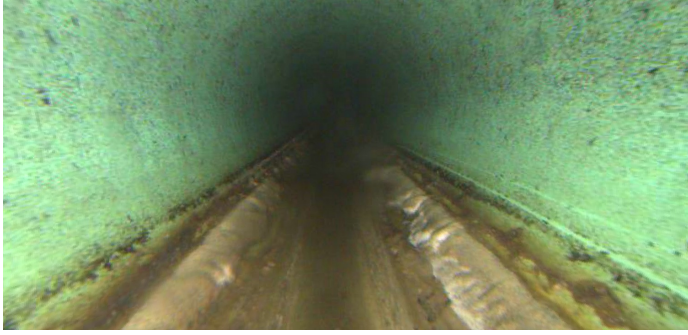
Code:	<b>DAGS</b>
Description:	<b>Deposits Attached Grease</b>
Distance (ft):	<b>351.3</b>
Structural Grade:	<b>0</b>
O&M Grade:	<b>2</b>
Clock Start/From:	<b>8</b>
Clock To:	<b>4</b>
1st Value:	
2nd Value:	
Value Percent:	<b>5.000</b>
Continuous Index:	<b>F01</b>
Within 8" of Joint:	<b>NO</b>
Remarks:
