Profile/Photo Observation Report

Date:	04/13/2018	Weather:		Coding:	PACP 6.0
Pipe Length (ft):	346.0	Owner:	NA	Pre Clean:	Not Known
P.O.#:		Surveyor:	Jen Costello	PSR:	
Customer:		Clean Date:	01/01/1900	Shape:	C

Street:	Capitol	Flow Control:	Not Controlled
City:	Hobart, IN	Year Renewed:	
Location:	Light Highway	Tape/Media #:	
Purpose:	Maintenance Related	Dia/Height:	8"
Use:	Sanitary	Material:	PVC
Drain Area:	NA	Lining:	Cured in Place
Category:	NA		
Comment:	new mh found.

Location Details:		Direction of Survey:	Upstream
US MH:	M-907-008A	DS MH:	M-907-008
		Total Length Surveyed (ft):	347.9

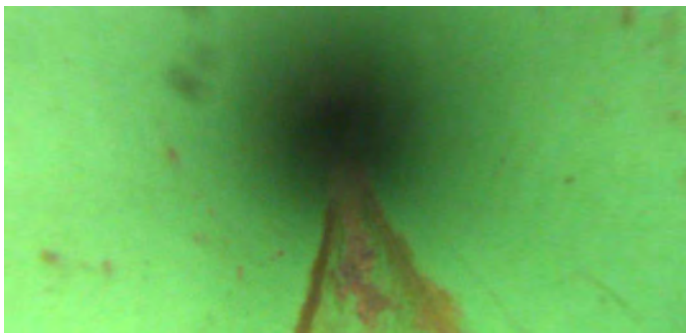
Code: **AMH**
Description: **Manhole**

Distance (ft): **.0**
Structural Grade: **0**
O&M Grade: **0**
Clock Start/From:
Clock To:
1st Value:
2nd Value:
Value Percent:
Continuous Index:
Within 8" of Joint: **NO**
Remarks: **M-907-008**

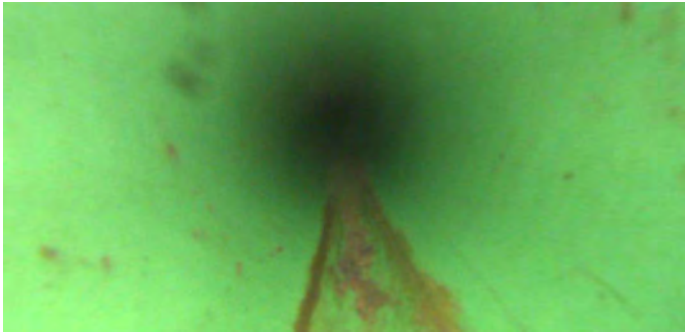
Code:	MWL
Description:	Water Level

Distance (ft):	.0
Structural Grade:	0
O&M Grade:	0
Clock Start/From:	
Clock To:	
1st Value:	
2nd Value:	
Value Percent:	5.000
Continuous Index:	
Within 8" of Joint:	NO
Remarks:

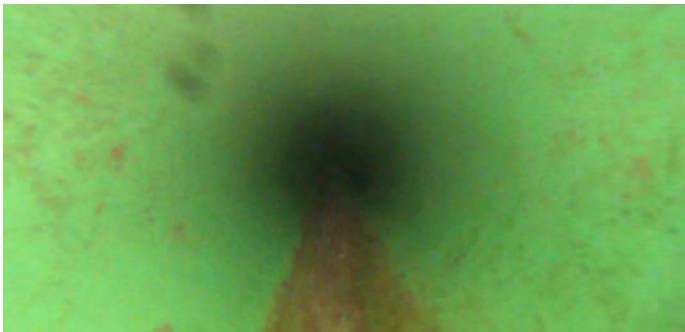
Code:	DSF
Description:	Deposits Settled Fine

Distance (ft):	6.6
Structural Grade:	0
O&M Grade:	2
Clock Start/From:	6
Clock To:	
1st Value:	
2nd Value:	
Value Percent:	5.000
Continuous Index:	
Within 8" of Joint:	NO
Remarks:

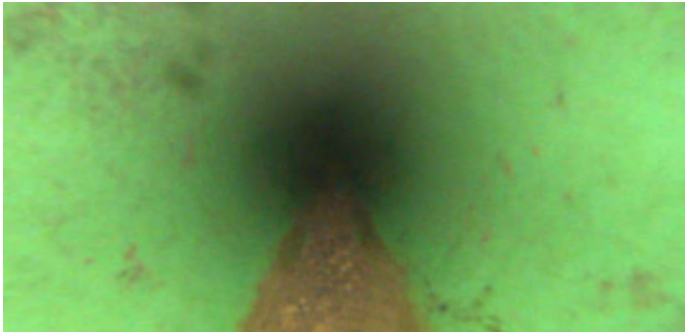
Code: **DSF**
Description: **Deposits Settled Fine**

Distance (ft): **20.5**
Structural Grade: **0**
O&M Grade: **2**
Clock Start/From: **6**
Clock To:
1st Value:
2nd Value:
Value Percent: **5.000**
Continuous Index:
Within 8" of Joint: **NO**
Remarks:

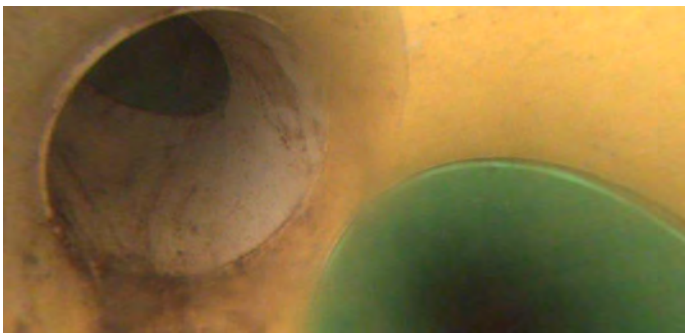
Code: **TF**
Description: **Tap Factory**

Distance (ft): **56.4**
Structural Grade: **0**
O&M Grade: **0**
Clock Start/From: **2**
Clock To:
1st Value: **4.000**
2nd Value:
Value Percent:
Continuous Index:
Within 8" of Joint:
Remarks:

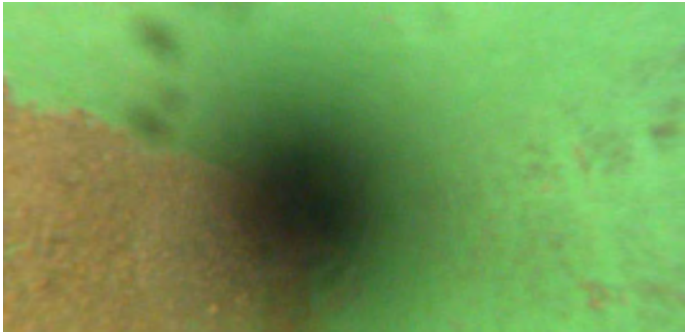
Code: **DAGS**
Description: **Deposits Attached Grease**

Distance (ft): **138.1**
Structural Grade: **0**
O&M Grade: **2**
Clock Start/From: **7**
Clock To: **9**
1st Value:
2nd Value:
Value Percent: **5.000**
Continuous Index: **S01**
Within 8" of Joint: **NO**
Remarks:

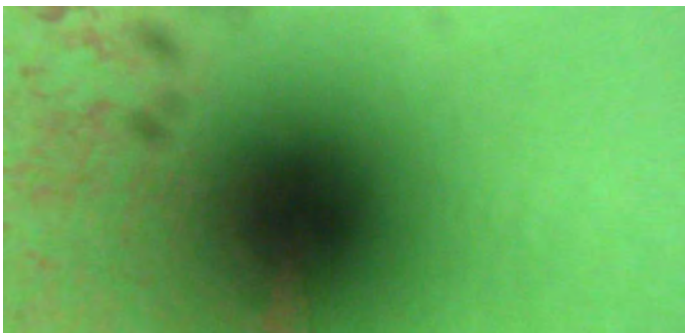
Code: **DAGS**
Description: **Deposits Attached Grease**

Distance (ft): **152.0**
Structural Grade: **0**
O&M Grade: **2**
Clock Start/From: **7**
Clock To: **9**
1st Value:
2nd Value:
Value Percent: **5.000**
Continuous Index: **F01**
Within 8" of Joint: **NO**
Remarks:

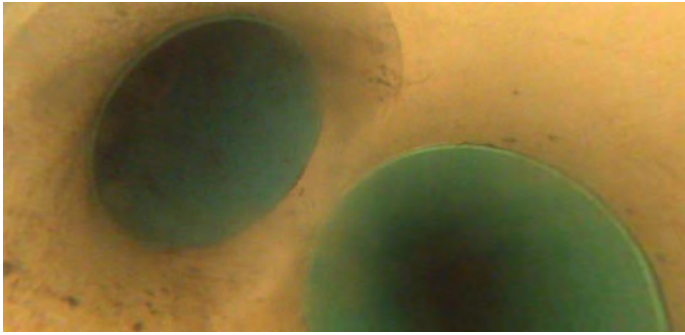
Code: **TF**
Description: **Tap Factory**

Distance (ft): **212.2**
Structural Grade: **0**
O&M Grade: **0**
Clock Start/From: **2**
Clock To:
1st Value: **4.000**
2nd Value:
Value Percent:
Continuous Index:
Within 8" of Joint:
Remarks:

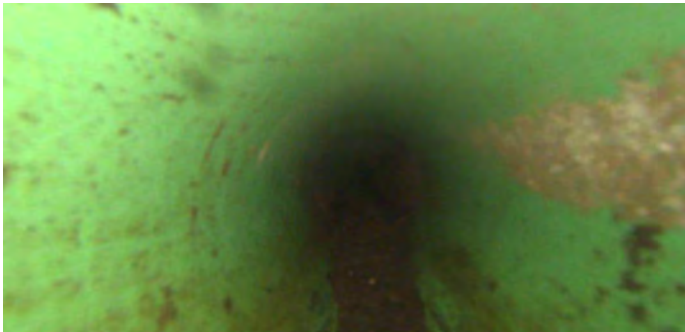
Code: **DSF**
Description: **Deposits Settled Fine**

Distance (ft): **344.3**
Structural Grade: **0**
O&M Grade: **2**
Clock Start/From: **6**
Clock To:
1st Value:
2nd Value:
Value Percent: **5.000**
Continuous Index:
Within 8" of Joint: **NO**
Remarks:

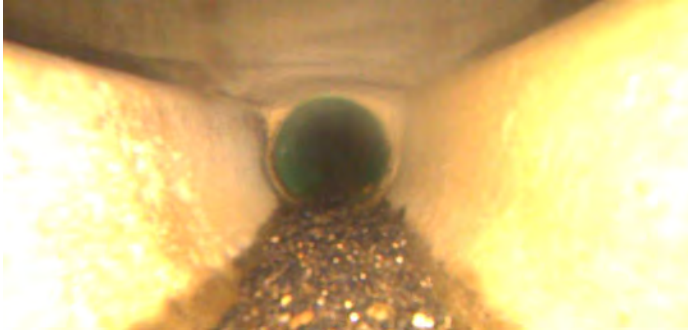
Code:	AMH
Description:	Manhole
Distance (ft):	347.9
Structural Grade:	0
O&M Grade:	0
Clock Start/From:	
Clock To:	
1st Value:	
2nd Value:	
Value Percent:	
Continuous Index:	
Within 8" of Joint:	NO
Remarks:	M-907-008A
