Profile/Photo Observation Report

Street:	Capitol	Flow Control:	Not Controlled
City:	Hobart, IN	Year Renewed:	
Location:	Light Highway	Tape/Media #:	
Purpose:	Maintenance Related	Dia/Height:	8"
Use:	Sanitary	Material:	PVC
Drain Area:	NA	Lining:	Cured in Place
Category:	NA		
Comment:	new mh found.

Location Details:		Direction of Survey:	Upstream
US MH:	M-907-008A	DS MH:	M-907-008
		Total Length Surveyed (ft):	347.9

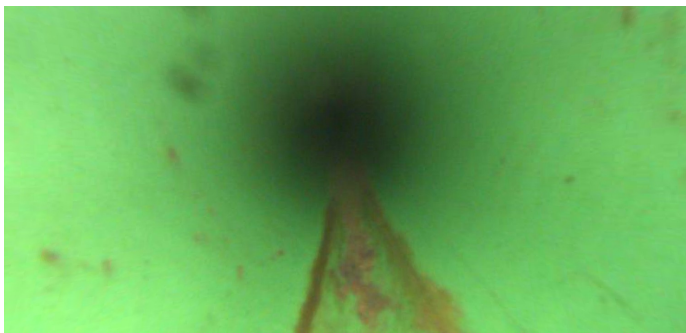
Code: **AMH**
Description: **Manhole**

Distance (ft): **.0**
Structural Grade: **0**
O&M Grade: **0**
Clock Start/From:
Clock To:
1st Value:
2nd Value:
Value Percent:
Continuous Index:
Within 8" of Joint: **NO**
Remarks: **M-907-008**

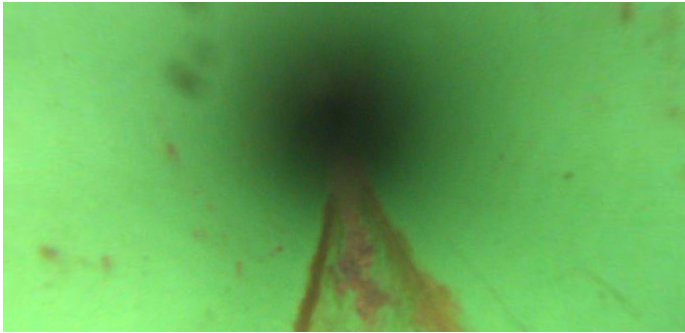
Code:	MWL
Description:	Water Level

Distance (ft):	.0
Structural Grade:	0
O&M Grade:	0
Clock Start/From:	
Clock To:	
1st Value:	
2nd Value:	
Value Percent:	5.000
Continuous Index:	
Within 8" of Joint:	NO
Remarks:

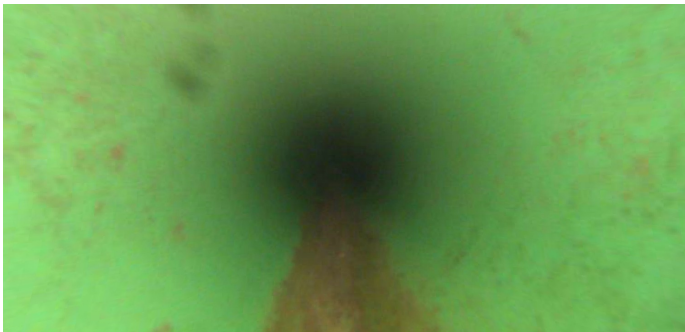
Code:	DSF
Description:	Deposits Settled Fine

Distance (ft):	6.6
Structural Grade:	0
O&M Grade:	2
Clock Start/From:	6
Clock To:	
1st Value:	
2nd Value:	
Value Percent:	5.000
Continuous Index:	
Within 8" of Joint:	NO
Remarks:

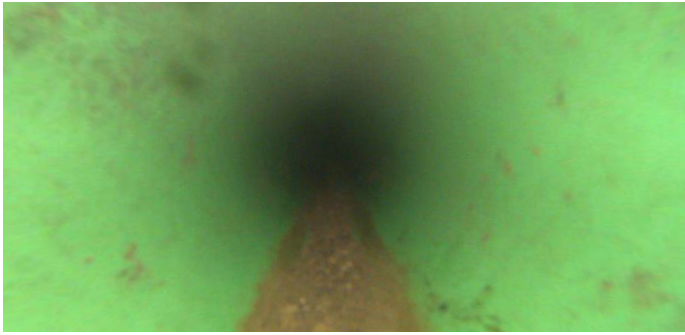
Code: **DSF**
Description: **Deposits Settled Fine**

Distance (ft): **20.5**
Structural Grade: **0**
O&M Grade: **2**
Clock Start/From: **6**
Clock To:
1st Value:
2nd Value:
Value Percent: **5.000**
Continuous Index:
Within 8" of Joint: **NO**
Remarks:

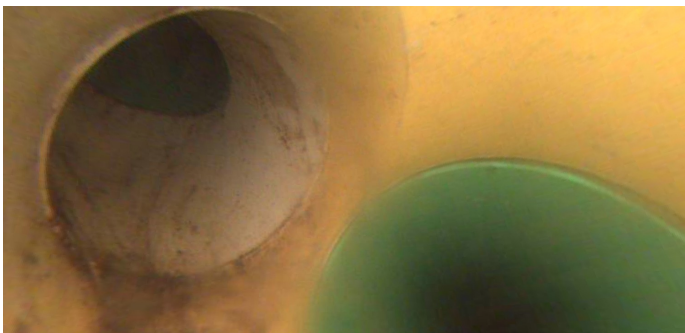
Code: **TF**
Description: **Tap Factory**

Distance (ft): **56.4**
Structural Grade: **0**
O&M Grade: **0**
Clock Start/From: **2**
Clock To:
1st Value: **4.000**
2nd Value:
Value Percent:
Continuous Index:
Within 8" of Joint:
Remarks:

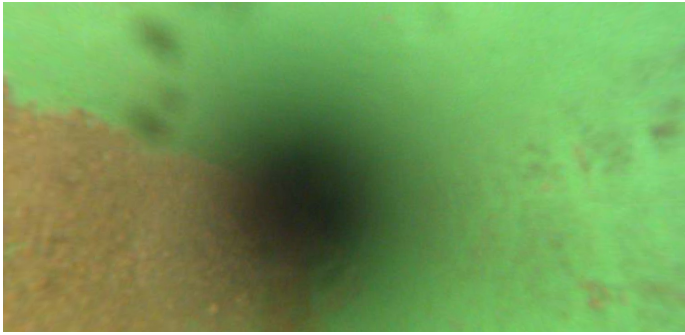
Code: **DAGS**
Description: **Deposits Attached Grease**

Distance (ft): **138.1**
Structural Grade: **0**
O&M Grade: **2**
Clock Start/From: **7**
Clock To: **9**
1st Value:
2nd Value:
Value Percent: **5.000**
Continuous Index: **S01**
Within 8" of Joint: **NO**
Remarks:

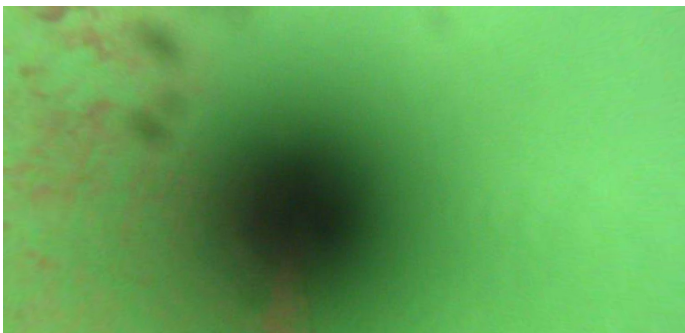
Code: **DAGS**
Description: **Deposits Attached Grease**

Distance (ft): **152.0**
Structural Grade: **0**
O&M Grade: **2**
Clock Start/From: **7**
Clock To: **9**
1st Value:
2nd Value:
Value Percent: **5.000**
Continuous Index: **F01**
Within 8" of Joint: **NO**
Remarks:

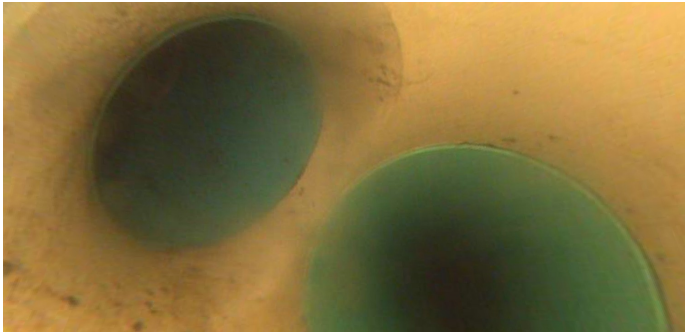
Code: **TF**
Description: **Tap Factory**

Distance (ft): **212.2**
Structural Grade: **0**
O&M Grade: **0**
Clock Start/From: **2**
Clock To:
1st Value: **4.000**
2nd Value:
Value Percent:
Continuous Index:
Within 8" of Joint:
Remarks:

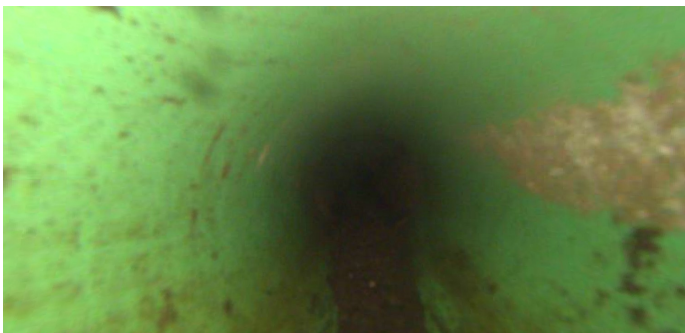
Code: **DSF**
Description: **Deposits Settled Fine**

Distance (ft): **344.3**
Structural Grade: **0**
O&M Grade: **2**
Clock Start/From: **6**
Clock To:
1st Value:
2nd Value:
Value Percent: **5.000**
Continuous Index:
Within 8" of Joint: **NO**
Remarks:

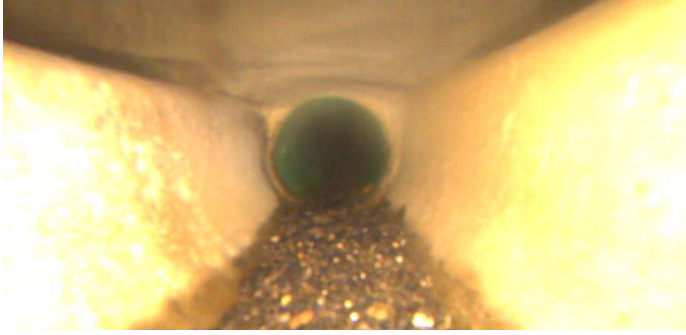
Code:	AMH
Description:	Manhole
Distance (ft):	347.9
Structural Grade:	0
O&M Grade:	0
Clock Start/From:	
Clock To:	
1st Value:	
2nd Value:	
Value Percent:	
Continuous Index:	
Within 8" of Joint:	NO
Remarks:	M-907-008A
