Profile/Photo Observation Report

Street:	Capitol	Flow Control:	Not Controlled
City:	Hobart, IN	Year Renewed:	
Location:	Ditch	Tape/Media #:	
Purpose:	Maintenance Related	Dia/Height:	8"
Use:	Sanitary	Material:	PVC
Drain Area:	NA	Lining:	Cured in Place
Category:	NA		
Comment:	track slipped off bot wheel at 331'.

Location Details:		Direction of Survey:	Downstream
US MH:	M-907-009	DS MH:	M-907-008A
		Total Length Surveyed (ft):	332.7

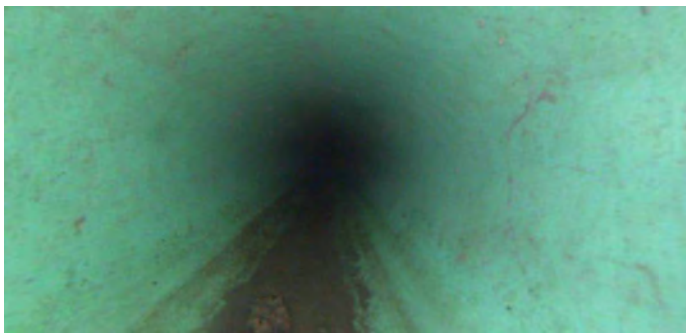
Code: **AMH**
Description: **Manhole**

Distance (ft): **.0**
Structural Grade: **0**
O&M Grade: **0**
Clock Start/From:
Clock To:
1st Value:
2nd Value:
Value Percent:
Continuous Index:
Within 8" of Joint: **NO**
Remarks: **M-907-009**

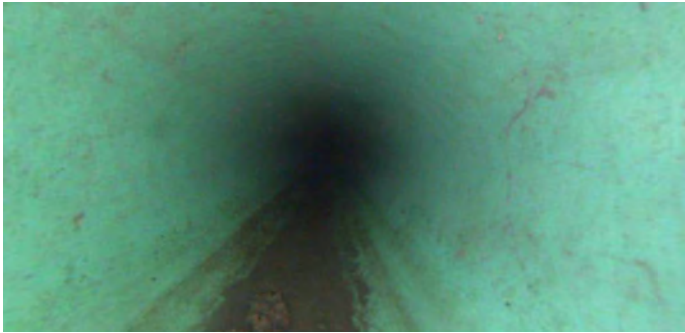
Code:	MWL
Description:	Water Level

Distance (ft):	.0
Structural Grade:	0
O&M Grade:	0
Clock Start/From:	
Clock To:	
1st Value:	
2nd Value:	
Value Percent:	5.000
Continuous Index:	
Within 8" of Joint:	NO
Remarks:

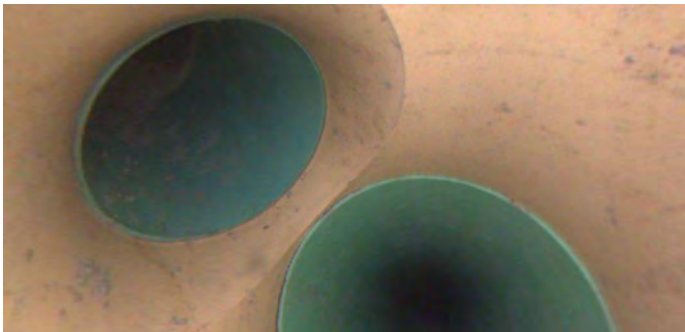
Code:	TF
Description:	Tap Factory

Distance (ft):	19.6
Structural Grade:	0
O&M Grade:	0
Clock Start/From:	11
Clock To:	
1st Value:	4.000
2nd Value:	
Value Percent:	
Continuous Index:	
Within 8" of Joint:	
Remarks:

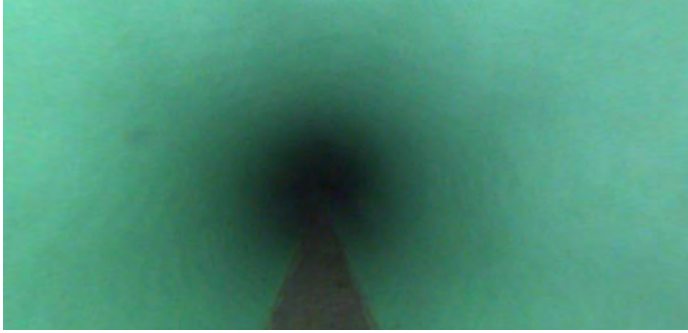
Code:	MSA
Description:	Abandoned Survey
Distance (ft):	332.7
Structural Grade:	0
O&M Grade:	0
Clock Start/From:	
Clock To:	
1st Value:	
2nd Value:	
Value Percent:	
Continuous Index:	
Within 8" of Joint:	NO
Remarks:	unknown
