## Profile/Photo Observation Report

Street:	<b>Capitol</b>	Flow Control:	<b>Not Controlled</b>
City:	<b>Hobart, IN</b>	Year Renewed:	
Location:	<b>Ditch</b>	Tape/Media #:	
Purpose:	<b>Maintenance Related</b>	Dia/Height:	<b>8"</b>
Use:	<b>Sanitary</b>	Material:	<b>PVC</b>
Drain Area:	<b>NA</b>	Lining:	<b>Cured in Place</b>
Category:	<b>NA</b>		
Comment:	<b>track slipped off bot wheel at 331'.</b>

Location Details:	Direction of Survey:	<b>Downstream</b>
US MH: <b>M-907-009</b>	DS MH: <b>M-907-008A</b>	Total Length Surveyed (ft): <b>332.7</b>

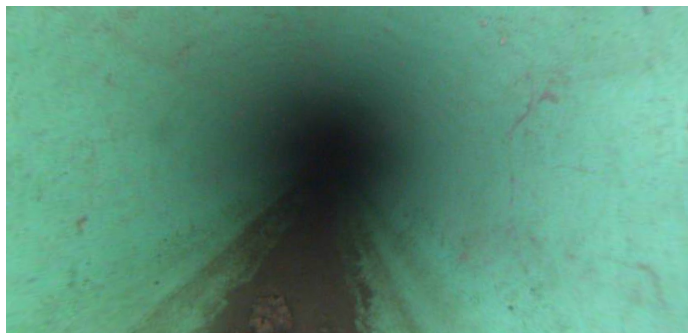
Code: **AMH**  
Description: **Manhole**

Distance (ft): **.0**  
Structural Grade: **0**  
O&M Grade: **0**  
Clock Start/From:  
Clock To:  
1st Value:  
2nd Value:  
Value Percent:  
Continuous Index:  
Within 8" of Joint: **NO**  
Remarks: **M-907-009**

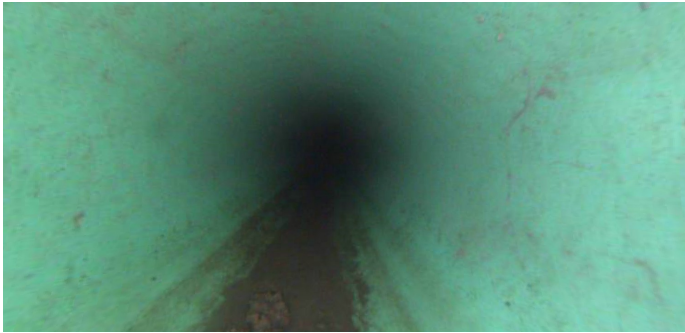
Code:	<b>MWL</b>
Description:	<b>Water Level</b>

Distance (ft):	<b>.0</b>
Structural Grade:	<b>0</b>
O&M Grade:	<b>0</b>
Clock Start/From:	
Clock To:	
1st Value:	
2nd Value:	
Value Percent:	<b>5.000</b>
Continuous Index:	
Within 8" of Joint:	<b>NO</b>
Remarks:

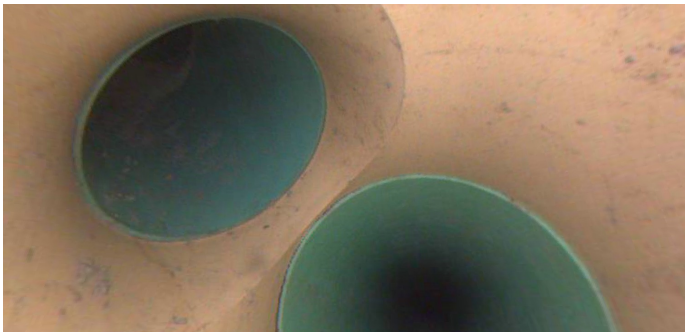
Code:	<b>TF</b>
Description:	<b>Tap Factory</b>

Distance (ft):	<b>19.6</b>
Structural Grade:	<b>0</b>
O&M Grade:	<b>0</b>
Clock Start/From:	<b>11</b>
Clock To:	
1st Value:	<b>4.000</b>
2nd Value:	
Value Percent:	
Continuous Index:	
Within 8" of Joint:	
Remarks:

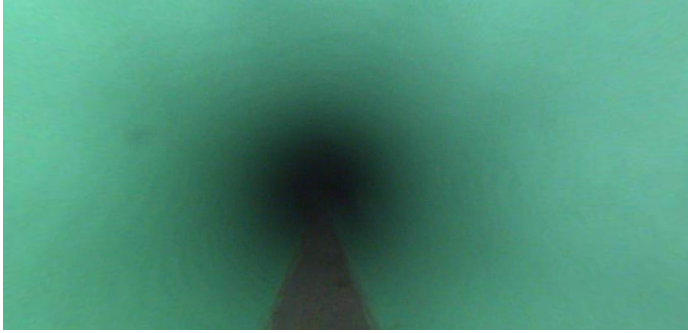
Code:	<b>MSA</b>
Description:	<b>Abandoned Survey</b>
Distance (ft):	<b>332.7</b>
Structural Grade:	<b>0</b>
O&M Grade:	<b>0</b>
Clock Start/From:	
Clock To:	
1st Value:	
2nd Value:	
Value Percent:	
Continuous Index:	
Within 8" of Joint:	<b>NO</b>
Remarks:	<b>unknown</b>
