Profile/Photo Observation Report

Street:	Capitol	Flow Control:	Not Controlled
City:	Hobart, IN	Year Renewed:	
Location:	Ditch	Tape/Media #:	
Purpose:	Maintenance Related	Dia/Height:	8"
Use:	Sanitary	Material:	PVC
Drain Area:	NA	Lining:	Cured in Place
Category:	NA		
Comment:	Reverse setup. user set max at 125'.

Location Details:		Direction of Survey:	Upstream
US MH:	M-907-009	DS MH:	M-907-008A
		Total Length Surveyed (ft):	126.6

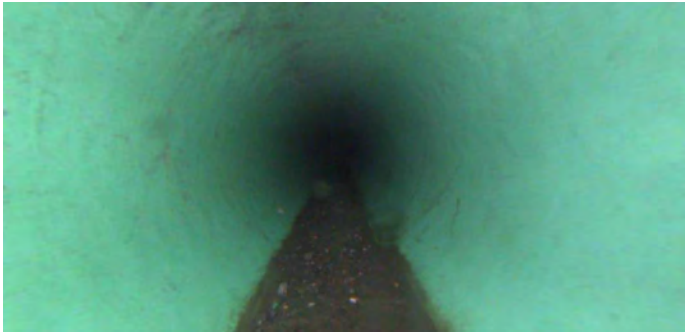
Code:	MWL
Description:	Water Level

Distance (ft):	.0
Structural Grade:	0
O&M Grade:	0
Clock Start/From:	
Clock To:	
1st Value:	
2nd Value:	
Value Percent:	5.000
Continuous Index:	
Within 8" of Joint:	NO
Remarks:

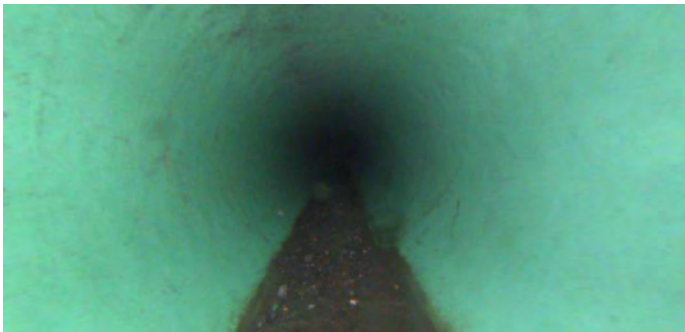
Code:	DSF
Description:	Deposits Settled Fine

Distance (ft):	.0
Structural Grade:	0
O&M Grade:	2
Clock Start/From:	6
Clock To:	
1st Value:	
2nd Value:	
Value Percent:	5.000
Continuous Index:	S01
Within 8" of Joint:	NO
Remarks:

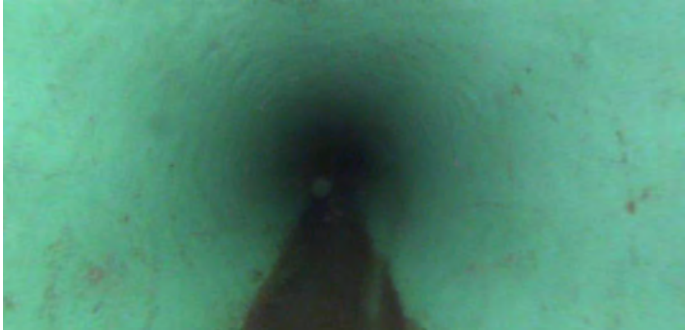
Code: **DSF**
Description: **Deposits Settled Fine**

Distance (ft): **4.9**
Structural Grade: **0**
O&M Grade: **2**
Clock Start/From: **6**
Clock To:
1st Value:
2nd Value:
Value Percent: **5.000**
Continuous Index: **F01**
Within 8" of Joint: **NO**
Remarks:

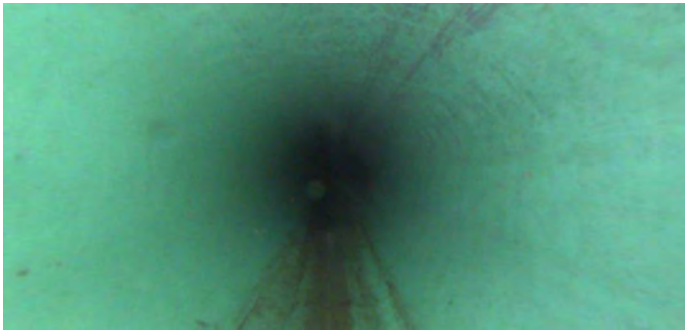
Code: **MSA**
Description: **Abandoned Survey**

Distance (ft): **126.6**
Structural Grade: **0**
O&M Grade: **0**
Clock Start/From:
Clock To:
1st Value:
2nd Value:
Value Percent:
Continuous Index:
Within 8" of Joint: **NO**
Remarks: **UNKNOWN**
