Profile/Photo Observation Report

Date:	04/11/2018	Weather:		Coding:	PACP 6.0
Pipe Length (ft):	398.0	Owner:	NA	Pre Clean:	Not Known
P.O.#:		Surveyor:	Jen Costello	PSR:	P-907-010-011
Customer:		Clean Date:	01/01/1900	Shape:	C

Street:	Capitol	Flow Control:	Not Controlled
City:	Hobart, IN	Year Renewed:	
Location:	Parking Lot	Tape/Media #:	
Purpose:	Maintenance Related	Dia/Height:	8"
Use:	Sanitary	Material:	PVC
Drain Area:	NA	Lining:	Cured in Place
Category:	NA		
Comment:

Location Details:		Direction of Survey:	Downstream
US MH:	M-907-011	DS MH:	M-907-010
		Total Length Surveyed (ft):	401.0

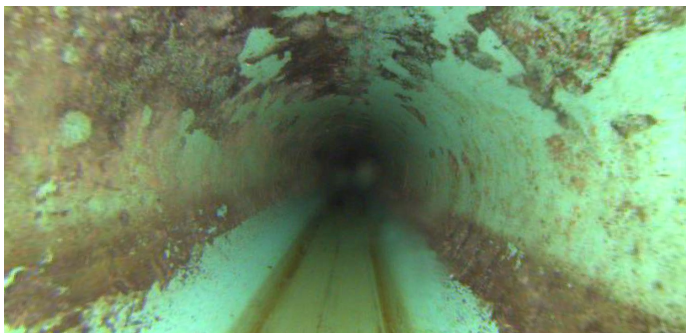
Code: **AMH**
Description: **Manhole**

Distance (ft): **.0**
Structural Grade: **0**
O&M Grade: **0**
Clock Start/From:
Clock To:
1st Value:
2nd Value:
Value Percent:
Continuous Index:
Within 8" of Joint: **NO**
Remarks: **M-907-011**

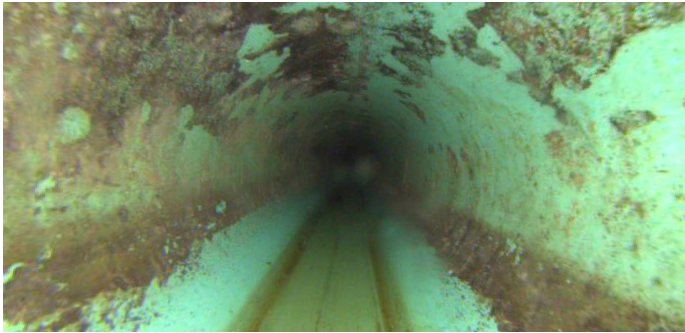
Code:	MWL
Description:	Water Level

Distance (ft):	.0
Structural Grade:	0
O&M Grade:	0
Clock Start/From:	
Clock To:	
1st Value:	
2nd Value:	
Value Percent:	5.000
Continuous Index:	
Within 8" of Joint:	NO
Remarks:

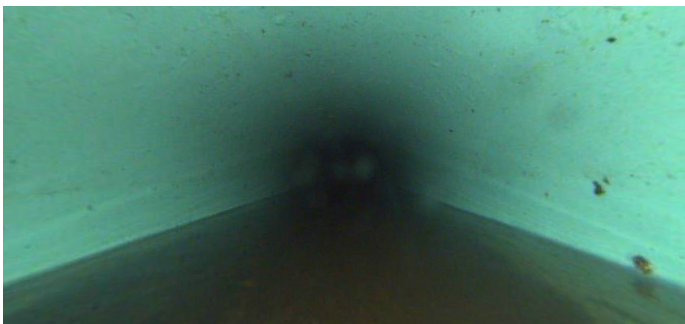
Code:	MWL
Description:	Water Level

Distance (ft):	56.2
Structural Grade:	0
O&M Grade:	0
Clock Start/From:	
Clock To:	
1st Value:	
2nd Value:	
Value Percent:	30.000
Continuous Index:	
Within 8" of Joint:	NO
Remarks:

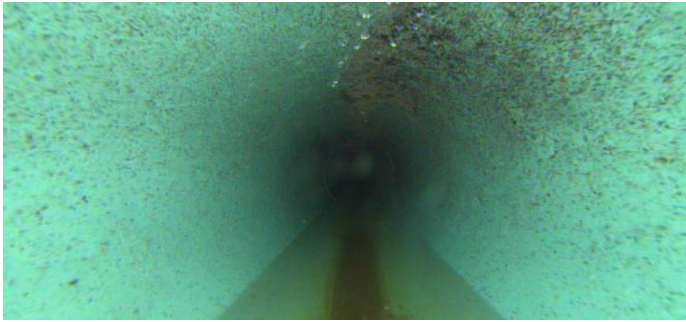
Code: **MWL**
Description: **Water Level**

Distance (ft): **80.6**
Structural Grade: **0**
O&M Grade: **0**
Clock Start/From:
Clock To:
1st Value:
2nd Value:
Value Percent: **5.000**
Continuous Index:
Within 8" of Joint: **NO**
Remarks:

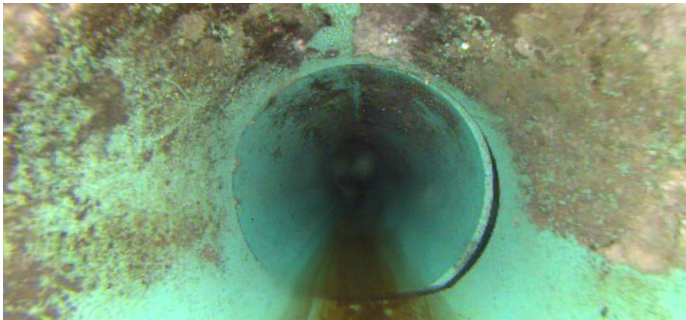
Code: **JOM**
Description: **Joint Offset Medium**

Distance (ft): **139.4**
Structural Grade: **1**
O&M Grade: **0**
Clock Start/From:
Clock To:
1st Value:
2nd Value:
Value Percent:
Continuous Index:
Within 8" of Joint: **NO**
Remarks:

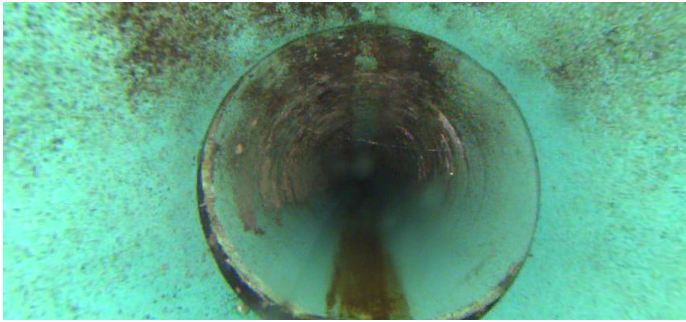
Code: **JOM**
Description: **Joint Offset Medium**

Distance (ft): **142.5**
Structural Grade: **1**
O&M Grade: **0**
Clock Start/From:
Clock To:
1st Value:
2nd Value:
Value Percent:
Continuous Index:
Within 8" of Joint: **NO**
Remarks:

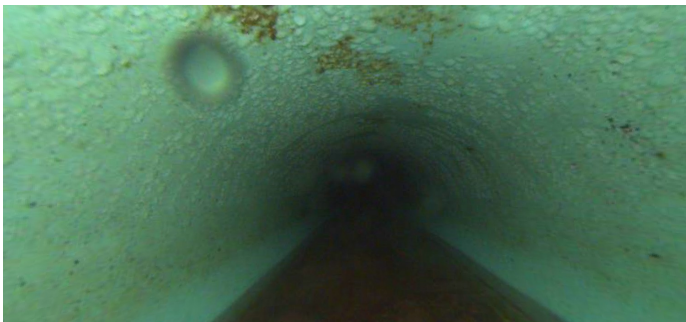
Code: **MWL**
Description: **Water Level**

Distance (ft): **199.8**
Structural Grade: **0**
O&M Grade: **0**
Clock Start/From:
Clock To:
1st Value:
2nd Value:
Value Percent: **10.000**
Continuous Index:
Within 8" of Joint: **NO**
Remarks:

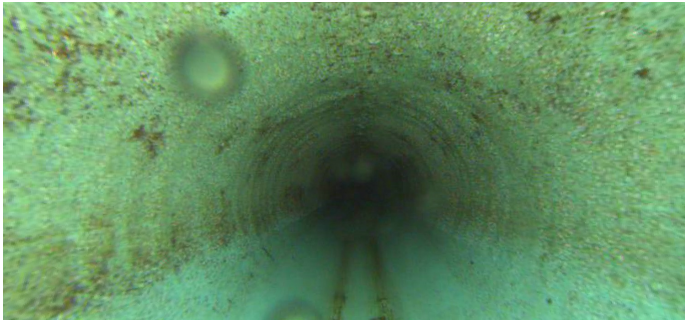
Code: **MWL**
Description: **Water Level**

Distance (ft): **204.7**
Structural Grade: **0**
O&M Grade: **0**
Clock Start/From:
Clock To:
1st Value:
2nd Value:
Value Percent: **5.000**
Continuous Index:
Within 8" of Joint: **NO**
Remarks:

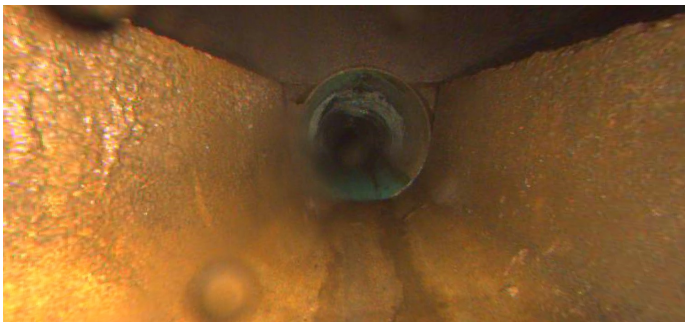
Code: **AMH**
Description: **Manhole**

Distance (ft): **401.0**
Structural Grade: **0**
O&M Grade: **0**
Clock Start/From:
Clock To:
1st Value:
2nd Value:
Value Percent:
Continuous Index:
Within 8" of Joint: **NO**
Remarks: **M-907-010**
