Profile/Photo Observation Report

Street:	OFF S UNION ST	Flow Control:	Not Controlled
City:	Hobart, IN	Year Renewed:	
Location:	Parking Lot	Tape/Media #:	
Purpose:	Maintenance Related	Dia/Height:	8"
Use:	Sanitary	Material:	PVC
Drain Area:	NA	Lining:	Cured in Place
Category:	NA		
Comment:	flow incorrect.

Location Details:		Direction of Survey:	Downstream
US MH:	M-907-012	DS MH:	M-907-011
		Total Length Surveyed (ft):	402.3

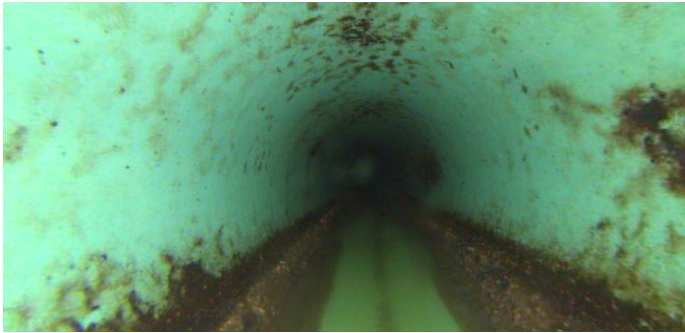
Code:	MWL
Description:	Water Level

Distance (ft):	.0
Structural Grade:	0
O&M Grade:	0
Clock Start/From:	
Clock To:	
1st Value:	
2nd Value:	
Value Percent:	5.000
Continuous Index:	
Within 8" of Joint:	NO
Remarks:

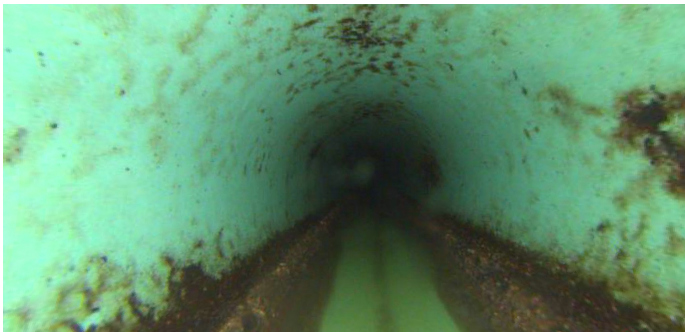
Code:	DAGS
Description:	Deposits Attached Grease

Distance (ft):	.0
Structural Grade:	0
O&M Grade:	2
Clock Start/From:	7
Clock To:	5
1st Value:	
2nd Value:	
Value Percent:	5.000
Continuous Index:	S01
Within 8" of Joint:	NO
Remarks:

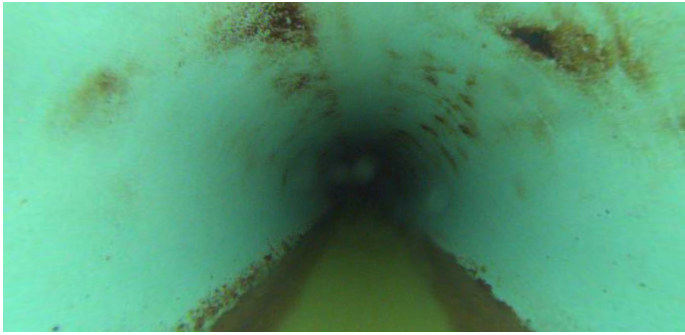
Code: **DAGS**
Description: **Deposits Attached Grease**

Distance (ft): **28.0**
Structural Grade: **0**
O&M Grade: **2**
Clock Start/From: **7**
Clock To: **5**
1st Value:
2nd Value:
Value Percent: **5.000**
Continuous Index: **F01**
Within 8" of Joint: **NO**
Remarks:

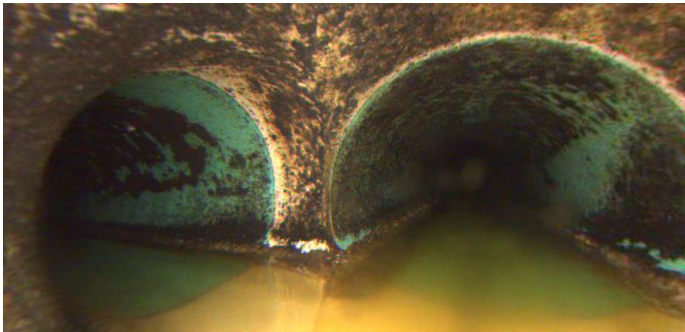
Code: **TFA**
Description: **Tap Factory Active**

Distance (ft): **111.2**
Structural Grade: **0**
O&M Grade: **0**
Clock Start/From: **9**
Clock To:
1st Value: **4.000**
2nd Value:
Value Percent:
Continuous Index:
Within 8" of Joint:
Remarks:

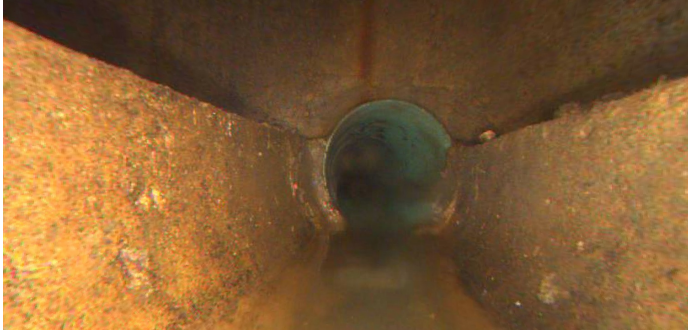
Code:	AMH
Description:	Manhole
Distance (ft):	402.3
Structural Grade:	0
O&M Grade:	0
Clock Start/From:	
Clock To:	
1st Value:	
2nd Value:	
Value Percent:	
Continuous Index:	
Within 8" of Joint:	NO
Remarks:	M-907-011
