## Profile/Photo Observation Report

Street:	<b>Capitol</b>	Flow Control:	<b>Not Controlled</b>
City:	<b>Hobart, IN</b>	Year Renewed:	
Location:	<b>Parking Lot</b>	Tape/Media #:	
Purpose:	<b>Maintenance Related</b>	Dia/Height:	<b>8"</b>
Use:	<b>Sanitary</b>	Material:	<b>PVC</b>
Drain Area:	<b>NA</b>	Lining:	<b>Cured in Place</b>
Category:	<b>NA</b>		
Comment:	<b>flow incorrect.</b>

Location Details:		Direction of Survey:	<b>Downstream</b>
US MH:	<b>M-907-012</b>	DS MH:	<b>M-907-011</b>
		Total Length Surveyed (ft):	<b>402.3</b>

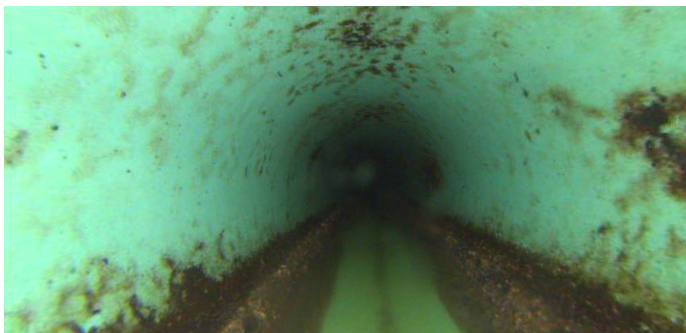
Code: **AMH**  
Description: **Manhole**

Distance (ft): **.0**  
Structural Grade: **0**  
O&M Grade: **0**  
Clock Start/From:  
Clock To:  
1st Value:  
2nd Value:  
Value Percent:  
Continuous Index:  
Within 8" of Joint: **NO**  
Remarks: **M-907-012**

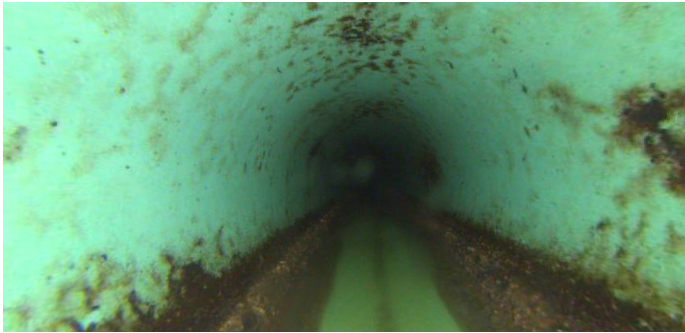
Code:	<b>MWL</b>
Description:	<b>Water Level</b>

Distance (ft):	<b>.0</b>
Structural Grade:	<b>0</b>
O&M Grade:	<b>0</b>
Clock Start/From:	
Clock To:	
1st Value:	
2nd Value:	
Value Percent:	<b>5.000</b>
Continuous Index:	
Within 8" of Joint:	<b>NO</b>
Remarks:

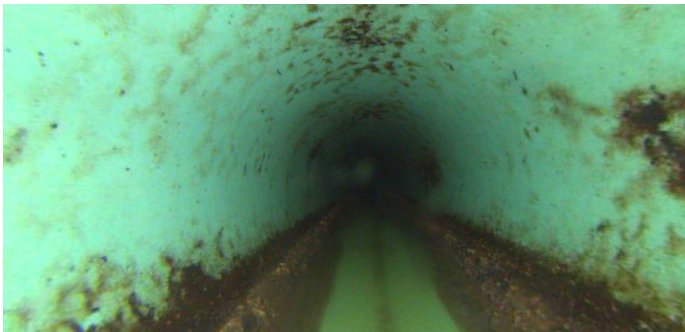
Code:	<b>DAGS</b>
Description:	<b>Deposits Attached Grease</b>

Distance (ft):	<b>.0</b>
Structural Grade:	<b>0</b>
O&M Grade:	<b>2</b>
Clock Start/From:	<b>7</b>
Clock To:	<b>5</b>
1st Value:	
2nd Value:	
Value Percent:	<b>5.000</b>
Continuous Index:	<b>S01</b>
Within 8" of Joint:	<b>NO</b>
Remarks:

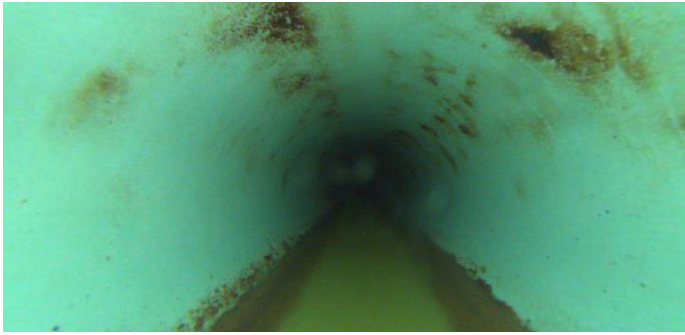
Code: **DAGS**  
Description: **Deposits Attached Grease**

Distance (ft): **28.0**  
Structural Grade: **0**  
O&M Grade: **2**  
Clock Start/From: **7**  
Clock To: **5**  
1st Value:  
2nd Value:  
Value Percent: **5.000**  
Continuous Index: **F01**  
Within 8" of Joint: **NO**  
Remarks:

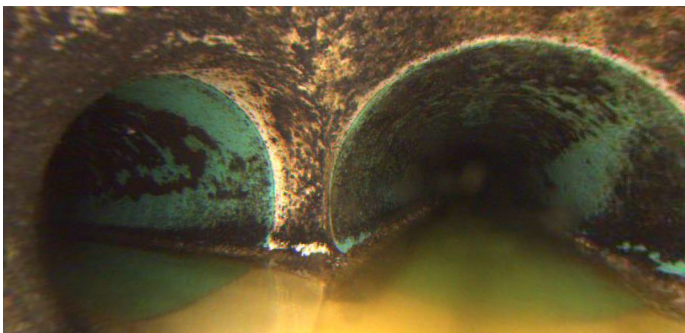
Code: **TFA**  
Description: **Tap Factory Active**

Distance (ft): **111.2**  
Structural Grade: **0**  
O&M Grade: **0**  
Clock Start/From: **9**  
Clock To:  
1st Value: **4.000**  
2nd Value:  
Value Percent:  
Continuous Index:  
Within 8" of Joint:  
Remarks:

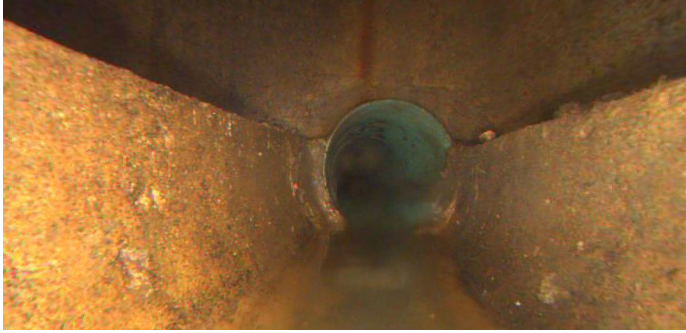
Code:	<b>AMH</b>
Description:	<b>Manhole</b>
Distance (ft):	<b>402.3</b>
Structural Grade:	<b>0</b>
O&M Grade:	<b>0</b>
Clock Start/From:	
Clock To:	
1st Value:	
2nd Value:	
Value Percent:	
Continuous Index:	
Within 8" of Joint:	<b>NO</b>
Remarks:	<b>M-907-011</b>
