Profile/Photo Observation Report

Date:	04/14/2018	Weather:		Coding:	PACP 6.0
Pipe Length (ft):	192.9	Owner:	NA	Pre Clean:	Not Known
P.O.#:		Surveyor:	Jen Costello	PSR:	P-907-013-014
Customer:		Clean Date:	01/01/1900	Shape:	C

Street:	OFF E 10TH ST	Flow Control:	Not Controlled
City:	Hobart, IN	Year Renewed:	
Location:	Parking Lot	Tape/Media #:	
Purpose:	Maintenance Related	Dia/Height:	8"
Use:	Sanitary	Material:	PVC
Drain Area:	NA	Lining:	Cured in Place
Category:	NA		
Comment:	sludge at 149'. flow incorrect.		
Location Details:		Direction of Survey:	Upstream
US MH:	M-907-014	DS MH:	M-907-013
		Total Length Surveyed (ft):	150.1

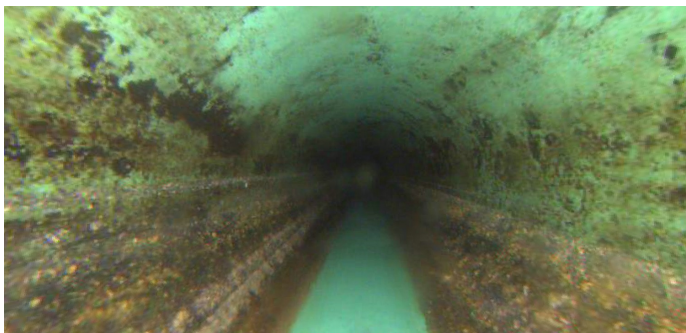
Code: **AMH**
Description: **Manhole**

Distance (ft): **.0**
Structural Grade: **0**
O&M Grade: **0**
Clock Start/From:
Clock To:
1st Value:
2nd Value:
Value Percent:
Continuous Index:
Within 8" of Joint: **NO**
Remarks: **M-907-013**

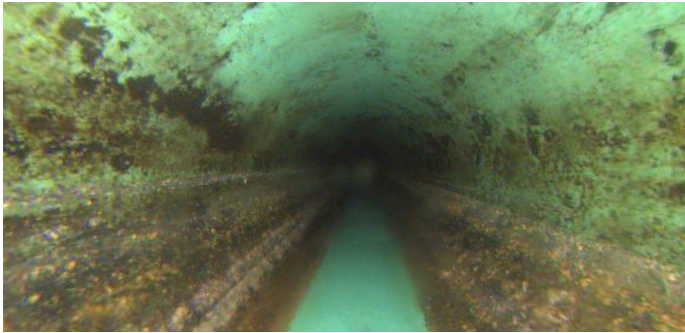
Code:	MWL
Description:	Water Level

Distance (ft):	.0
Structural Grade:	0
O&M Grade:	0
Clock Start/From:	
Clock To:	
1st Value:	
2nd Value:	
Value Percent:	5.000
Continuous Index:	
Within 8" of Joint:	NO
Remarks:

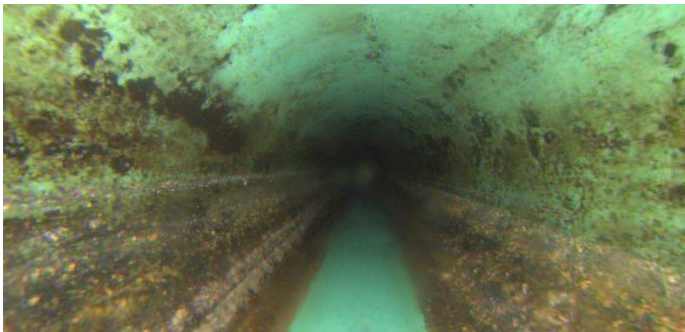
Code:	DAGS
Description:	Deposits Attached Grease

Distance (ft):	.0
Structural Grade:	0
O&M Grade:	2
Clock Start/From:	7
Clock To:	5
1st Value:	
2nd Value:	
Value Percent:	5.000
Continuous Index:	S01
Within 8" of Joint:	NO
Remarks:

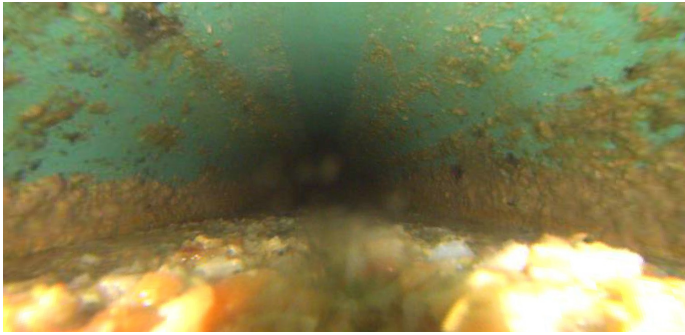
Code: **MWL**
Description: **Water Level**

Distance (ft): **81.1**
Structural Grade: **0**
O&M Grade: **0**
Clock Start/From:
Clock To:
1st Value:
2nd Value:
Value Percent: **40.000**
Continuous Index:
Within 8" of Joint: **NO**
Remarks:

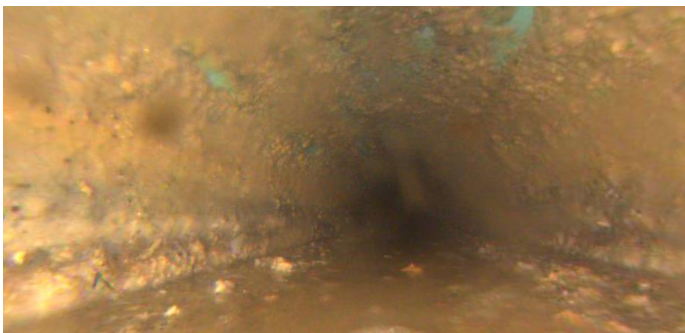
Code: **MGO**
Description: **General Observation**

Distance (ft): **99.9**
Structural Grade: **0**
O&M Grade: **0**
Clock Start/From:
Clock To:
1st Value:
2nd Value:
Value Percent:
Continuous Index:
Within 8" of Joint: **NO**
Remarks: **rear camera**

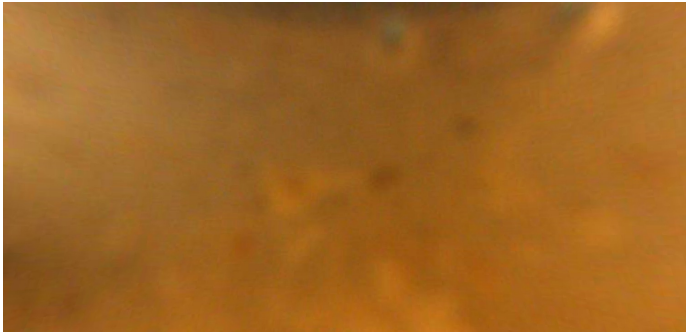
Code: **MCU**
Description: **Camera Underwater**

Distance (ft): **129.7**
Structural Grade: **0**
O&M Grade: **4**
Clock Start/From:
Clock To:
1st Value:
2nd Value:
Value Percent:
Continuous Index: **S02**
Within 8" of Joint: **NO**
Remarks:

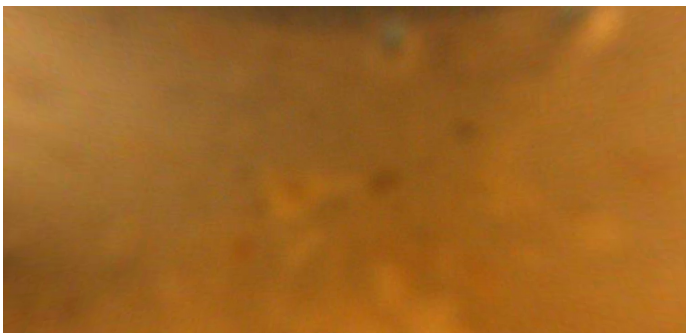
Code: **DAGS**
Description: **Deposits Attached Grease**

Distance (ft): **129.7**
Structural Grade: **0**
O&M Grade: **2**
Clock Start/From: **7**
Clock To: **5**
1st Value:
2nd Value:
Value Percent: **5.000**
Continuous Index: **F01**
Within 8" of Joint: **NO**
Remarks:
