Profile/Photo Observation Report

| Street: | Capitol | Flow Control: | Not Controlled |
| City: | Hobart, IN | Year Renewed: | |
| US MH: | M-907-014 | DS MH: | M-907-013 |

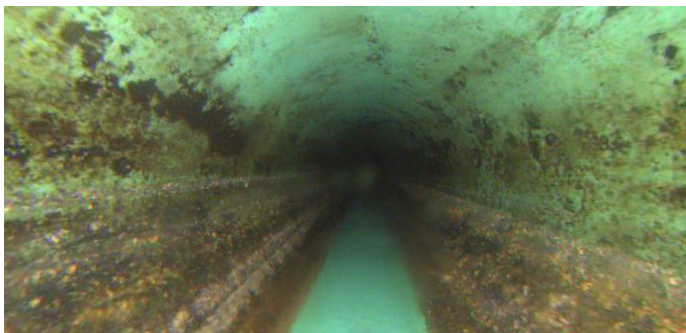
Code: **AMH**
Description: **Manhole**

Distance (ft): **.0**
Structural Grade: **0**
O&M Grade: **0**
Clock Start/From:
Clock To:
1st Value:
2nd Value:
Value Percent:
Continuous Index:
Within 8" of Joint: **NO**
Remarks: **M-907-013**

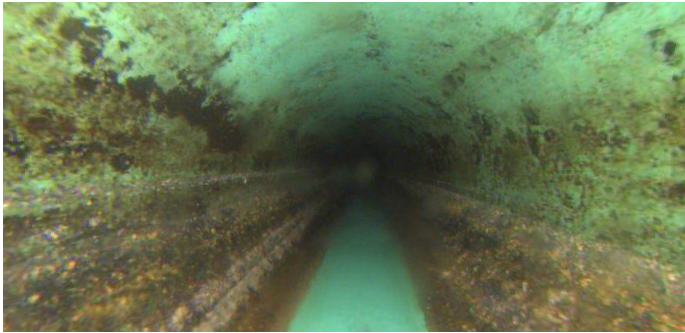
| Code: | MWL |

| Description: | Water Level |

| Value Percent: | 5.000 |

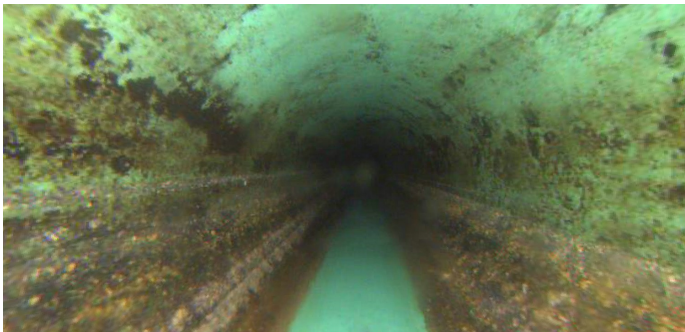
| Code: | DAGS |

| Description: | Deposits Attached Grease |

| O&M Grade: | 2 |
| Clock Start/From: | 7 |
| Clock To: | 5 |
| Value Percent: | 5.000 |

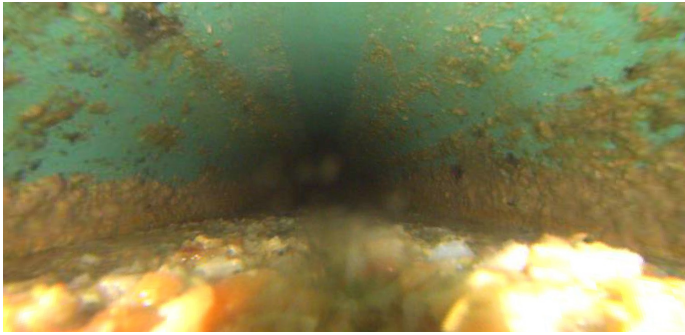
Code: **MWL**
Description: **Water Level**

Distance (ft): **81.1**
Structural Grade: **0**
O&M Grade: **0**
Clock Start/From:
Clock To:
1st Value:
2nd Value:
Value Percent: **40.000**
Continuous Index:
Within 8" of Joint: **NO**
Remarks:

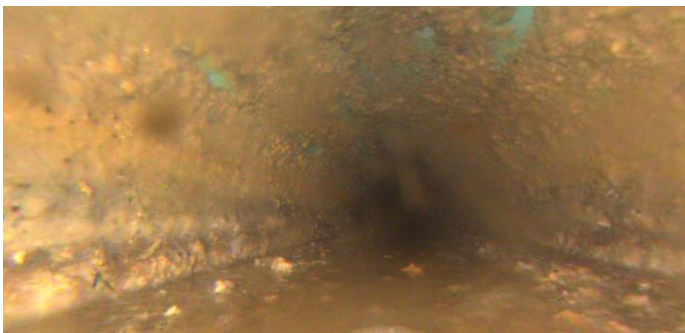
Code: **MGO**
Description: **General Observation**

Distance (ft): **99.9**
Structural Grade: **0**
O&M Grade: **0**
Clock Start/From:
Clock To:
1st Value:
2nd Value:
Value Percent:
Continuous Index:
Within 8" of Joint: **NO**
Remarks: **rear camera**

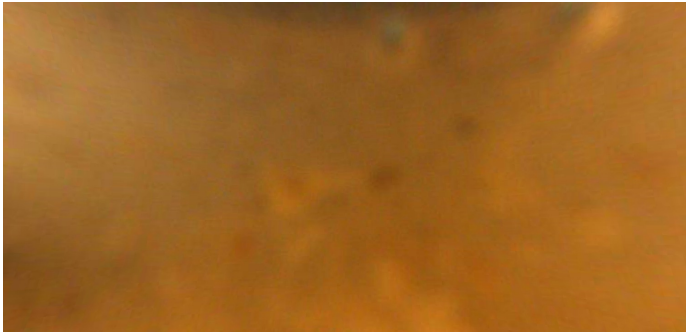
Code: **MCU**
Description: **Camera Underwater**

Distance (ft): **129.7**
Structural Grade: **0**
O&M Grade: **4**
Clock Start/From:
Clock To:
1st Value:
2nd Value:
Value Percent:
Continuous Index: **S02**
Within 8" of Joint: **NO**
Remarks:

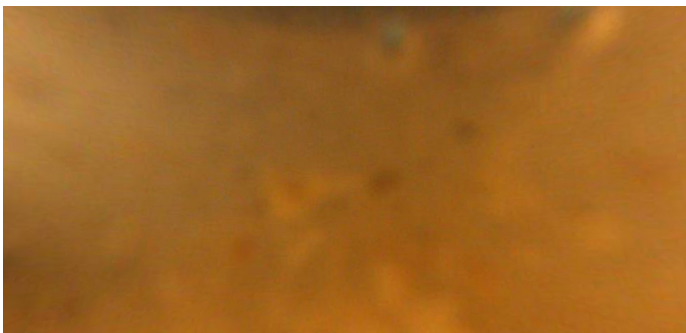
Code: **DAGS**
Description: **Deposits Attached Grease**

Distance (ft): **129.7**
Structural Grade: **0**
O&M Grade: **2**
Clock Start/From: **7**
Clock To: **5**
1st Value:
2nd Value:
Value Percent: **5.000**
Continuous Index: **F01**
Within 8" of Joint: **NO**
Remarks:
