Profile/Photo Observation Report

Street:	OFF S UNION ST	Flow Control:	Not Controlled
City:	Hobart, IN	Year Renewed:	
Location:	Parking Lot	Tape/Media #:	
Purpose:	Maintenance Related	Dia/Height:	8"
Use:	Sanitary	Material:	PVC
Drain Area:	NA	Lining:	Cured in Place
Category:	NA		
Comment:	flow incorrect.

Location Details:		Direction of Survey:	Upstream
US MH:	M-907-019	DS MH:	M-907-018
		Total Length Surveyed (ft):	377.6

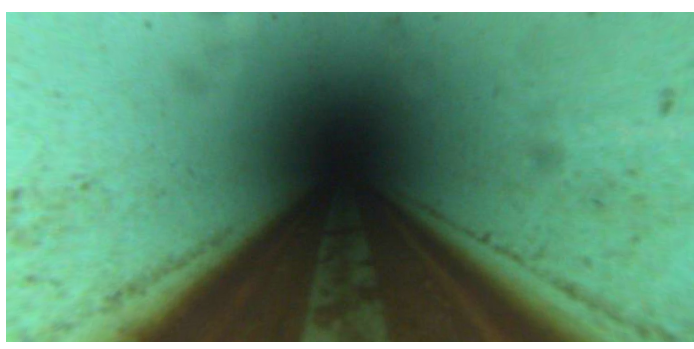
Code: **AMH**
Description: **Manhole**

Distance (ft): **.0**
Structural Grade: **0**
O&M Grade: **0**
Clock Start/From:
Clock To:
1st Value:
2nd Value:
Value Percent:
Continuous Index:
Within 8" of Joint: **NO**
Remarks: **M-907-018**

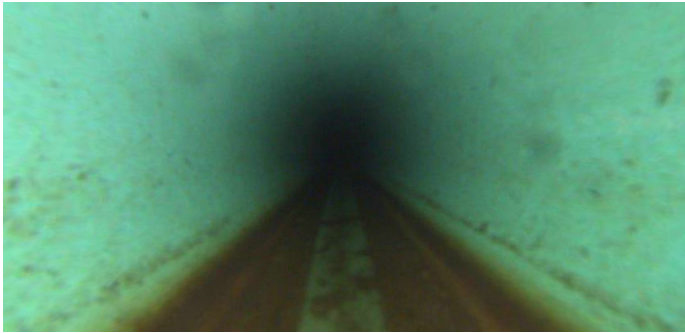
Code:	MWL
Description:	Water Level

Distance (ft):	.0
Structural Grade:	0
O&M Grade:	0
Clock Start/From:	
Clock To:	
1st Value:	
2nd Value:	
Value Percent:	5.000
Continuous Index:	
Within 8" of Joint:	NO
Remarks:

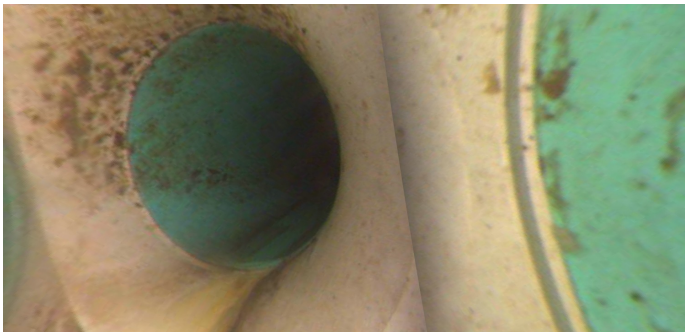
Code:	TF
Description:	Tap Factory

Distance (ft):	198.2
Structural Grade:	0
O&M Grade:	0
Clock Start/From:	10
Clock To:	
1st Value:	4.000
2nd Value:	
Value Percent:	
Continuous Index:	
Within 8" of Joint:	
Remarks:

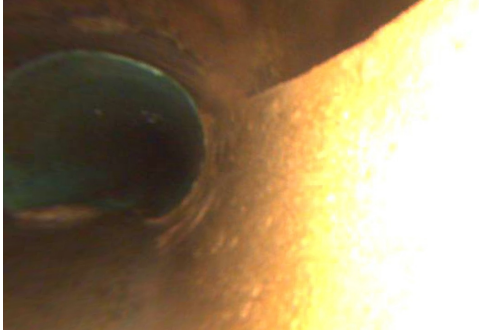
Code:	AMH
Description:	Manhole
Distance (ft):	377.6
Structural Grade:	0
O&M Grade:	0
Clock Start/From:	
Clock To:	
1st Value:	
2nd Value:	
Value Percent:	
Continuous Index:	
Within 8" of Joint:	NO
Remarks:	M-907-019
