Profile/Photo Observation Report

Date:	04/12/2018	Weather:		Coding:	PACP 6.0
Pipe Length (ft):	377.0	Owner:	NA	Pre Clean:	Not Known
P.O.#:		Surveyor:	Jen Costello	PSR:	P-907-018-019
Customer:		Clean Date:	01/01/1900	Shape:	C

Street:	Capitol	Flow Control:	Not Controlled
City:	Hobart, IN	Year Renewed:	
Location:	Parking Lot	Tape/Media #:	
Purpose:	Maintenance Related	Dia/Height:	8"
Use:	Sanitary	Material:	PVC
Drain Area:	NA	Lining:	Cured in Place
Category:	NA		
Comment:	flow incorrect.

Location Details:		Direction of Survey:	Upstream
US MH:	M-907-019	DS MH:	M-907-018
		Total Length Surveyed (ft):	377.6

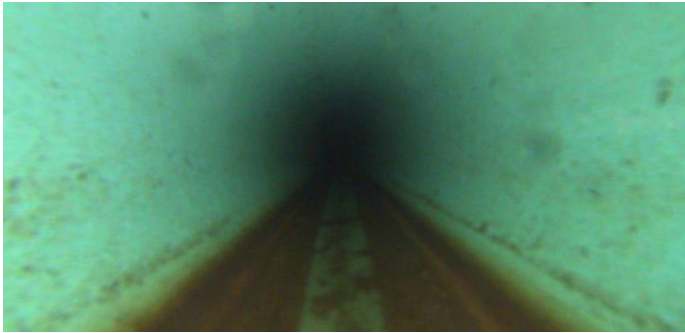
Code:	MWL
Description:	Water Level

Distance (ft):	.0
Structural Grade:	0
O&M Grade:	0
Clock Start/From:	
Clock To:	
1st Value:	
2nd Value:	
Value Percent:	5.000
Continuous Index:	
Within 8" of Joint:	NO
Remarks:

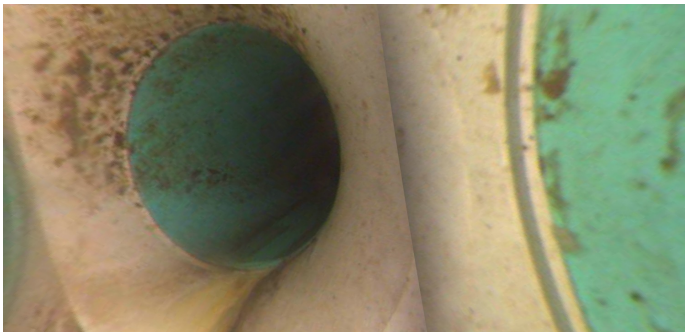
Code:	TF
Description:	Tap Factory

Distance (ft):	198.2
Structural Grade:	0
O&M Grade:	0
Clock Start/From:	10
Clock To:	
1st Value:	4.000
2nd Value:	
Value Percent:	
Continuous Index:	
Within 8" of Joint:	
Remarks:

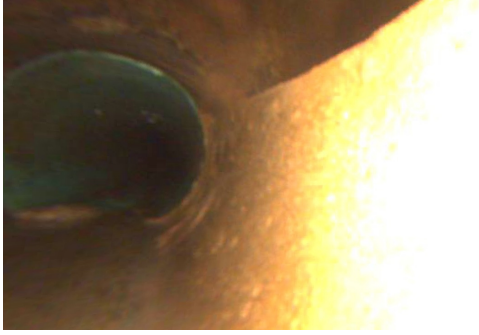
Code:	AMH
Description:	Manhole
Distance (ft):	377.6
Structural Grade:	0
O&M Grade:	0
Clock Start/From:	
Clock To:	
1st Value:	
2nd Value:	
Value Percent:	
Continuous Index:	
Within 8" of Joint:	NO
Remarks:	M-907-019
