Profile/Photo Observation Report

Street:	E 10TH ST	Flow Control:	Not Controlled
City:	Hobart, IN	Year Renewed:	
Location:	Parking Lot	Tape/Media #:	
Purpose:	Maintenance Related	Dia/Height:	8"
Use:	Sanitary	Material:	PVC
Drain Area:	NA	Lining:	Cured in Place
Category:	NA		
Comment:	pipe change just before Drop connection-flow incorrect.		
Location Details:		Direction of Survey:	Upstream
US MH:	M-907-020	DS MH:	M-907-019
		Total Length Surveyed (ft):	164.7

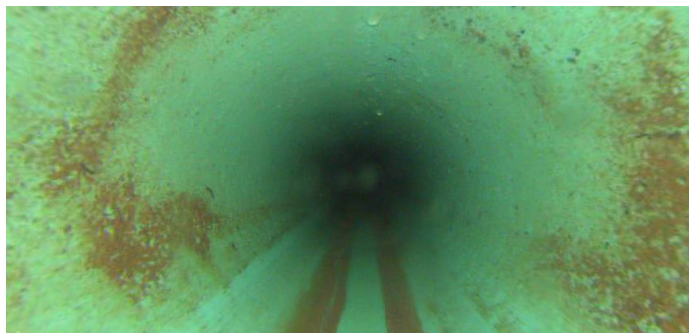
Code: **AMH**
Description: **Manhole**

Distance (ft): **.0**
Structural Grade: **0**
O&M Grade: **0**
Clock Start/From:
Clock To:
1st Value:
2nd Value:
Value Percent:
Continuous Index:
Within 8" of Joint: **NO**
Remarks: **M-907-019**

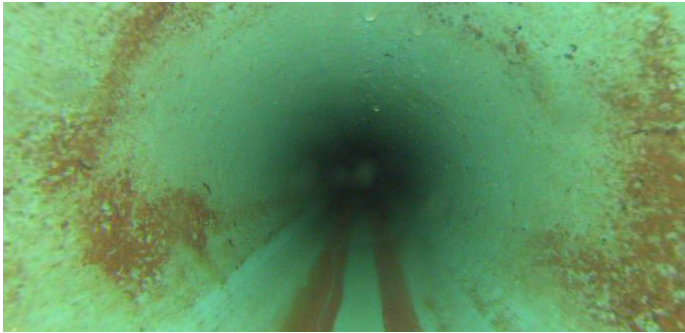
Code:	MWL
Description:	Water Level

Distance (ft):	.0
Structural Grade:	0
O&M Grade:	0
Clock Start/From:	
Clock To:	
1st Value:	
2nd Value:	
Value Percent:	5.000
Continuous Index:	
Within 8" of Joint:	NO
Remarks:

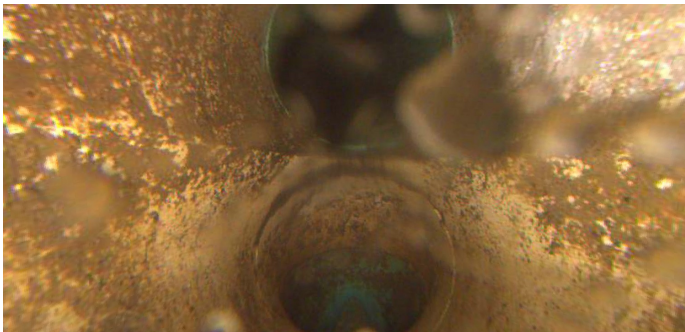
Code:	TF
Description:	Tap Factory

Distance (ft):	162.7
Structural Grade:	0
O&M Grade:	0
Clock Start/From:	6
Clock To:	
1st Value:	6.000
2nd Value:	
Value Percent:	
Continuous Index:	
Within 8" of Joint:	
Remarks:	drop connection

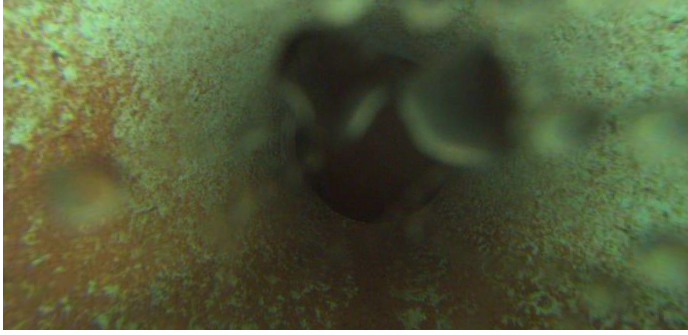
Code:	AMH
Description:	Manhole
Distance (ft):	164.7
Structural Grade:	0
O&M Grade:	0
Clock Start/From:	
Clock To:	
1st Value:	
2nd Value:	
Value Percent:	
Continuous Index:	
Within 8" of Joint:	NO
Remarks:	M-907-020 in drop
