Profile/Photo Observation Report

Street:	Capitol	Flow Control:	Not Controlled
City:	Hobart, IN	Year Renewed:	
Location:	Parking Lot	Tape/Media #:	
Purpose:	Maintenance Related	Dia/Height:	8"
Use:	Sanitary	Material:	PVC
Drain Area:	NA	Lining:	Cured in Place
Category:	NA		
Comment:	pipe change just before Drop connection-flow incorrect.		
Location Details:		Direction of Survey:	Upstream
US MH:	M-907-020	DS MH:	M-907-019
		Total Length Surveyed (ft):	164.7

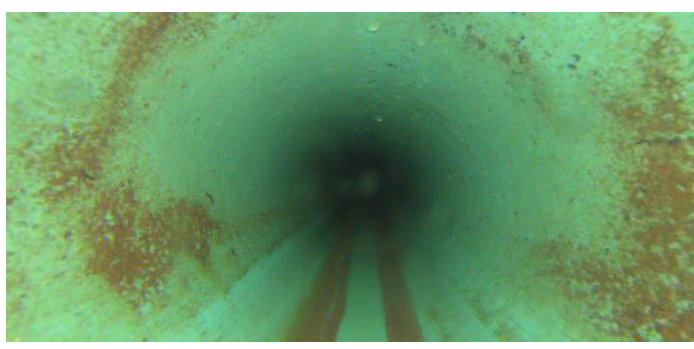
Code: **AMH**
Description: **Manhole**

Distance (ft): **.0**
Structural Grade: **0**
O&M Grade: **0**
Clock Start/From:
Clock To:
1st Value:
2nd Value:
Value Percent:
Continuous Index:
Within 8" of Joint: **NO**
Remarks: **M-907-019**

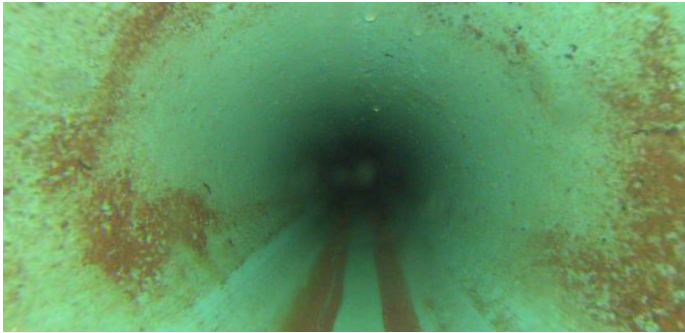
Code:	MWL
Description:	Water Level

Distance (ft):	.0
Structural Grade:	0
O&M Grade:	0
Clock Start/From:	
Clock To:	
1st Value:	
2nd Value:	
Value Percent:	5.000
Continuous Index:	
Within 8" of Joint:	NO
Remarks:

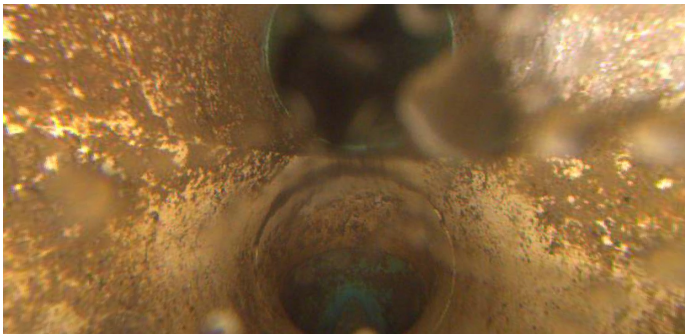
Code:	TF
Description:	Tap Factory

Distance (ft):	162.7
Structural Grade:	0
O&M Grade:	0
Clock Start/From:	6
Clock To:	
1st Value:	6.000
2nd Value:	
Value Percent:	
Continuous Index:	
Within 8" of Joint:	
Remarks:	drop connection

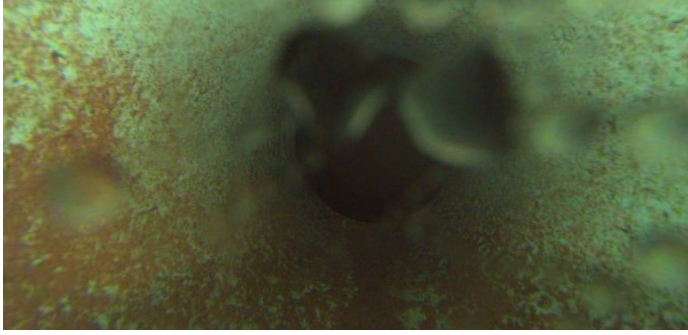
Code:	AMH
Description:	Manhole
Distance (ft):	164.7
Structural Grade:	0
O&M Grade:	0
Clock Start/From:	
Clock To:	
1st Value:	
2nd Value:	
Value Percent:	
Continuous Index:	
Within 8" of Joint:	NO
Remarks:	M-907-020 in drop
