Profile/Photo Observation Report

Street:	E 10TH ST	Flow Control:	Not Controlled
City:	Hobart, IN	Year Renewed:	
Location:	Yard	Tape/Media #:	
Purpose:	Maintenance Related	Dia/Height:	10"
Use:	Sanitary	Material:	PVC
Drain Area:	NA	Lining:	Cured in Place
Category:	NA		
Comment:	mh confirmed by wheel at 60'.		
Location Details:		Direction of Survey:	Downstream
US MH:	M-907-022	DS MH:	M-907-021
		Total Length Surveyed (ft):	61.3

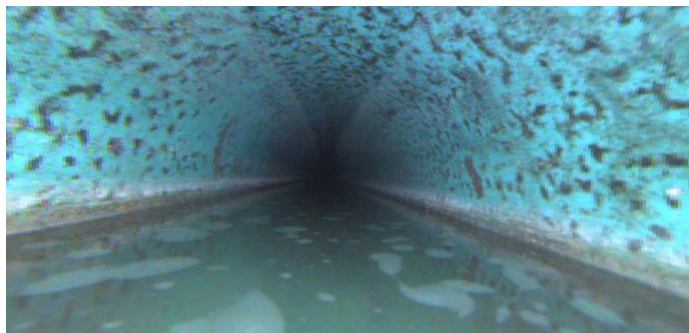
Code: **AMH**
Description: **Manhole**

Distance (ft): **.0**
Structural Grade: **0**
O&M Grade: **0**
Clock Start/From:
Clock To:
1st Value:
2nd Value:
Value Percent:
Continuous Index:
Within 8" of Joint: **NO**
Remarks: **M-907-022**

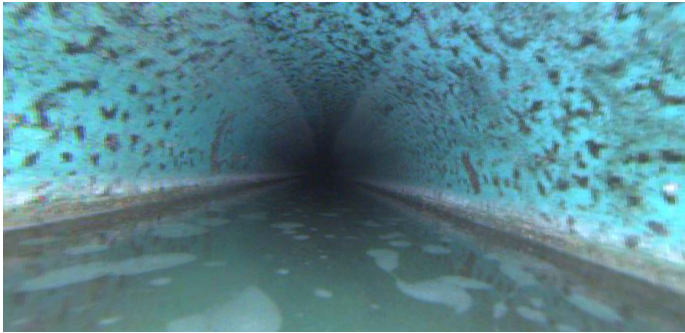
Code:	MWL
Description:	Water Level

Distance (ft):	.0
Structural Grade:	0
O&M Grade:	0
Clock Start/From:	
Clock To:	
1st Value:	
2nd Value:	
Value Percent:	5.000
Continuous Index:	
Within 8" of Joint:	NO
Remarks:

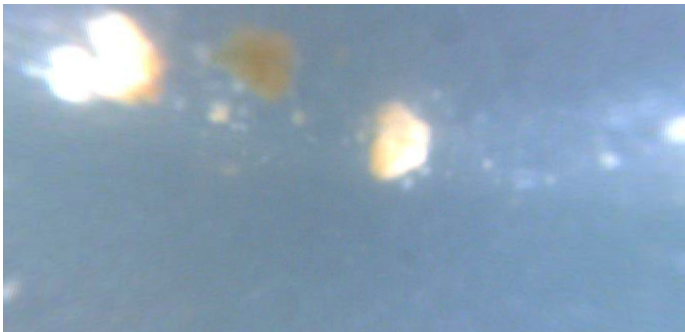
Code:	MCU
Description:	Camera Underwater

Distance (ft):	43.9
Structural Grade:	0
O&M Grade:	4
Clock Start/From:	
Clock To:	
1st Value:	
2nd Value:	
Value Percent:	
Continuous Index:	S01
Within 8" of Joint:	NO
Remarks:

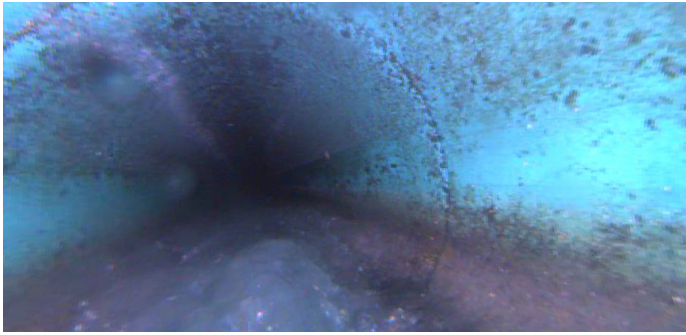
Code: **MGO**
Description: **General Observation**

Distance (ft): **53.4**
Structural Grade: **0**
O&M Grade: **0**
Clock Start/From:
Clock To:
1st Value:
2nd Value:
Value Percent:
Continuous Index:
Within 8" of Joint: **NO**
Remarks: **rear camera/mcu**

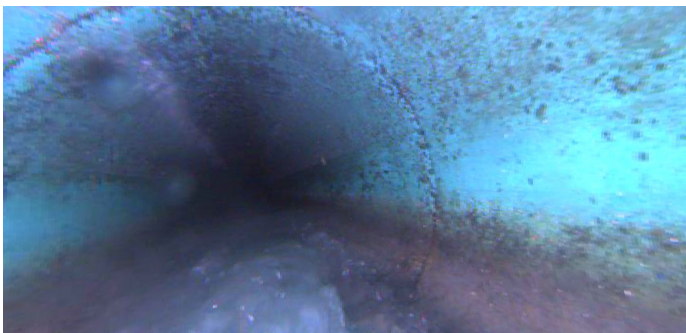
Code: **MCU**
Description: **Camera Underwater**

Distance (ft): **53.4**
Structural Grade: **0**
O&M Grade: **4**
Clock Start/From:
Clock To:
1st Value:
2nd Value:
Value Percent:
Continuous Index: **F01**
Within 8" of Joint: **NO**
Remarks:
