Profile/Photo Observation Report

Street:	East 10th Street	Flow Control:	Not Controlled
City:	Hobart, IN	Year Renewed:	
Location:	Sidewalk	Tape/Media #:	DEP280
Purpose:	Routine Assessment	Dia/Height:	8"
Use:	Sanitary	Material:	PVC
Drain Area:		Lining:	
Category:	NA		
Comment:	5-21-2018

Location Details:		Direction of Survey:	Downstream
US MH:	M-907-022	DS MH:	M-907-022
		Total Length Surveyed (ft):	54.0

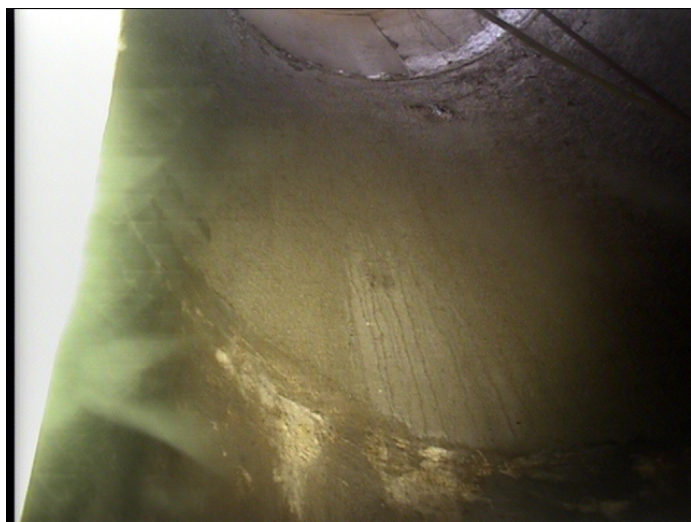
Code: **AMH**
Description: **Manhole**

Distance (ft): **.0**
Structural Grade: **0**
O&M Grade: **0**
Clock Start/From:
Clock To:
1st Value:
2nd Value:
Value Percent:
Continuous Index:
Within 8" of Joint: **NO**
Remarks: **M-907-022**

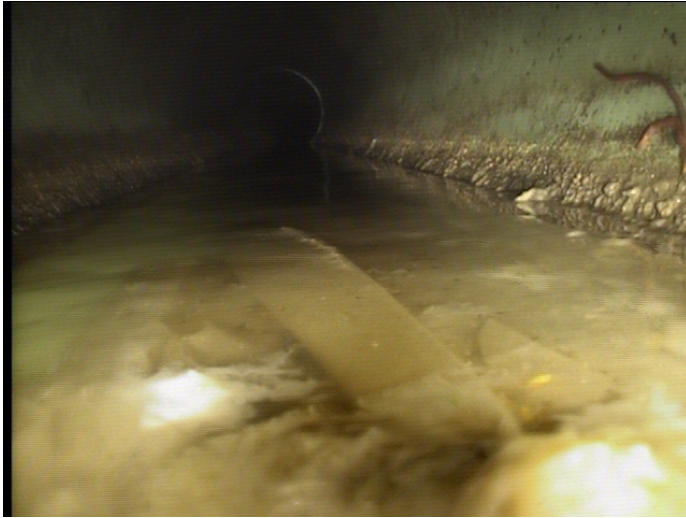
Code:	MWL
Description:	Water Level
Distance (ft):	.0
Structural Grade:	0
O&M Grade:	0
Clock Start/From:	
Clock To:	
1st Value:	
2nd Value:	
Value Percent:	5.000
Continuous Index:	
Within 8" of Joint:	NO
Remarks:

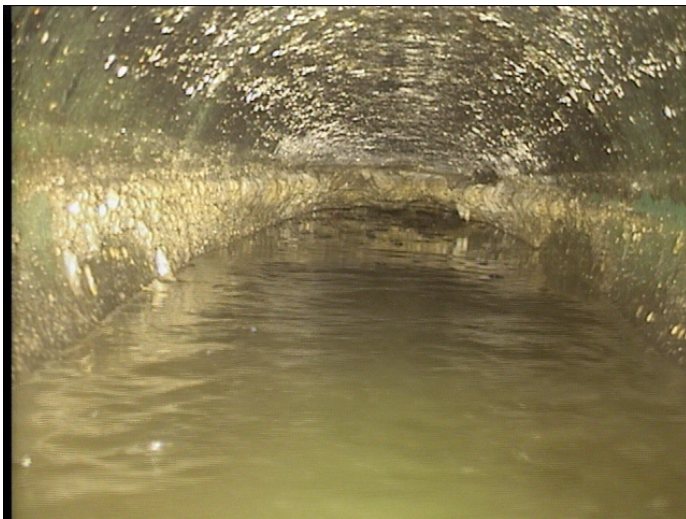
Code:	MWL
Description:	Water Level
Distance (ft):	54.0
Structural Grade:	0
O&M Grade:	0
Clock Start/From:	
Clock To:	
1st Value:	
2nd Value:	
Value Percent:	80.000
Continuous Index:	
Within 8" of Joint:	NO
Remarks:

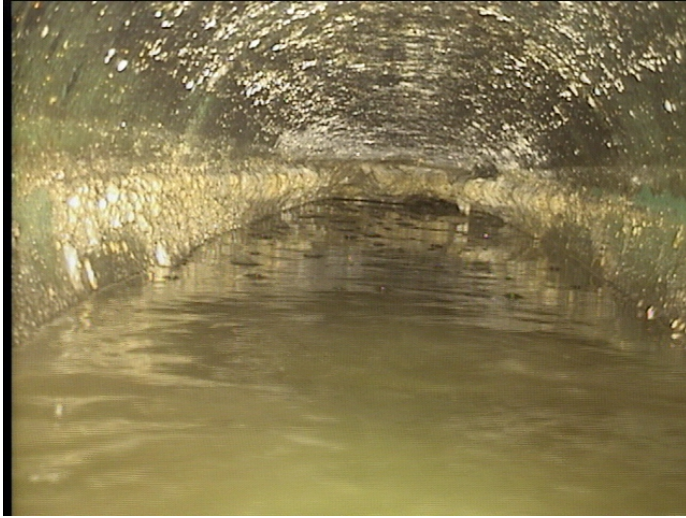
Code:	MSA
Description:	Abandoned Survey
Distance (ft):	54.0
Structural Grade:	0
O&M Grade:	0
Clock Start/From:	
Clock To:	
1st Value:	
2nd Value:	
Value Percent:	
Continuous Index:	
Within 8" of Joint:	NO
Remarks:	Pipe becomes surcharged just before entering lift station.
