## Profile/Photo Observation Report

Street:	<b>NORRIS DR</b>	Flow Control:	<b>Not Controlled</b>
City:	<b>Hobart, IN</b>	Year Renewed:	
Location:	<b>Sidewalk</b>	Tape/Media #:	
Purpose:	<b>Maintenance Related</b>	Dia/Height:	<b>8"</b>
Use:	<b>Sanitary</b>	Material:	<b>PVC</b>
Drain Area:	<b>NA</b>	Lining:	
Category:	<b>NA</b>		
Comment:	<b>Flow direction wrong. Debris at 2'.</b>

Location Details:		Direction of Survey:	<b>Downstream</b>
US MH:	<b>M-910-002</b>	DS MH:	<b>M-910-003</b>
		Total Length Surveyed (ft):	<b>4.3</b>

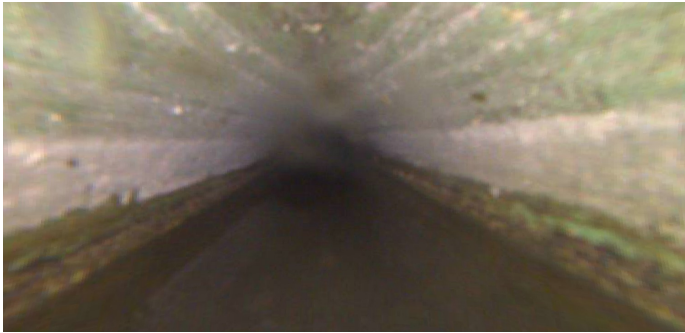
Code:	<b>MWL</b>
Description:	<b>Water Level</b>

Distance (ft):	<b>.0</b>
Structural Grade:	<b>0</b>
O&M Grade:	<b>0</b>
Clock Start/From:	
Clock To:	
1st Value:	
2nd Value:	
Value Percent:	<b>50.000</b>
Continuous Index:	
Within 8" of Joint:	<b>NO</b>
Remarks:

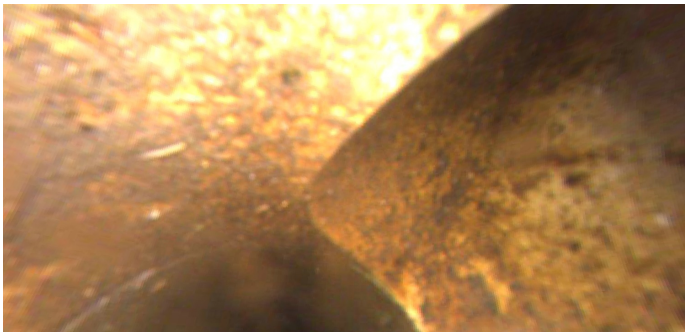
Code:	<b>TF</b>
Description:	<b>Tap Factory</b>

Distance (ft):	<b>4.3</b>
Structural Grade:	<b>0</b>
O&M Grade:	<b>0</b>
Clock Start/From:	<b>2</b>
Clock To:	
1st Value:	<b>4.000</b>
2nd Value:	
Value Percent:	
Continuous Index:	
Within 8" of Joint:	<b>YES</b>
Remarks:

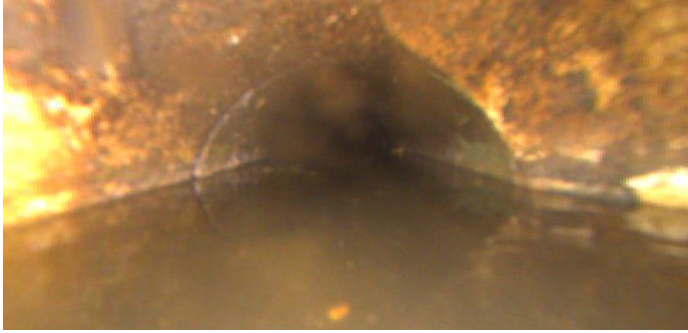
Code:	<b>MSA</b>
Description:	<b>Abandoned Survey</b>
Distance (ft):	<b>4.3</b>
Structural Grade:	<b>0</b>
O&M Grade:	<b>0</b>
Clock Start/From:	
Clock To:	
1st Value:	
2nd Value:	
Value Percent:	
Continuous Index:	
Within 8" of Joint:	<b>NO</b>
Remarks:	<b>camera stopped/no blockage</b>
