## Profile/Photo Observation Report

Street:	<b>Norris</b>	Flow Control:	<b>Not Controlled</b>
City:	<b>Hobart, IN</b>	Year Renewed:	
Location:	<b>Sidewalk</b>	Tape/Media #:	
Purpose:	<b>Maintenance Related</b>	Dia/Height:	<b>8"</b>
Use:	<b>Sanitary</b>	Material:	<b>PVC</b>
Drain Area:	<b>NA</b>	Lining:	
Category:	<b>NA</b>		
Comment:	<b>Flow direction wrong. Debris at 2'.</b>

Location Details:		Direction of Survey:	<b>Downstream</b>
US MH:	<b>M-910-002</b>	DS MH:	<b>M-910-003</b>
		Total Length Surveyed (ft):	<b>4.3</b>

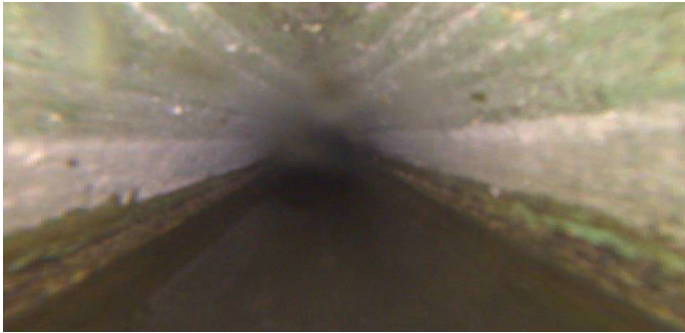
Code:	<b>MWL</b>
Description:	<b>Water Level</b>

Distance (ft):	<b>.0</b>
Structural Grade:	<b>0</b>
O&M Grade:	<b>0</b>
Clock Start/From:	
Clock To:	
1st Value:	
2nd Value:	
Value Percent:	<b>50.000</b>
Continuous Index:	
Within 8" of Joint:	<b>NO</b>
Remarks:

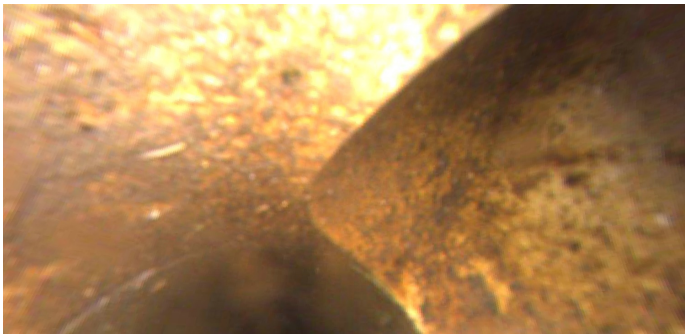
Code:	<b>TF</b>
Description:	<b>Tap Factory</b>

Distance (ft):	<b>4.3</b>
Structural Grade:	<b>0</b>
O&M Grade:	<b>0</b>
Clock Start/From:	<b>2</b>
Clock To:	
1st Value:	<b>4.000</b>
2nd Value:	
Value Percent:	
Continuous Index:	
Within 8" of Joint:	<b>YES</b>
Remarks:

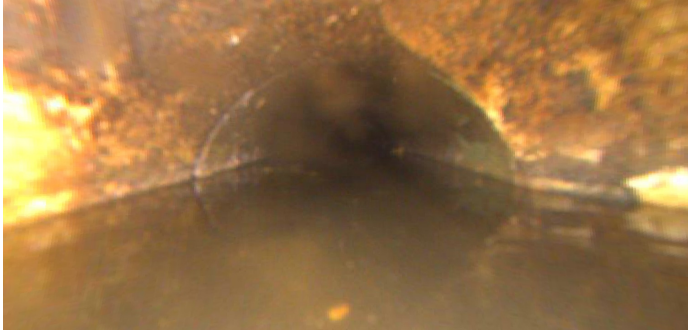
Code:	<b>MSA</b>
Description:	<b>Abandoned Survey</b>
Distance (ft):	<b>4.3</b>
Structural Grade:	<b>0</b>
O&M Grade:	<b>0</b>
Clock Start/From:	
Clock To:	
1st Value:	
2nd Value:	
Value Percent:	
Continuous Index:	
Within 8" of Joint:	<b>NO</b>
Remarks:	<b>camera stopped/no blockage</b>
