## Profile/Photo Observation Report

Street:	<b>NORRIS DR</b>	Flow Control:	<b>Not Controlled</b>
City:	<b>Hobart, IN</b>	Year Renewed:	
Location:	<b>Sidewalk</b>	Tape/Media #:	
Purpose:	<b>Maintenance Related</b>	Dia/Height:	<b>8"</b>
Use:	<b>Sanitary</b>	Material:	<b>PVC</b>
Drain Area:	<b>NA</b>	Lining:	
Category:	<b>NA</b>		
Comment:	<b>Flow direction wrong. Reverse setup. Debris at 79'.</b>		
Location Details:		Direction of Survey:	<b>Upstream</b>
US MH:	<b>M-910-003</b>	DS MH:	<b>M-910-004</b>
		Total Length Surveyed (ft):	<b>81.0</b>

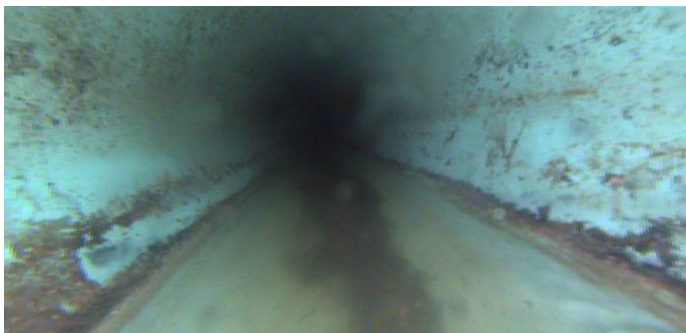
Code: **AMH**  
Description: **Manhole**

Distance (ft): **.0**  
Structural Grade: **0**  
O&M Grade: **0**  
Clock Start/From:  
Clock To:  
1st Value:  
2nd Value:  
Value Percent:  
Continuous Index:  
Within 8" of Joint: **NO**  
Remarks: **M-910-004**

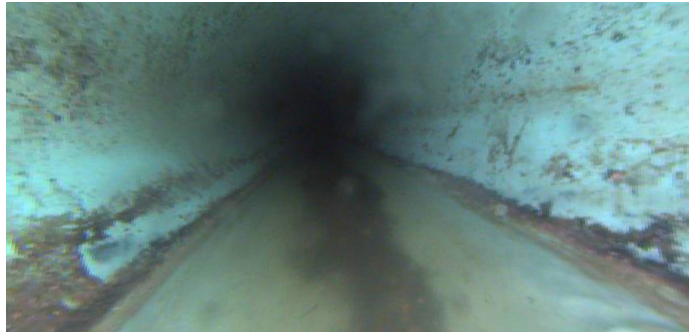
Code:	<b>MWL</b>
Description:	<b>Water Level</b>
Distance (ft):	<b>.0</b>
Structural Grade:	<b>0</b>
O&M Grade:	<b>0</b>
Clock Start/From:	
Clock To:	
1st Value:	
2nd Value:	
Value Percent:	<b>5.000</b>
Continuous Index:	
Within 8" of Joint:	<b>NO</b>
Remarks:

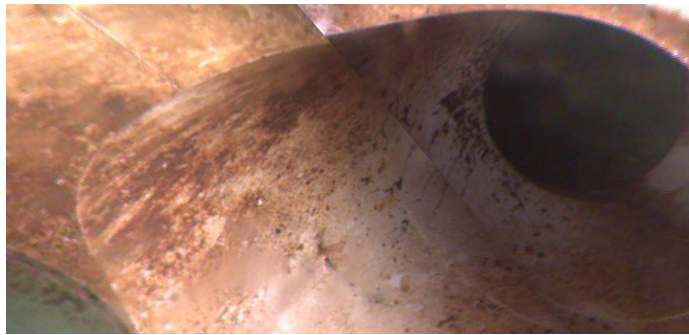
Code:	<b>TF</b>
Description:	<b>Tap Factory</b>
Distance (ft):	<b>74.5</b>
Structural Grade:	<b>0</b>
O&M Grade:	<b>0</b>
Clock Start/From:	<b>1</b>
Clock To:	
1st Value:	<b>4.000</b>
2nd Value:	
Value Percent:	
Continuous Index:	
Within 8" of Joint:	<b>YES</b>
Remarks:

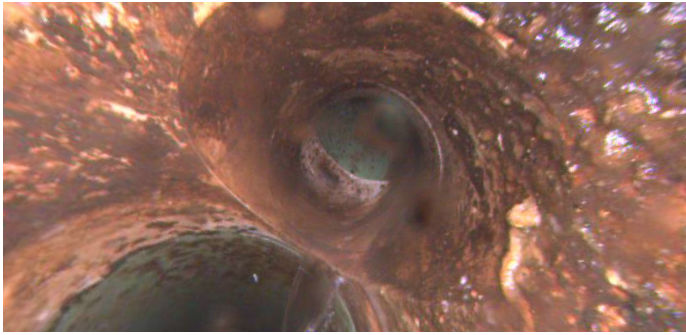
Code: **TFA**  
Description: **Tap Factory Active**

Distance (ft): **78.3**  
Structural Grade: **0**  
O&M Grade: **0**  
Clock Start/From: **1**  
Clock To:  
1st Value: **4.000**  
2nd Value:  
Value Percent:  
Continuous Index:  
Within 8" of Joint:  
Remarks:

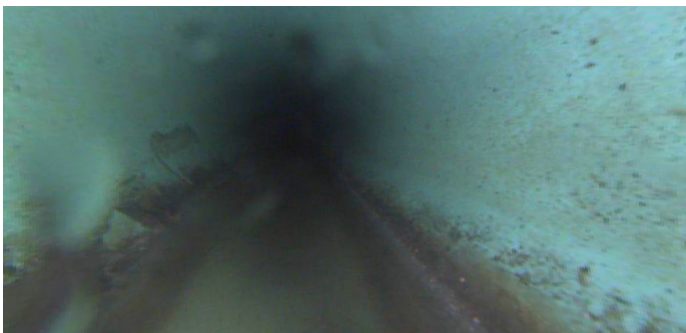
Code: **MSA**  
Description: **Abandoned Survey**

Distance (ft): **81.0**  
Structural Grade: **0**  
O&M Grade: **0**  
Clock Start/From:  
Clock To:  
1st Value:  
2nd Value:  
Value Percent:  
Continuous Index:  
Within 8" of Joint: **NO**  
Remarks: **debris**
