Profile/Photo Observation Report

Date:	03/27/2018	Weather:		Coding:	PACP 6.0
Pipe Length (ft):	141.2	Owner:	NA	Pre Clean:	Not Known
P.O.#:		Surveyor:	Byrd Fitzgerald	PSR:	P-910-004-003
Customer:		Clean Date:	01/01/1900	Shape:	C

Street:	Norris	Flow Control:	Not Controlled
City:	Hobart, IN	Year Renewed:	
Location:	Sidewalk	Tape/Media #:	
Purpose:	Maintenance Related	Dia/Height:	8"
Use:	Sanitary	Material:	PVC
Drain Area:	NA	Lining:	
Category:	NA		
Comment:	Flow direction wrong. Reverse setup. Debris at 79'.		
Location Details:		Direction of Survey:	Upstream
US MH:	M-910-003	DS MH:	M-910-004
		Total Length Surveyed (ft):	81.0

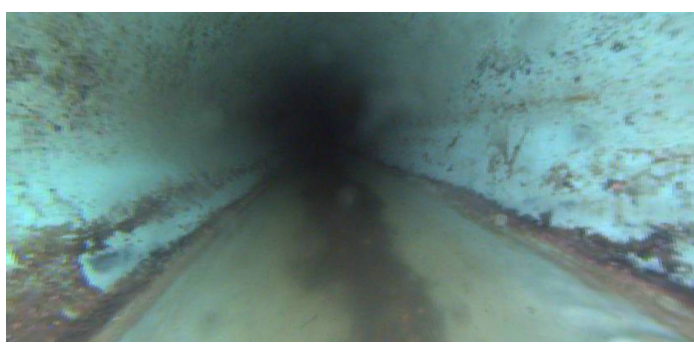
Code: **AMH**
Description: **Manhole**

Distance (ft): **.0**
Structural Grade: **0**
O&M Grade: **0**
Clock Start/From:
Clock To:
1st Value:
2nd Value:
Value Percent:
Continuous Index:
Within 8" of Joint: **NO**
Remarks: **M-910-004**

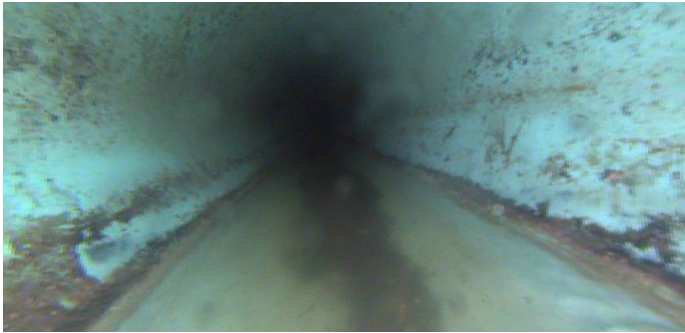
Code:	MWL
Description:	Water Level

Distance (ft):	.0
Structural Grade:	0
O&M Grade:	0
Clock Start/From:	
Clock To:	
1st Value:	
2nd Value:	
Value Percent:	5.000
Continuous Index:	
Within 8" of Joint:	NO
Remarks:

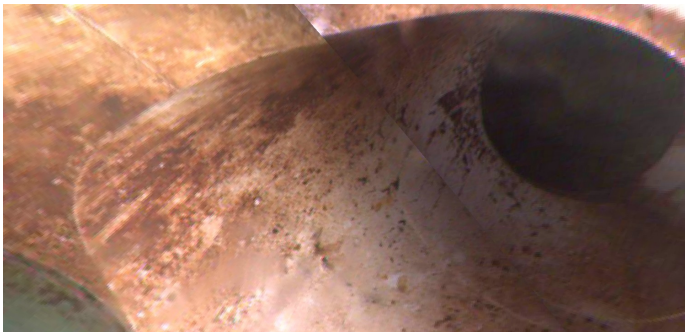
Code:	TF
Description:	Tap Factory

Distance (ft):	74.5
Structural Grade:	0
O&M Grade:	0
Clock Start/From:	1
Clock To:	
1st Value:	4.000
2nd Value:	
Value Percent:	
Continuous Index:	
Within 8" of Joint:	YES
Remarks:

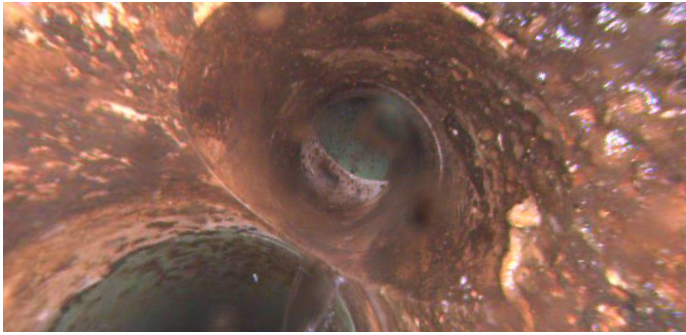
Code: **TFA**
Description: **Tap Factory Active**

Distance (ft): **78.3**
Structural Grade: **0**
O&M Grade: **0**
Clock Start/From: **1**
Clock To:
1st Value: **4.000**
2nd Value:
Value Percent:
Continuous Index:
Within 8" of Joint:
Remarks:

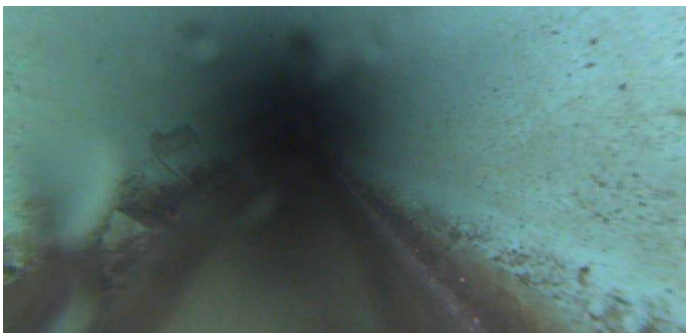
Code: **MSA**
Description: **Abandoned Survey**

Distance (ft): **81.0**
Structural Grade: **0**
O&M Grade: **0**
Clock Start/From:
Clock To:
1st Value:
2nd Value:
Value Percent:
Continuous Index:
Within 8" of Joint: **NO**
Remarks: **debris**
