Profile/Photo Observation Report

Date:	03/27/2018	Weather:		Coding:	PACP 6.0
Pipe Length (ft):	141.2	Owner:	NA	Pre Clean:	Not Known
P.O.#:		Surveyor:	Byrd Fitzgerald	PSR:	P-910-004-003
Customer:		Clean Date:	01/01/1900	Shape:	C

Location Details:		Direction of Survey:	Downstream
US MH:	M-910-003	DS MH:	M-910-004
		Total Length Surveyed (ft):	3.4

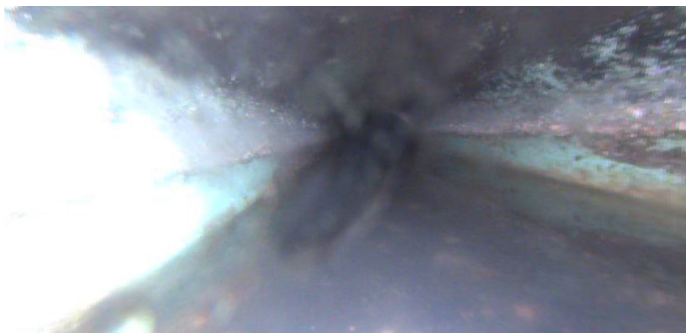
Code: **AMH**
Description: **Manhole**

Distance (ft): **.0**
Structural Grade: **0**
O&M Grade: **0**
Clock Start/From:
Clock To:
1st Value:
2nd Value:
Value Percent:
Continuous Index:
Within 8" of Joint: **NO**
Remarks: **M-910-003**

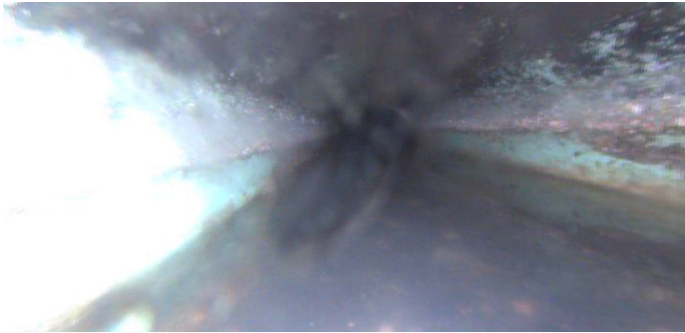
Code:	MWL
Description:	Water Level

Distance (ft):	.0
Structural Grade:	0
O&M Grade:	0
Clock Start/From:	
Clock To:	
1st Value:	
2nd Value:	
Value Percent:	50.000
Continuous Index:	
Within 8" of Joint:	NO
Remarks:

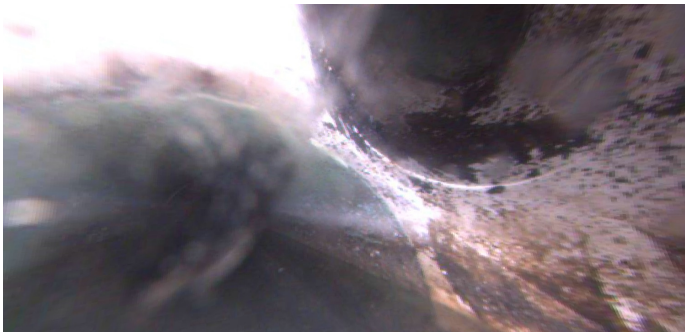
Code:	TF
Description:	Tap Factory

Distance (ft):	3.4
Structural Grade:	0
O&M Grade:	0
Clock Start/From:	1
Clock To:	
1st Value:	4.000
2nd Value:	
Value Percent:	
Continuous Index:	
Within 8" of Joint:	YES
Remarks:

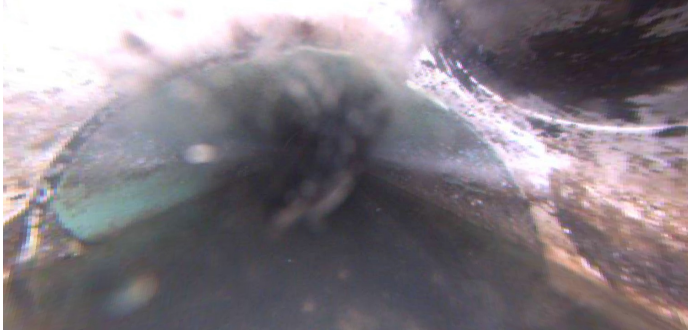
Code:	MSA
Description:	Abandoned Survey
Distance (ft):	3.4
Structural Grade:	0
O&M Grade:	0
Clock Start/From:	
Clock To:	
1st Value:	
2nd Value:	
Value Percent:	
Continuous Index:	
Within 8" of Joint:	NO
Remarks:	debris
