Profile/Photo Observation Report

Date:	10/13/2018	Weather:		Coding:	PACP 6.0
Pipe Length (ft):	141.2	Owner:	NA	Pre Clean:	Not Known
P.O.#:		Surveyor:	Selasie Honu	PSR:	P-910-004-003
Customer:		Clean Date:	01/01/1900	Shape:	C

Street:	NORRIS DR	Flow Control:	Not Controlled
City:	Hobart, IN	Year Renewed:	
Location:	Light Highway	Tape/Media #:	
Purpose:	Routine Assessment	Dia/Height:	8"
Use:	Sanitary	Material:	PVC
Drain Area:	NA	Lining:	
Category:	NA		
Comment:

Location Details:		Direction of Survey:	Upstream
US MH:	M-910-003	DS MH:	M-910-004
		Total Length Surveyed (ft):	143.8

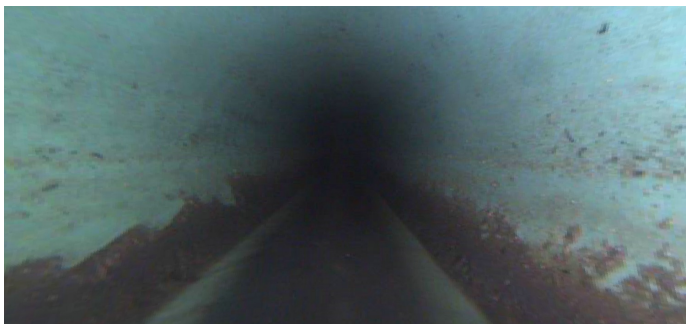
Code: **AMH**
Description: **Manhole**

Distance (ft): **.0**
Structural Grade: **0**
O&M Grade: **0**
Clock Start/From:
Clock To:
1st Value:
2nd Value:
Value Percent:
Continuous Index:
Within 8" of Joint: **NO**
Remarks: **M-910-004**

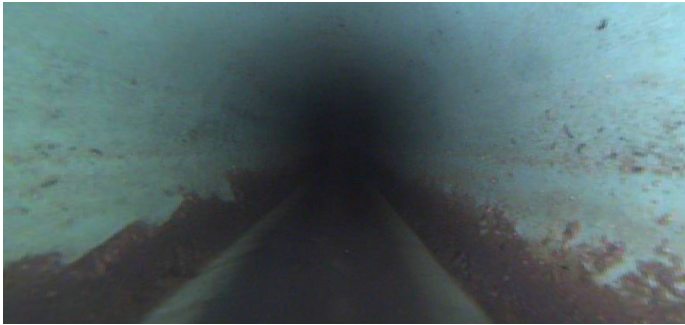
Code:	MWL
Description:	Water Level

Distance (ft):	.0
Structural Grade:	0
O&M Grade:	0
Clock Start/From:	
Clock To:	
1st Value:	
2nd Value:	
Value Percent:	5.000
Continuous Index:	
Within 8" of Joint:	NO
Remarks:

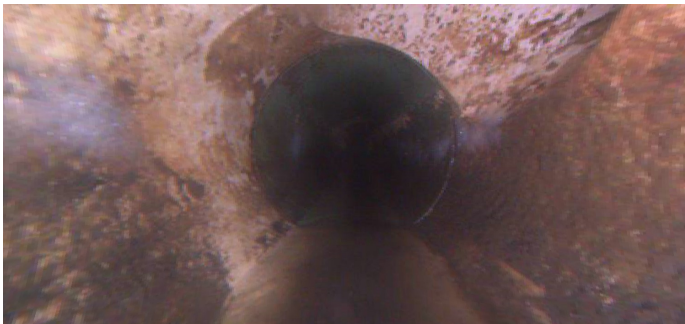
Code:	TF
Description:	Tap Factory

Distance (ft):	77.0
Structural Grade:	0
O&M Grade:	0
Clock Start/From:	2
Clock To:	
1st Value:	4.000
2nd Value:	
Value Percent:	
Continuous Index:	
Within 8" of Joint:	
Remarks:

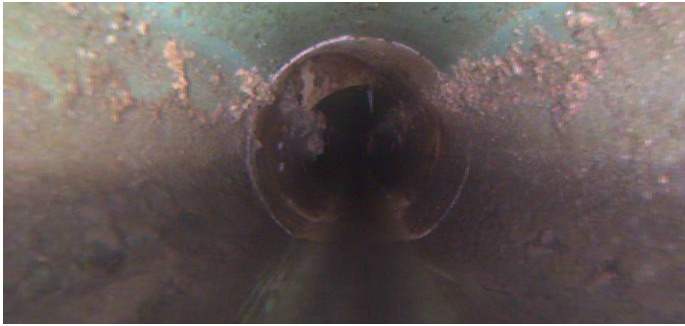
Code: **DAGS**
Description: **Deposits Attached Grease**

Distance (ft): **79.6**
Structural Grade: **0**
O&M Grade: **5**
Clock Start/From: **8**
Clock To: **4**
1st Value:
2nd Value:
Value Percent: **50.000**
Continuous Index: **S01**
Within 8" of Joint: **YES**
Remarks:

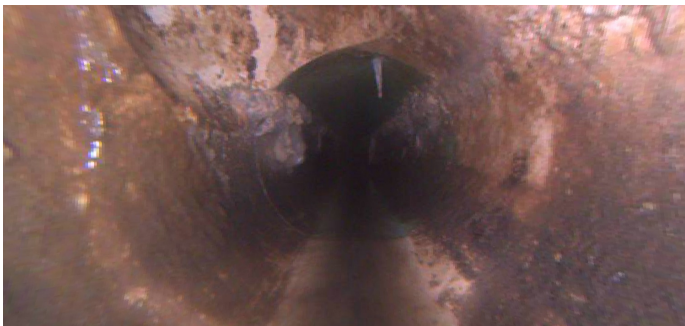
Code: **TF**
Description: **Tap Factory**

Distance (ft): **80.3**
Structural Grade: **0**
O&M Grade: **0**
Clock Start/From: **11**
Clock To:
1st Value: **4.000**
2nd Value:
Value Percent:
Continuous Index:
Within 8" of Joint:
Remarks:

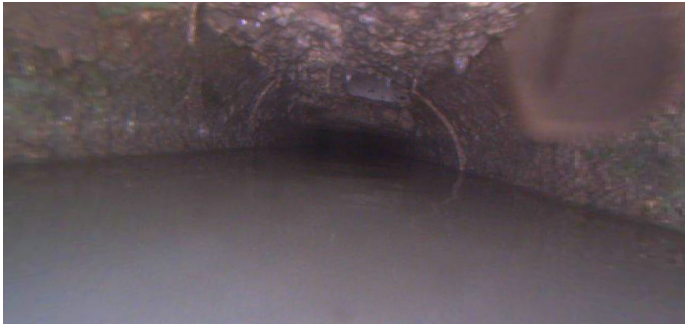
Code: **FL**
Description: **Fracture Longitudinal**

Distance (ft): **132.5**
Structural Grade: **3**
O&M Grade: **0**
Clock Start/From: **12**
Clock To:
1st Value: **4.000**
2nd Value:
Value Percent:
Continuous Index:
Within 8" of Joint:
Remarks:

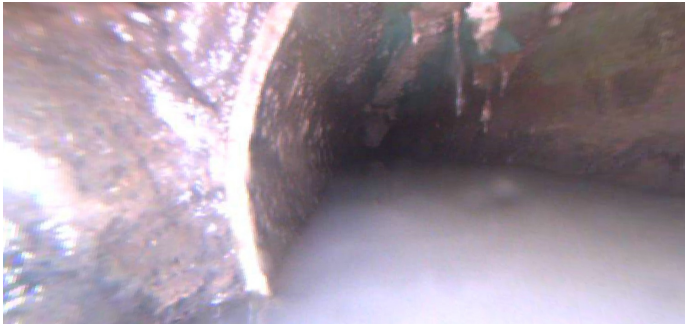
Code: **AMH**
Description: **Manhole**

Distance (ft): **143.8**
Structural Grade: **0**
O&M Grade: **0**
Clock Start/From:
Clock To:
1st Value:
2nd Value:
Value Percent:
Continuous Index:
Within 8" of Joint: **NO**
Remarks: **M-910-003**

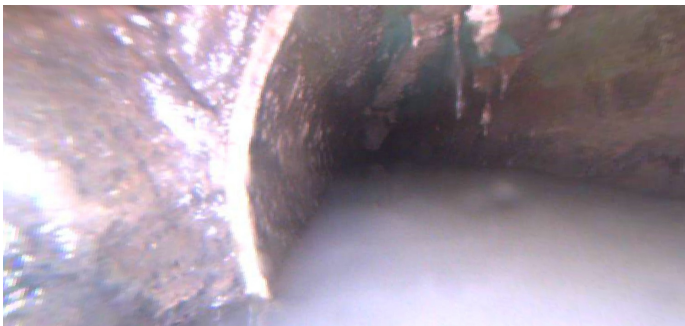
Code: **DAGS**
Description: **Deposits Attached Grease**

Distance (ft): **143.8**
Structural Grade: **0**
O&M Grade: **5**
Clock Start/From: **8**
Clock To: **4**
1st Value:
2nd Value:
Value Percent: **50.000**
Continuous Index: **F01**
Within 8" of Joint: **YES**
Remarks:
