Profile/Photo Observation Report

Date:	10/13/2018	Weather:		Coding:	PACP 6.0
Pipe Length (ft):	141.2	Owner:	NA	Pre Clean:	Not Known
P.O.#:		Surveyor:	Selasie Honu	PSR:	P-910-004-003
Customer:		Clean Date:	01/01/1900	Shape:	C

Street:	Norris Dr.	Flow Control:	Not Controlled
City:	Hobart, IN	Year Renewed:	
Location:	Light Highway	Tape/Media #:	
Purpose:	Routine Assessment	Dia/Height:	8"
Use:	Sanitary	Material:	PVC
Drain Area:	NA	Lining:	
Category:	NA		
Comment:

Location Details:		Direction of Survey:	Upstream
US MH:	M-910-003	DS MH:	M-910-004
		Total Length Surveyed (ft):	143.8

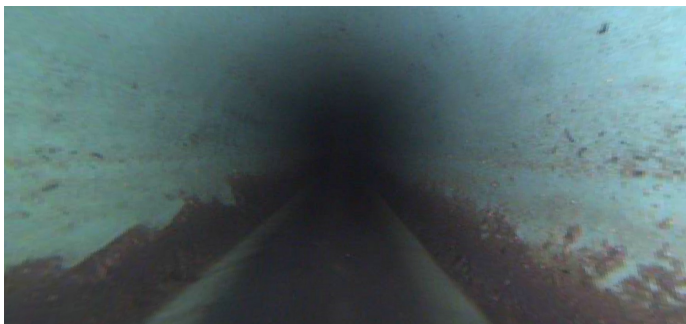
Code: **AMH**
Description: **Manhole**

Distance (ft): **.0**
Structural Grade: **0**
O&M Grade: **0**
Clock Start/From:
Clock To:
1st Value:
2nd Value:
Value Percent:
Continuous Index:
Within 8" of Joint: **NO**
Remarks: **M-910-004**

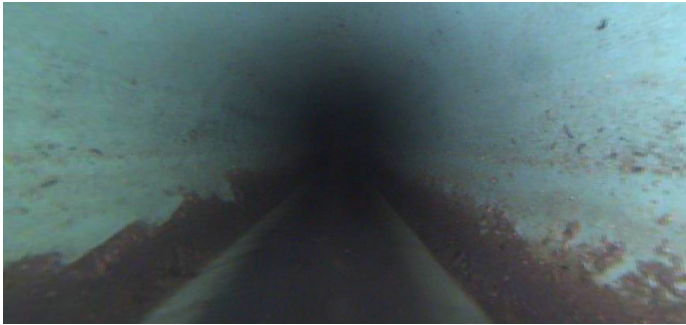
Code:	MWL
Description:	Water Level

Distance (ft):	.0
Structural Grade:	0
O&M Grade:	0
Clock Start/From:	
Clock To:	
1st Value:	
2nd Value:	
Value Percent:	5.000
Continuous Index:	
Within 8" of Joint:	NO
Remarks:

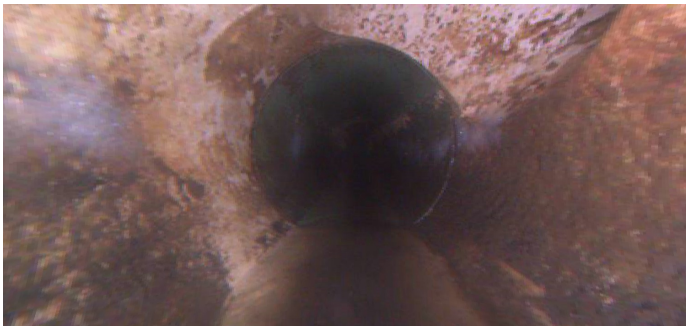
Code:	TF
Description:	Tap Factory

Distance (ft):	77.0
Structural Grade:	0
O&M Grade:	0
Clock Start/From:	2
Clock To:	
1st Value:	4.000
2nd Value:	
Value Percent:	
Continuous Index:	
Within 8" of Joint:	
Remarks:

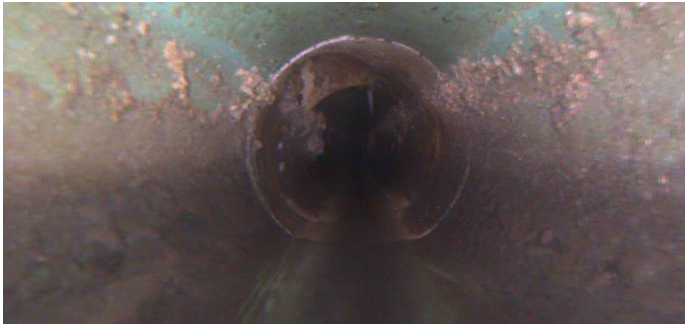
Code: **DAGS**
Description: **Deposits Attached Grease**

Distance (ft): **79.6**
Structural Grade: **0**
O&M Grade: **5**
Clock Start/From: **8**
Clock To: **4**
1st Value:
2nd Value:
Value Percent: **50.000**
Continuous Index: **S01**
Within 8" of Joint: **YES**
Remarks:

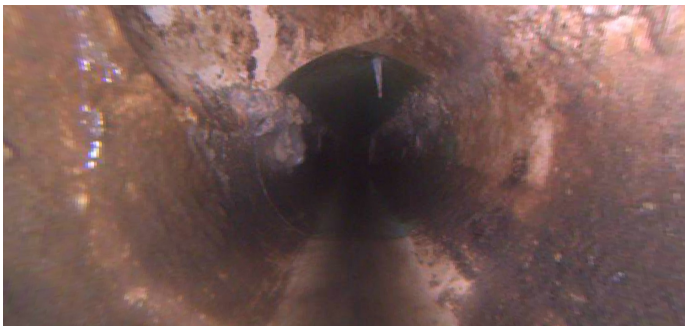
Code: **TF**
Description: **Tap Factory**

Distance (ft): **80.3**
Structural Grade: **0**
O&M Grade: **0**
Clock Start/From: **11**
Clock To:
1st Value: **4.000**
2nd Value:
Value Percent:
Continuous Index:
Within 8" of Joint:
Remarks:

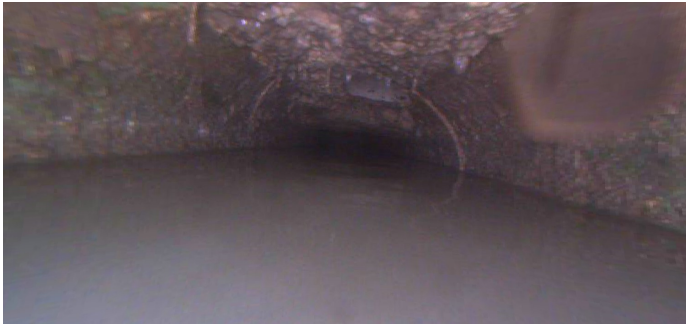
Code: **FL**
Description: **Fracture Longitudinal**

Distance (ft): **132.5**
Structural Grade: **3**
O&M Grade: **0**
Clock Start/From: **12**
Clock To:
1st Value: **4.000**
2nd Value:
Value Percent:
Continuous Index:
Within 8" of Joint:
Remarks:

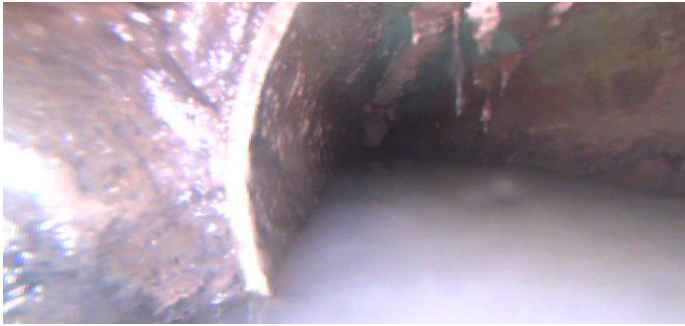
Code: **AMH**
Description: **Manhole**

Distance (ft): **143.8**
Structural Grade: **0**
O&M Grade: **0**
Clock Start/From:
Clock To:
1st Value:
2nd Value:
Value Percent:
Continuous Index:
Within 8" of Joint: **NO**
Remarks: **M-910-003**

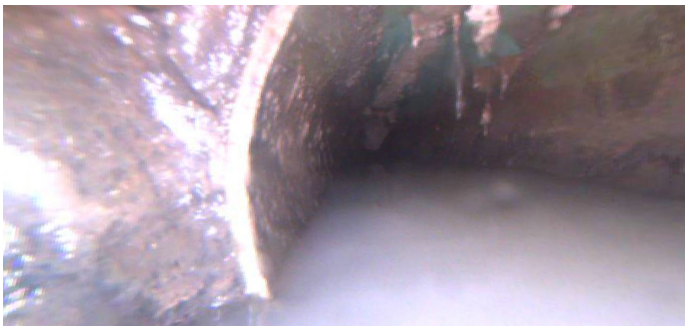
Code: **DAGS**
Description: **Deposits Attached Grease**

Distance (ft): **143.8**
Structural Grade: **0**
O&M Grade: **5**
Clock Start/From: **8**
Clock To: **4**
1st Value:
2nd Value:
Value Percent: **50.000**
Continuous Index: **F01**
Within 8" of Joint: **YES**
Remarks:
