## Profile/Photo Observation Report

Date:	<b>10/13/2018</b>	Weather:		Coding:	<b>PACP 6.0</b>
Pipe Length (ft):	<b>182.4</b>	Owner:	<b>NA</b>	Pre Clean:	<b>Not Known</b>
P.O.#:		Surveyor:	<b>Selasie Honu</b>	PSR:	<b>P-910-008-007</b>
Customer:		Clean Date:	<b>01/01/1900</b>	Shape:	<b>C</b>

Street:	<b>NORRIS DR</b>	Flow Control:	<b>Not Controlled</b>
City:	<b>Hobart, IN</b>	Year Renewed:	
Location:	<b>Light Highway</b>	Tape/Media #:	
Purpose:	<b>Routine Assessment</b>	Dia/Height:	<b>8"</b>
Use:	<b>Sanitary</b>	Material:	<b>PVC</b>
Drain Area:	<b>NA</b>	Lining:	
Category:	<b>NA</b>		
Comment:

Location Details:		Direction of Survey:	<b>Upstream</b>
US MH:	<b>M-910-007</b>	DS MH:	<b>M-910-008</b>
		Total Length Surveyed (ft):	<b>186.0</b>

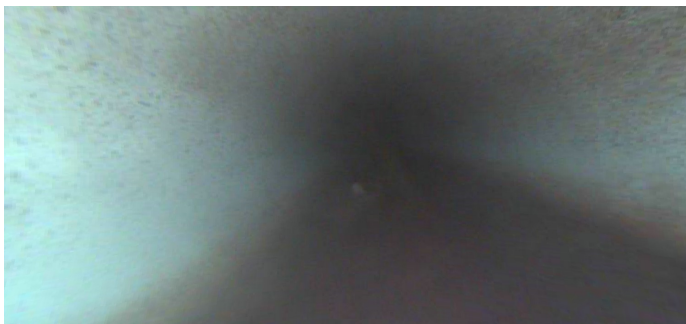
Code: **AMH**  
Description: **Manhole**

Distance (ft): **.0**  
Structural Grade: **0**  
O&M Grade: **0**  
Clock Start/From:  
Clock To:  
1st Value:  
2nd Value:  
Value Percent:  
Continuous Index:  
Within 8" of Joint: **NO**  
Remarks: **M-910-008**

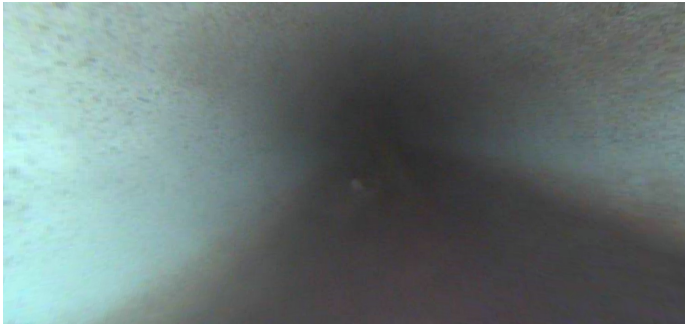
Code:	<b>MWL</b>
Description:	<b>Water Level</b>

Distance (ft):	<b>.0</b>
Structural Grade:	<b>0</b>
O&M Grade:	<b>0</b>
Clock Start/From:	
Clock To:	
1st Value:	
2nd Value:	
Value Percent:	<b>5.000</b>
Continuous Index:	
Within 8" of Joint:	<b>NO</b>
Remarks:

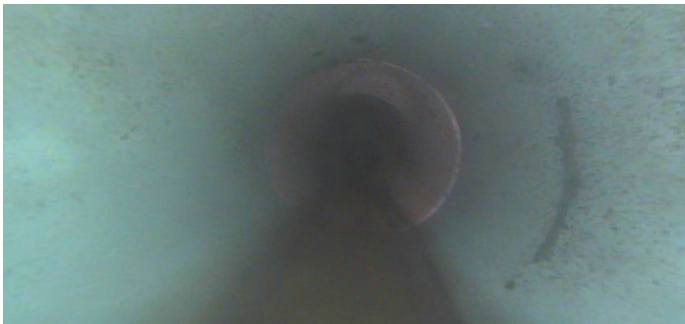
Code:	<b>TF</b>
Description:	<b>Tap Factory</b>

Distance (ft):	<b>47.5</b>
Structural Grade:	<b>0</b>
O&M Grade:	<b>0</b>
Clock Start/From:	<b>1</b>
Clock To:	
1st Value:	<b>4.000</b>
2nd Value:	
Value Percent:	
Continuous Index:	
Within 8" of Joint:	
Remarks:

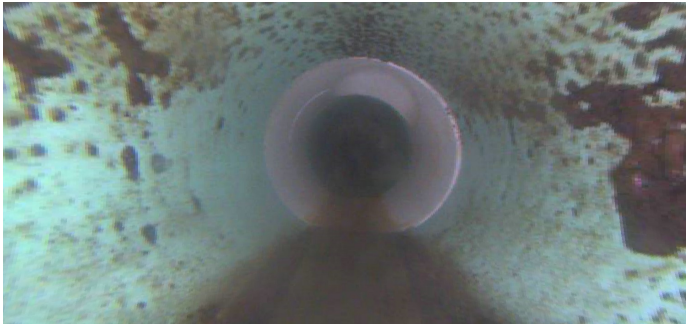
Code: **TF**  
Description: **Tap Factory**

Distance (ft): **114.0**  
Structural Grade: **0**  
O&M Grade: **0**  
Clock Start/From: **1**  
Clock To:  
1st Value: **4.000**  
2nd Value:  
Value Percent:  
Continuous Index:  
Within 8" of Joint:  
Remarks:

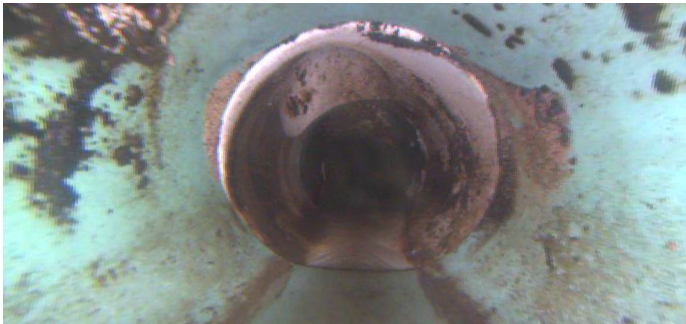
Code: **TF**  
Description: **Tap Factory**

Distance (ft): **141.1**  
Structural Grade: **0**  
O&M Grade: **0**  
Clock Start/From: **11**  
Clock To:  
1st Value: **4.000**  
2nd Value:  
Value Percent:  
Continuous Index:  
Within 8" of Joint:  
Remarks:

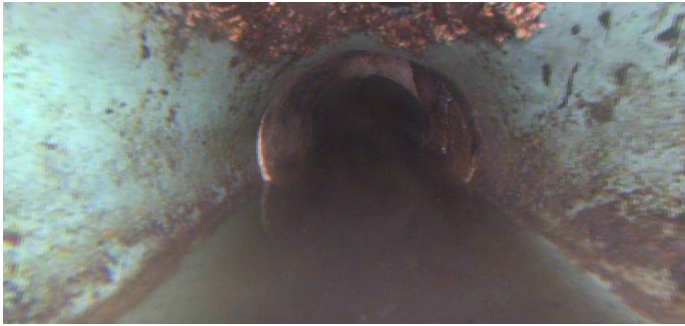
Code: **TF**  
Description: **Tap Factory**

Distance (ft): **142.8**  
Structural Grade: **0**  
O&M Grade: **0**  
Clock Start/From: **12**  
Clock To:  
1st Value: **4.000**  
2nd Value:  
Value Percent:  
Continuous Index:  
Within 8" of Joint:  
Remarks:

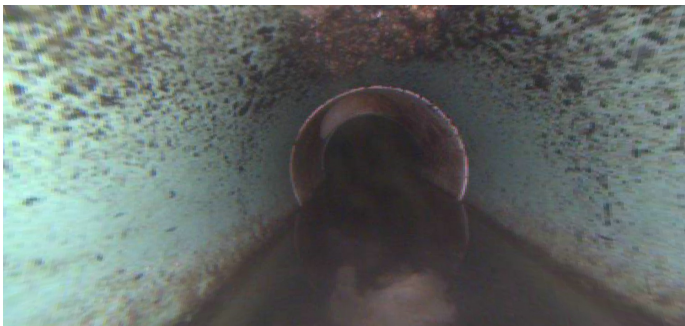
Code: **TF**  
Description: **Tap Factory**

Distance (ft): **180.0**  
Structural Grade: **0**  
O&M Grade: **0**  
Clock Start/From: **11**  
Clock To:  
1st Value: **4.000**  
2nd Value:  
Value Percent:  
Continuous Index:  
Within 8" of Joint:  
Remarks:

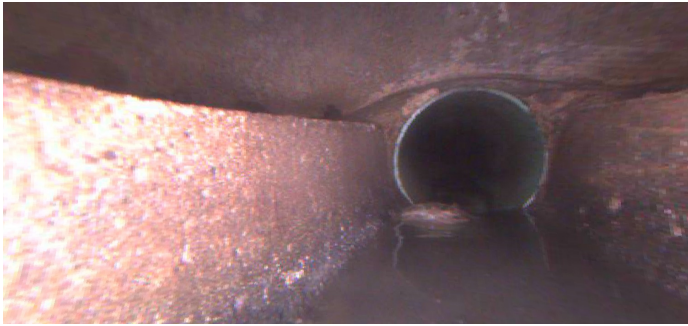
Code:	<b>AMH</b>
Description:	<b>Manhole</b>
Distance (ft):	<b>186.0</b>
Structural Grade:	<b>0</b>
O&M Grade:	<b>0</b>
Clock Start/From:	
Clock To:	
1st Value:	
2nd Value:	
Value Percent:	
Continuous Index:	
Within 8" of Joint:	<b>NO</b>
Remarks:	<b>M-910-007</b>
