## Profile/Photo Observation Report

Street:	<b>Norris Dr.</b>	Flow Control:	<b>Not Controlled</b>
City:	<b>Hobart, IN</b>	Year Renewed:	
Location:	<b>Light Highway</b>	Tape/Media #:	
Purpose:	<b>Routine Assessment</b>	Dia/Height:	<b>8"</b>
Use:	<b>Sanitary</b>	Material:	<b>PVC</b>
Drain Area:	<b>NA</b>	Lining:	
Category:	<b>NA</b>		
Comment:

Location Details:		Direction of Survey:	<b>Downstream</b>
US MH:	<b>M-910-008</b>	DS MH:	<b>M-910-009</b>
		Total Length Surveyed (ft):	<b>242.3</b>

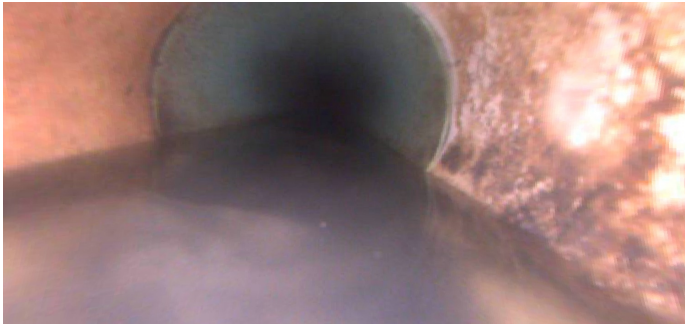
Code:	<b>MWL</b>
Description:	<b>Water Level</b>

Distance (ft):	<b>.0</b>
Structural Grade:	<b>0</b>
O&M Grade:	<b>0</b>
Clock Start/From:	
Clock To:	
1st Value:	
2nd Value:	
Value Percent:	<b>5.000</b>
Continuous Index:	
Within 8" of Joint:	<b>NO</b>
Remarks:

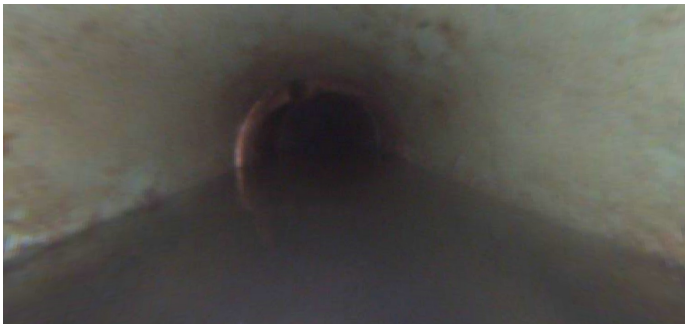
Code:	<b>TF</b>
Description:	<b>Tap Factory</b>

Distance (ft):	<b>71.5</b>
Structural Grade:	<b>0</b>
O&M Grade:	<b>0</b>
Clock Start/From:	<b>11</b>
Clock To:	
1st Value:	<b>4.000</b>
2nd Value:	
Value Percent:	
Continuous Index:	
Within 8" of Joint:	
Remarks:

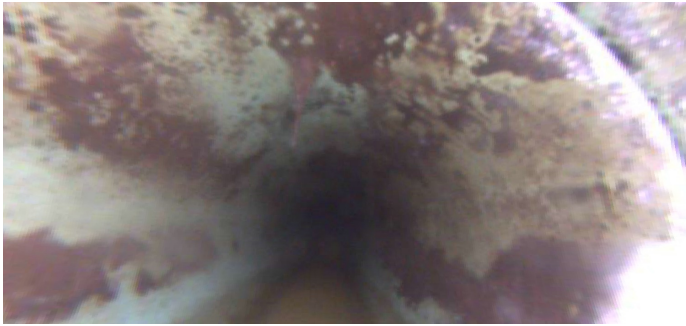
Code: **RFB**  
Description: **Roots Fine Barrel**

Distance (ft): **87.8**  
Structural Grade: **0**  
O&M Grade: **2**  
Clock Start/From: **12**  
Clock To:  
1st Value:  
2nd Value:  
Value Percent:  
Continuous Index:  
Within 8" of Joint: **NO**  
Remarks:

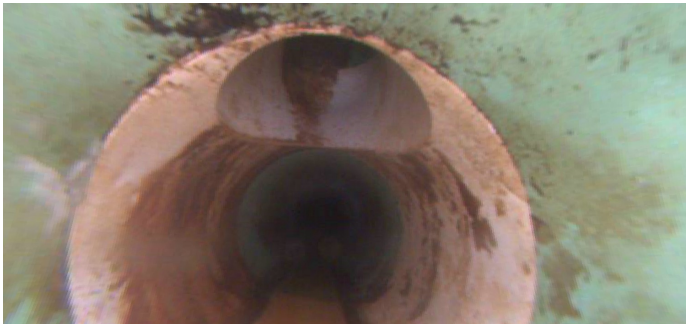
Code: **TF**  
Description: **Tap Factory**

Distance (ft): **222.1**  
Structural Grade: **0**  
O&M Grade: **0**  
Clock Start/From: **12**  
Clock To:  
1st Value: **4.000**  
2nd Value:  
Value Percent:  
Continuous Index:  
Within 8" of Joint:  
Remarks:

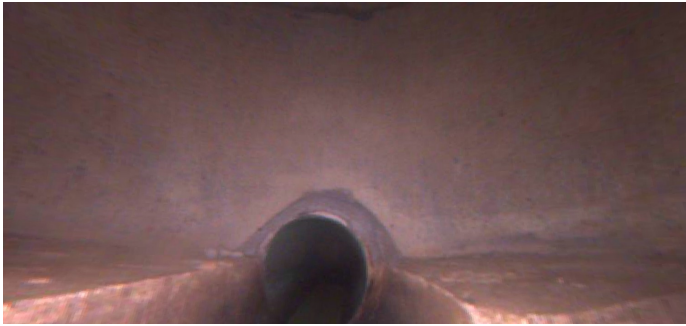
Code:	<b>AMH</b>
Description:	<b>Manhole</b>
Distance (ft):	<b>242.3</b>
Structural Grade:	<b>0</b>
O&M Grade:	<b>0</b>
Clock Start/From:	
Clock To:	
1st Value:	
2nd Value:	
Value Percent:	
Continuous Index:	
Within 8" of Joint:	<b>NO</b>
Remarks:	<b>M-910-009</b>
