## Profile/Photo Observation Report

Street:	<b>NORRIS DR</b>	Flow Control:	<b>Not Controlled</b>
City:	<b>Hobart, IN</b>	Year Renewed:	
Location:	<b>Sidewalk</b>	Tape/Media #:	
Purpose:	<b>Maintenance Related</b>	Dia/Height:	<b>8"</b>
Use:	<b>Sanitary</b>	Material:	<b>PVC</b>
Drain Area:	<b>NA</b>	Lining:	
Category:	<b>NA</b>		
Comment:	<b>Flow direction wrong.</b>

Location Details:		Direction of Survey:	<b>Downstream</b>
US MH:	<b>M-910-009</b>	DS MH:	<b>M-910-010</b>
		Total Length Surveyed (ft):	<b>82.1</b>

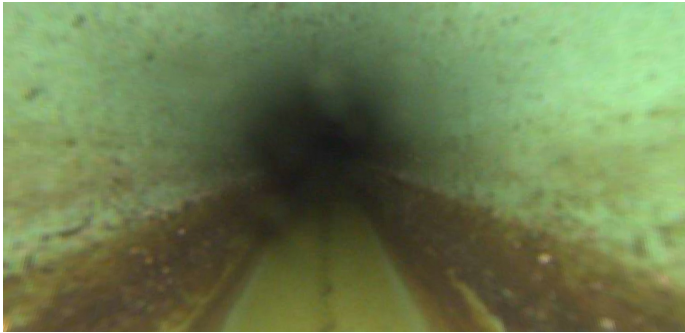
Code:	<b>MWL</b>
Description:	<b>Water Level</b>

Distance (ft):	<b>.0</b>
Structural Grade:	<b>0</b>
O&M Grade:	<b>0</b>
Clock Start/From:	
Clock To:	
1st Value:	
2nd Value:	
Value Percent:	<b>5.000</b>
Continuous Index:	
Within 8" of Joint:	<b>NO</b>
Remarks:

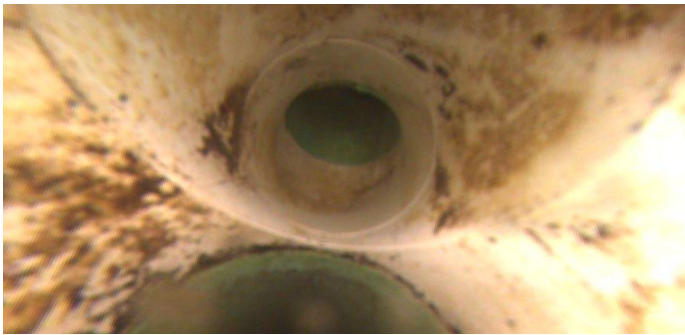
Code:	<b>TF</b>
Description:	<b>Tap Factory</b>

Distance (ft):	<b>5.8</b>
Structural Grade:	<b>0</b>
O&M Grade:	<b>0</b>
Clock Start/From:	<b>12</b>
Clock To:	
1st Value:	<b>4.000</b>
2nd Value:	
Value Percent:	
Continuous Index:	
Within 8" of Joint:	<b>YES</b>
Remarks:

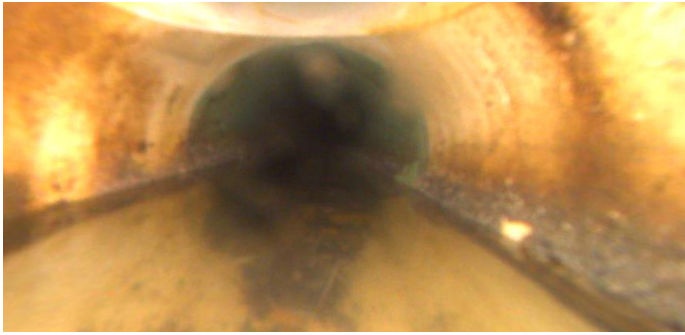
Code: **MWL**  
Description: **Water Level**

Distance (ft): **63.0**  
Structural Grade: **0**  
O&M Grade: **0**  
Clock Start/From:  
Clock To:  
1st Value:  
2nd Value:  
Value Percent: **30.000**  
Continuous Index:  
Within 8" of Joint: **NO**  
Remarks:

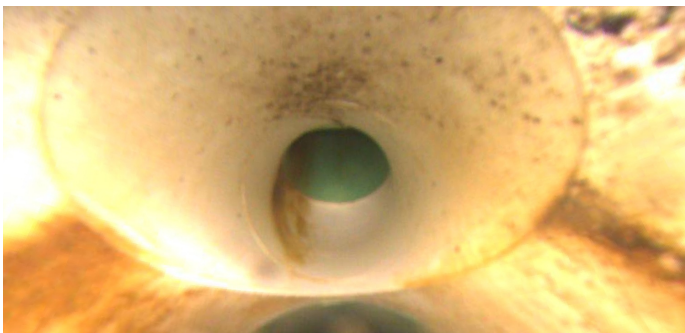
Code: **TF**  
Description: **Tap Factory**

Distance (ft): **63.1**  
Structural Grade: **0**  
O&M Grade: **0**  
Clock Start/From: **12**  
Clock To:  
1st Value: **4.000**  
2nd Value:  
Value Percent:  
Continuous Index:  
Within 8" of Joint:  
Remarks:

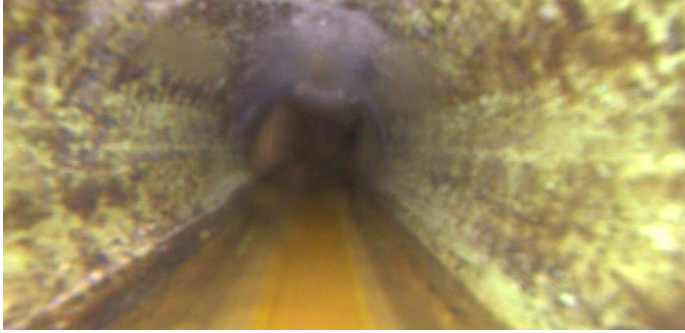
Code: **MWL**  
Description: **Water Level**

Distance (ft): **78.4**  
Structural Grade: **0**  
O&M Grade: **0**  
Clock Start/From:  
Clock To:  
1st Value:  
2nd Value:  
Value Percent: **10.000**  
Continuous Index:  
Within 8" of Joint: **NO**  
Remarks:

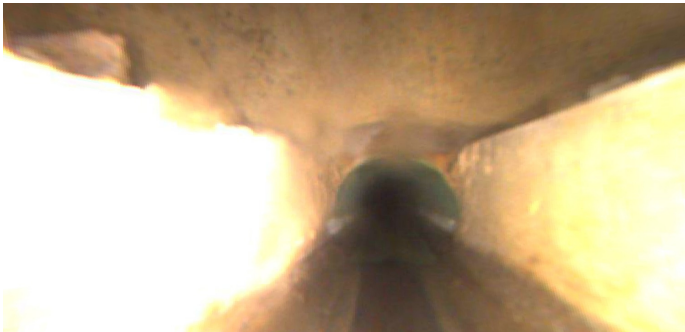
Code: **AMH**  
Description: **Manhole**

Distance (ft): **82.1**  
Structural Grade: **0**  
O&M Grade: **0**  
Clock Start/From:  
Clock To:  
1st Value:  
2nd Value:  
Value Percent:  
Continuous Index:  
Within 8" of Joint: **NO**  
Remarks: **M-910-010**
